MARINE SAFETY INVESTIGATION REPORT

OWNER/IMO NO : İLHAN YILMAZ 5/ 9892638

LOCATION OF ACCIDENT: Nouadhibou/MORİTANYA

DATE OF ACCIDENT : 26.11.2019/13:00 Lt

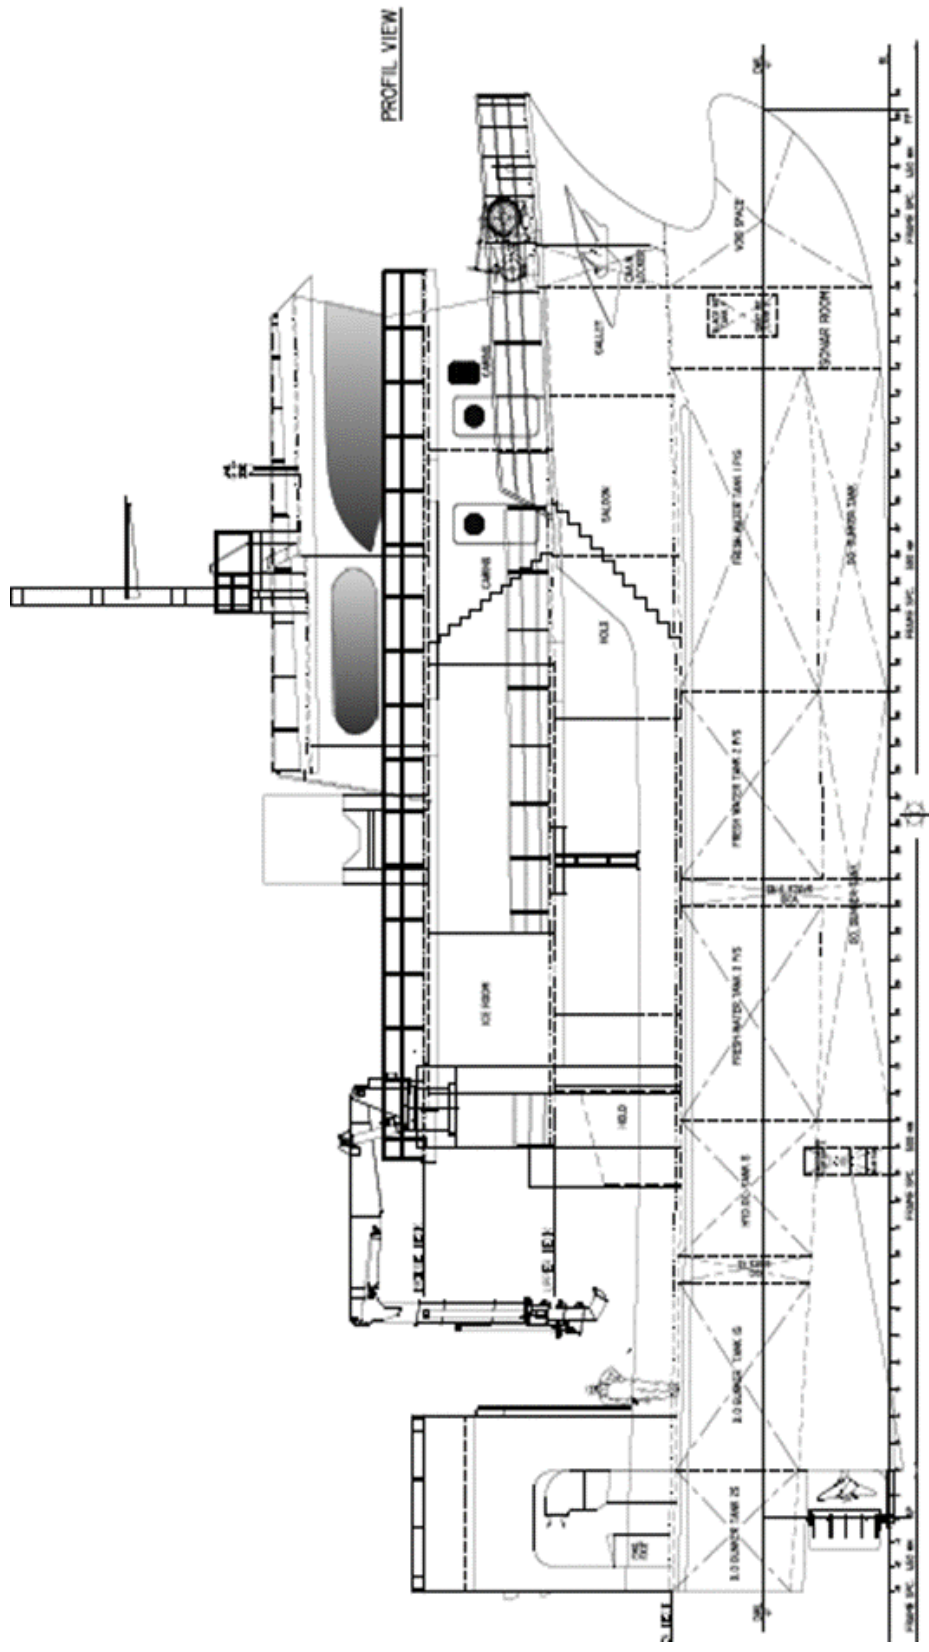
Profile View of the Hull

There are two fish holds and four hatches in total; each hold has two hatches (at sizes of 100 cm x 100 cm).

The vessel is equipped with two diesel main engines, each having 858 kW power, and two propellers. The fore draught of the vessel is 150 cm, aft draught is 200 cm and the vessel is trimmed by the stern for 50 cm while in ballast.

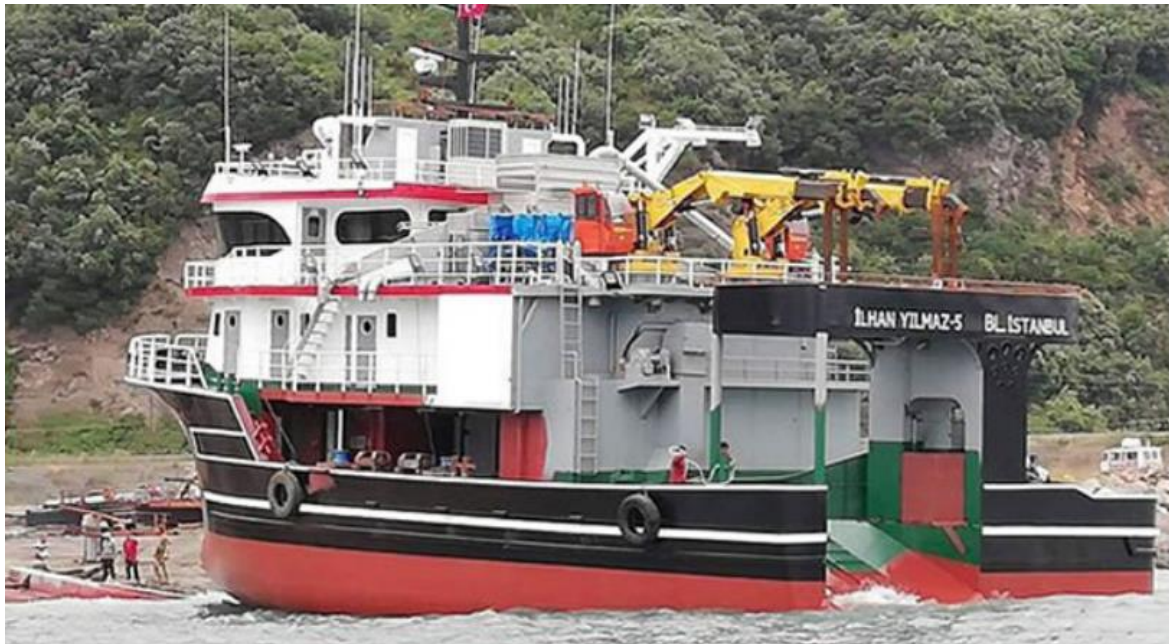
Image 2: View of the vessel, İlhan Yılmaz 5 from port side
