**Accident Investigation Report On**  
**The Foundering of KURT C**

**Off Kaleiçi Port / Antalya**

**03 September 2016**

**36/DNZ-05/2017**

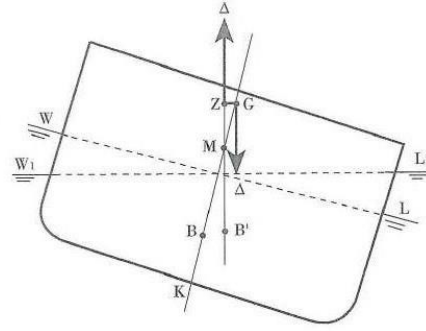
Figure 12: A ship at unstable equilibrium

In this accident, KURT C toppled to her starboard side at such an angle that was too big for her to be able to become upright again and due to the magnitude of the leaning angle, fell into an unstable equilibrium, and as a result could not become upright again and sank.

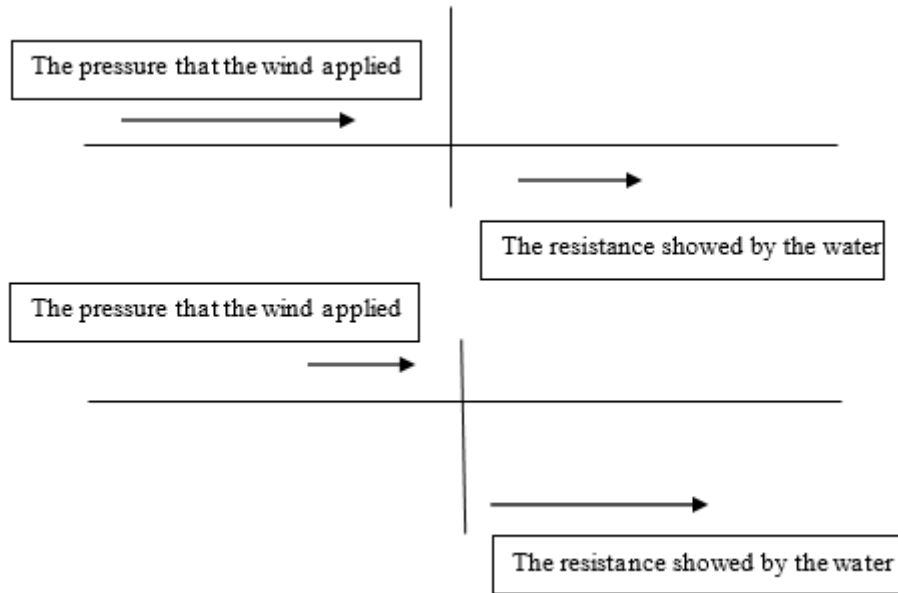
Figure 13: Effect of wind and water at ships with high upperstructure and low upperstructure

The fact that the ship has a high freeboard is a factor that will increase the effect of the winds to which the ship is exposed. The larger the surface exposed to the wind, the greater will be the force that will drift or lean the the ship.

KURT C was also more affected by the prevailing strong wind conditions, compared to other small boats, especially in comparison with ADONIS, which was very close to the scene of the accident.

As we have tried to explain schematically above, the larger the surface of the boat compared to the underwater section, the greater the power balance will change in favor of wind pressure and against the resistance of the water, and with the effect of wind the boat will lean more and more to her side. In the case of an inverse ratio, the resistance of the water will be higher than the effect of the wind.

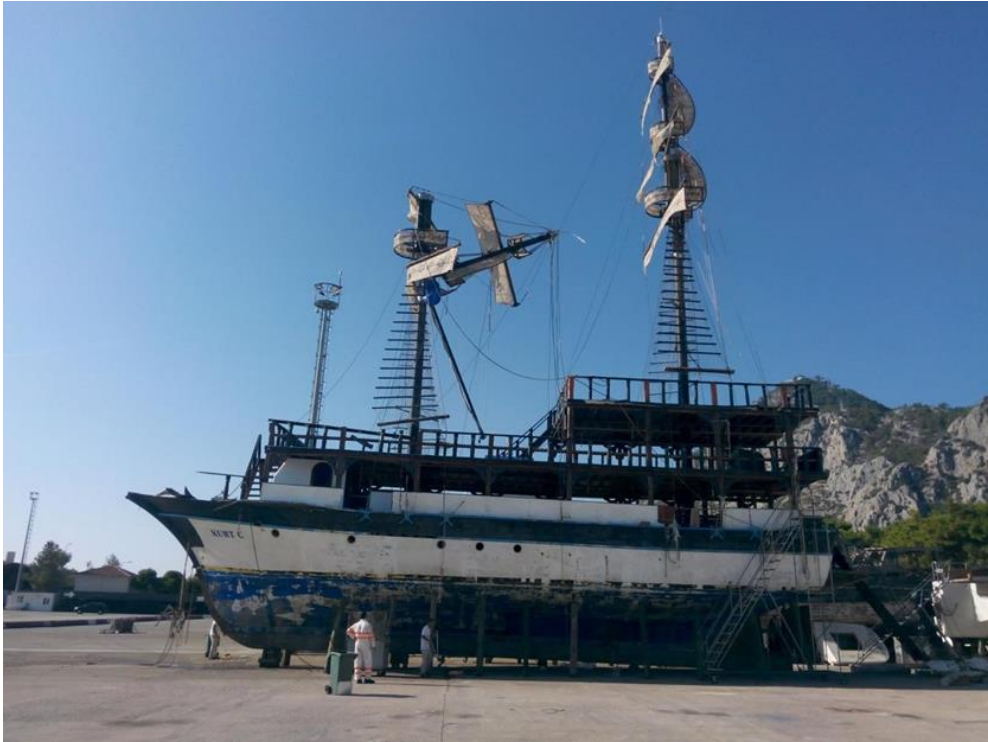
Figure 17: KURT C ashore, at SETUR Marina

The portholes at the freeboard of the boat have been equipped with watertight covers. The purpose of these covers is to be closed at high waves when there is the possibility of water ingress from the freeboards and thus to prevent the boat from being flooded. The pictures taken while the boat was under the water show that the portholes were open. This can be interpreted as the Captain and the crew members had not remembered to close the portholes or they didn't have time to do it.

As a result of the boat' tilting, water penetration from the open portholes caused the boat to lean on its side further more and caused the weights that sank the boat to increase, thus constituting one of the factors in the sinking of the boat or accelerating this process.

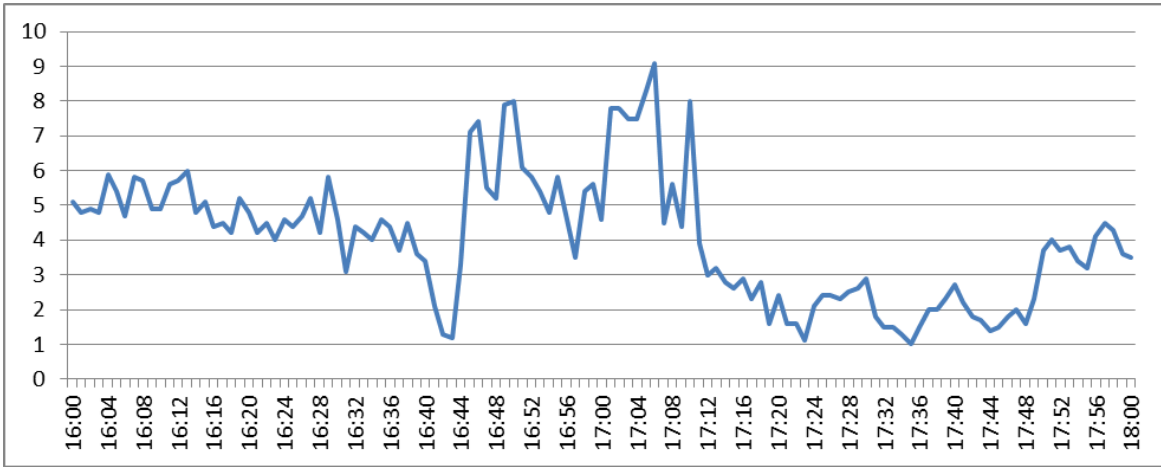
Figure 21: Wind Force (m/s)

As can be seen from the graphs, the wind values measured at the station are well below the maximum wind values measured in the last decade. However, it is considered that a much stronger wind gust occurred locally in the immediate area where the accident occurred.

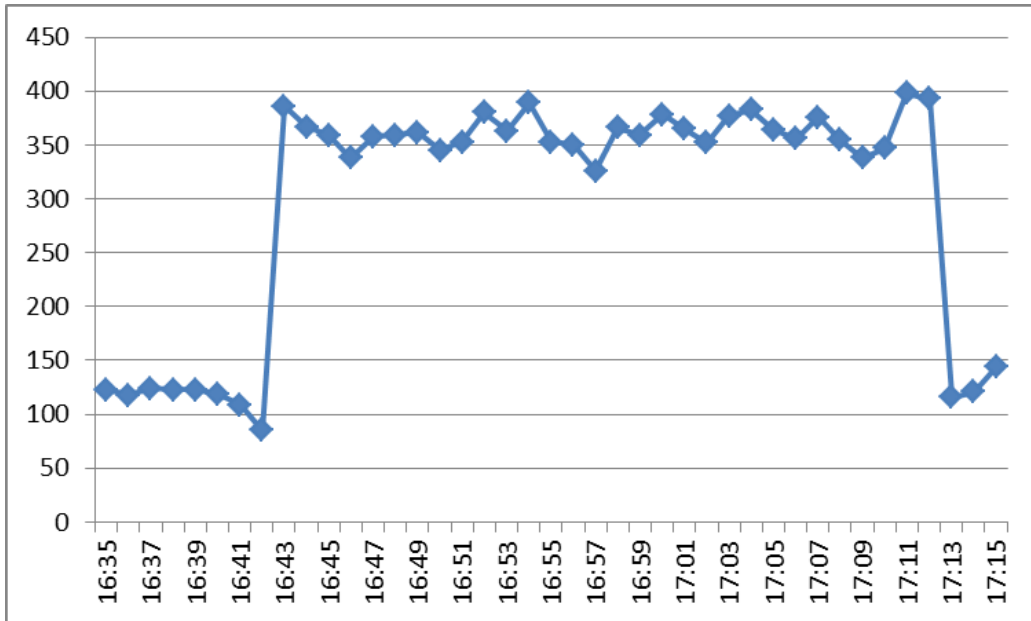
Figure 23:Wind Direction Table

at 16:47 and it was measured 5,2 at 16:48; increased back to 7,9 at 16:49 and 8,0 at 16:50; after decreasing after 16:51 to as low as 3,5 at 16:57 increased again until 17:06 and reaching 9,1 and decreasing to below 4,0 m/s after 17:11 hours and losing its effect.
