MARINE SAFETY INVESTIGATION REPORT

OWNER	: SAREIA SHIPPING INC.
MANAGER	: OTONIO SHIP MANAGEMENT COMPANY INC.
NAME OF SHIP / CALL SIGN	: KYME / XUPY9
FLAG	: KING OF CAMBODIA
SCENE OF ACCIDENT	: İstanbul - Zeytinburnu Anchorage Area / TURKEY
DATE OF ACCIDENT / TIME	: 03.06.2014 / 15:15 LT
FATALITY / INJURY	: 1/-
DAMAGE / POLLUTION	: -/-

Board Resolution No: 18/DNZ-06/2019

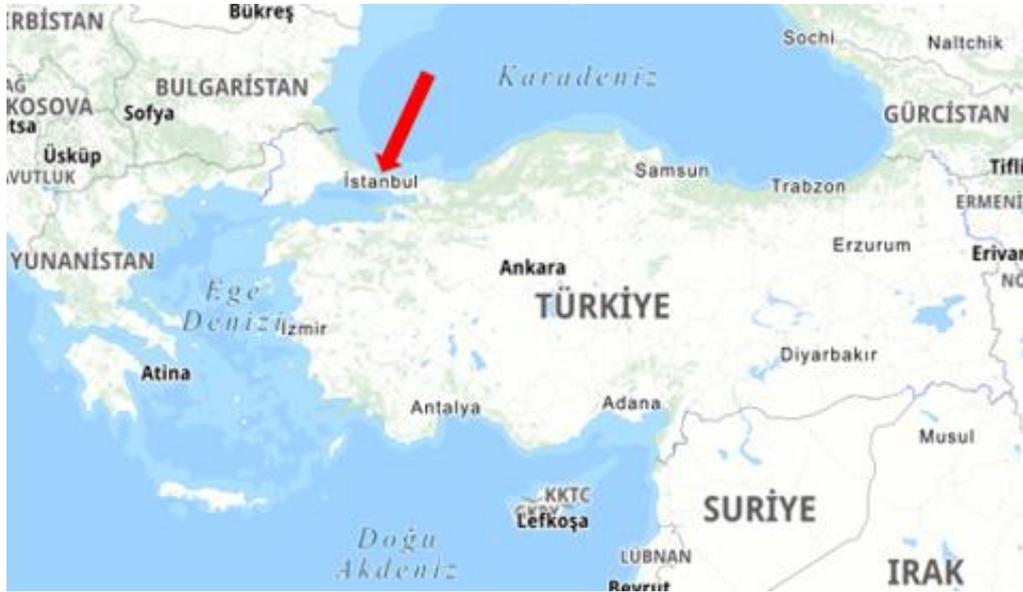
Figure 1: Site of Accident

Water, diesel bunker and lub oil were supplied to KYME which was at anchorage, one after the other. Agent boat YILDIRAY I was sent to the ship by the agent company Yıldıray Gemi Acenteliği Ltd. Şti. which was carrying out the agency services to the vessel, which went alongside the ship at 14:55 to supply provisions. Later on, as the agent boat was delivering the metal plates to the ship, which would be used for the ship's repair activities, using the boat's own Crane, the ship's chief officer was stuck between the metal plates and the the ship's starboard bulwarks. The chief officer was rescued from where he was stuck, but he lost his life despite the first aid.

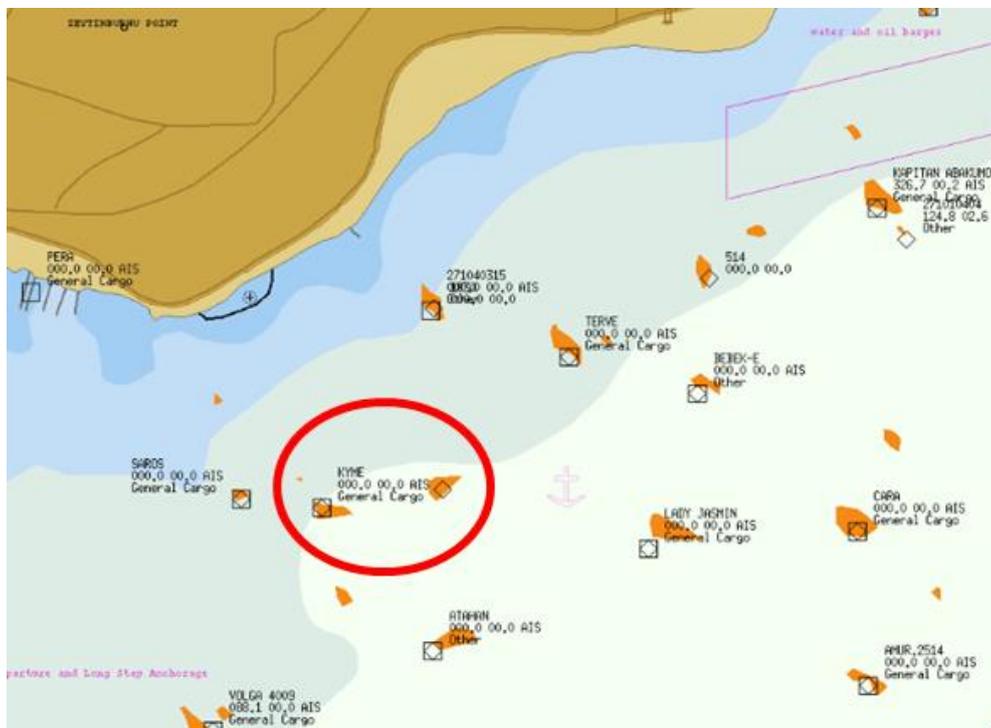
Figure 4: KYME's Anchorage Position

After the completion of her scrap Cargo at Nemrut Bay Habaş Port, MV KYME departed from the port at 20:15 on 01.06.2014 to sail to the port of Kherson in Ukraine in ballast condition. The ship passed Kumkale Burnu at 12:15 and started her Çanakkale Strait passage, passed Gelibolu Burnu at 17:25 and completed her Çanakkale Strait passage and dropped anchor at Zeytinburnu anchorage area (40° 58' 3"N - 28° 54' 5"E) on 03 06 2014 at 09:00 hours for water, bunker, provision and spare parts supply (Figure 4).

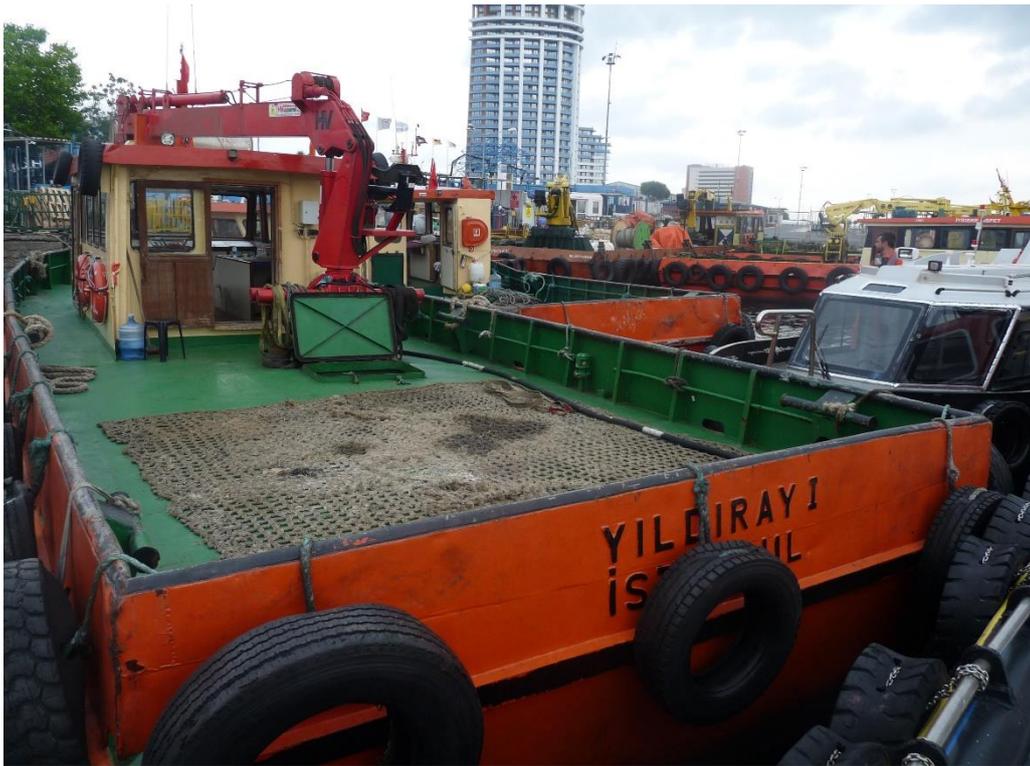
Figure 5: Agent Boat YILDIRAY I

MV KYME was supplied 30 tonnes of water between 09:15 and 10:05, 40 tonnes of diesel oil and 1,18 tonnes of lub oil between 12:10 and 13:35. Later on, agent boat YILDIRAY I (Figure 5), which was sent by the agent company Yıldırım Gemi Acenteliği Ltd. Şti. for provision and spare parts supply, came alongside the vessel at the position of starboard No. 4 hold and was safely moored to the vessel by means of one rope from the forward and another rope from her aft. YILDIRAY I was preparing to lift the provision basket at her aft side, using her own Crane¹ (Figure 6-7). In this regard, while the boat's captain was at the operation seat to operate the boat's crane, the seaman at the boat was preparing to fix the slings of the provision basket to the crane's hook.

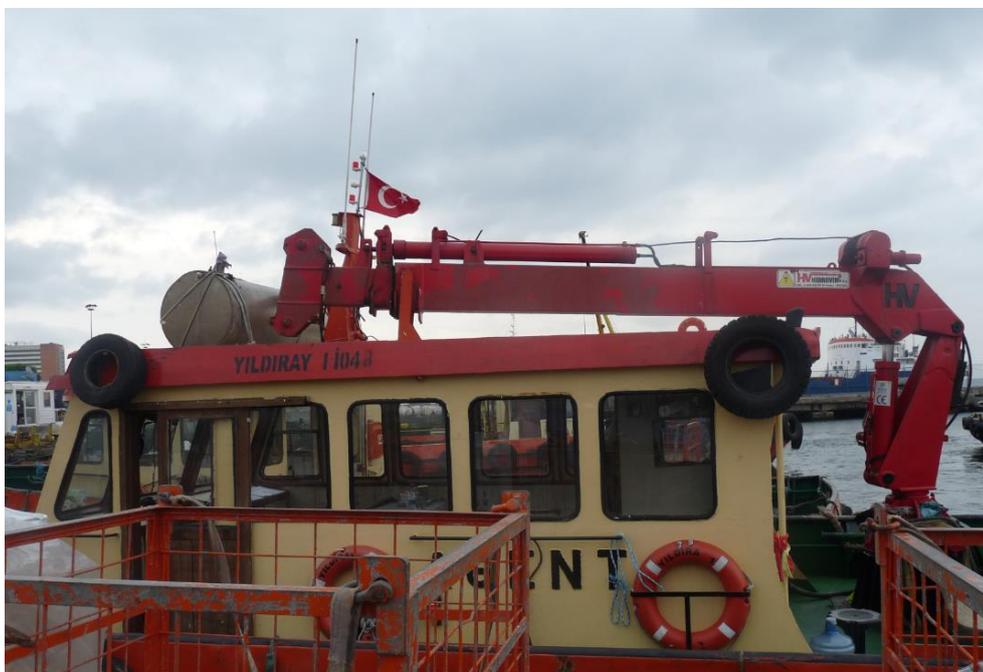
Figure 7: YILDIRAY I's Crane

After the provision basket was put over the No. 4 hold by the ship's crane, the boat's seaman went up to the Captain's Office in order to give him the cash money sent to the ship and to have the agency invoice signed. The provision basket which was emptied by the ship's crew was taken back to the boat's aft by the boat's crane. Upon the chief officer's orders to place the 10 pieces of metal plates over the No. 1 hold, each of which weighed 100 kg and with the dimensions 1,5x2,5 metres, the agent boat YILDIRAY I moved from the side of starboard No. 4 hold towards the side of starboard No. 1 hold.
