REPUBLIC OF TURKEY
MINISTRY OF TRANSPORT, MARITIME AFFAIRS AND
COMMUNICATIONS
Accident Investigation Board

Marine Accident Investigation Report
On the Injury of a Person
As a Result of Breaking of Towing Line of
M/V KRISTIN-C

Port of Gllk
21st August 2013

Report No: 10/2015

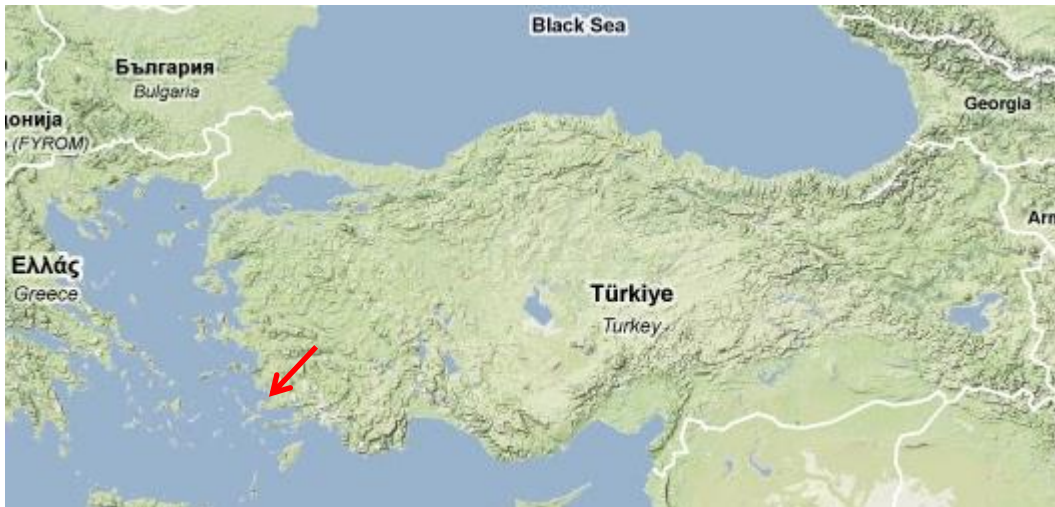
Picture 1: Location of the accident

speed, the rope used in towing suddenly broke from the middle part at 11:15 and snapped back to the dock struck and caused grave injury to the port's personnel who was serving at the wharf as mooring staff.

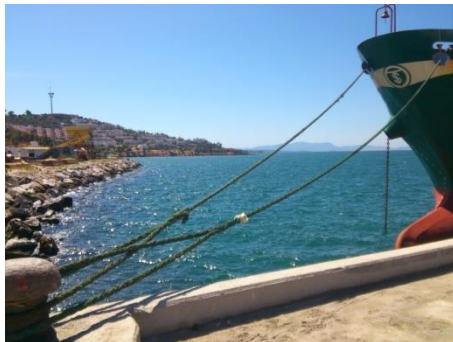
Picture 5: *Picture showing the distance of ship from the bow to the shore (another ship in the same position)*

When KRISTIN-C started the maneuver of departing from the port, there was another ship at the aft side (at dock no 3) and there was a distance of 2-3 meters between the ships (*Picture 5*). Although there was 6-7 meters distance from the stern side of the ship towards the shore (port area) (*Picture 6*), the distance of safe maneuvering towards the stern side is about 2-3 meters because the sea depth decreases towards the coast.

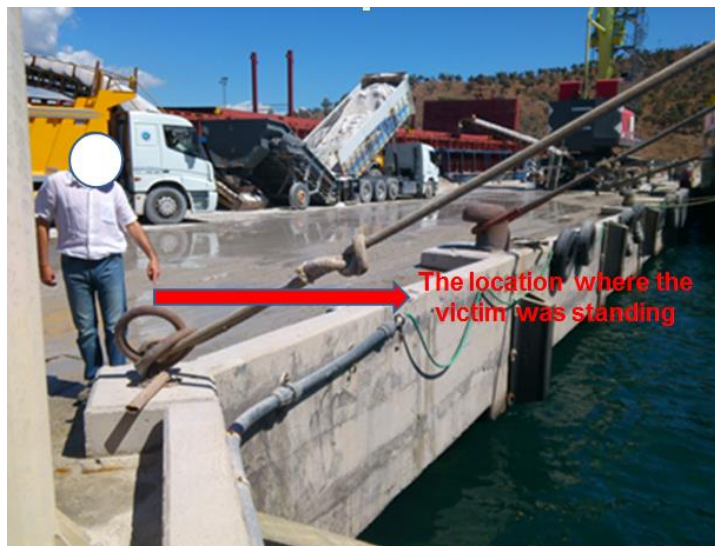
Picture 7: Dock No 4 where the accident occurred

Meanwhile, the mooring personnel Önal KARADUMAN, the accident victim who casted off the stern lines of the ship, went, with a rubber fender (automobile tire) against the possibility of damage to the ship by resting against the section of the berth where there are not any fenders (Picture 7); there stood another mooring personnel who had cast off the aft lines of the ship and who was informing the pilot about the distance between the ship and the other ship.

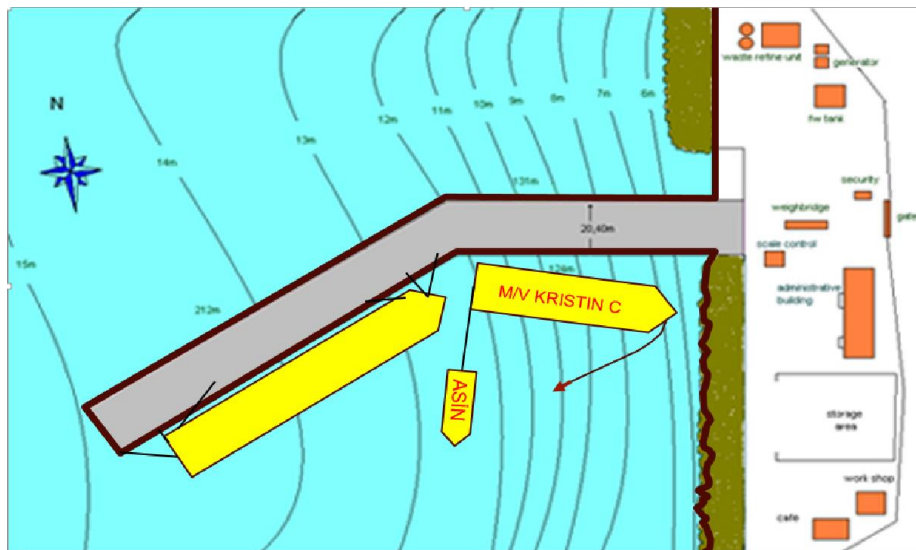
Figure 1: Maneuver scheme

While the aft of ship edged away only 2-3 meters (*Figure 1*) and the tugboat was continuing the towing process by increasing its pulling force from slow to half speed gradually (1000-1100 rpm), the rope given by the ship to the tugboat and used in the towing process suddenly broke into two from the middle (a portion of 17,3 m being left on board of the tugboat) at 11:15 and hit Önal KARADUMAN, one of the two mooring personnel who were standing side by side at the snapback area of the rope (*Picture 8*) and caused grave injury to him , ..

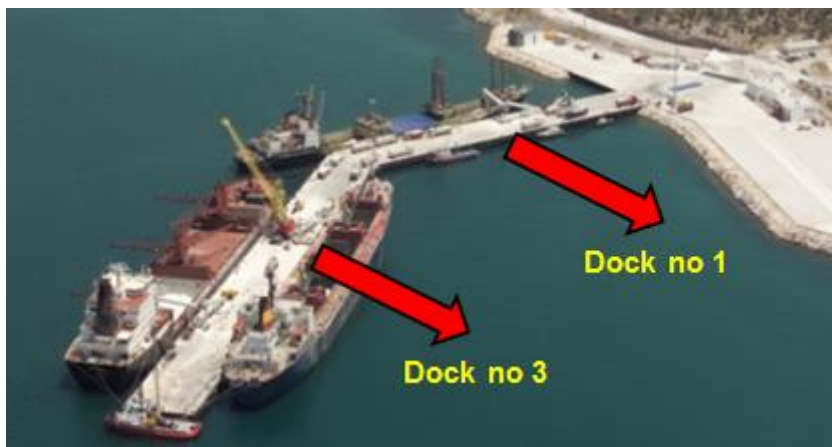
Picture 12: Güllük port docks no 1 and 3

Dock number 1 which the ship was moored to before departure maneuver has a length of 124 meters. Depth of the sea varies between 6 to 12 meters at the dock. The ships have to approach to and depart from dock no 1 in a more controlled manner due to the reason that dock no 1 makes an angle of approximately 140 degrees at the point of joining dock no 3 (Picture 12) and the depth of sea decreases towards the coast.

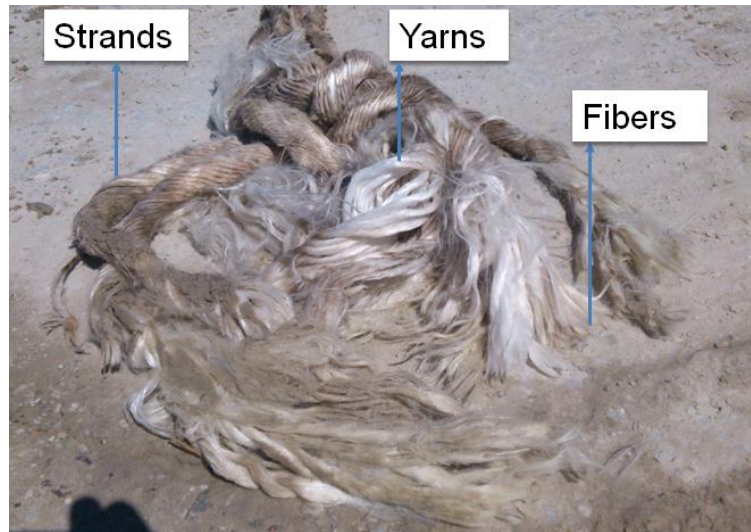
Picture 15: Parts of the rope used in the maneuver

By joining the “*fibers*” which are the thinnest piece of the material from which the rope is made, “*yarns*” are formed; by uniting the “*yarns*”, the “*strands*” are formed; by uniting the “*strands*”, the “*rope’s body*” is formed. (Picture 15)
