REPUBLIC OF TURKEY
MINISTRY OF TRANSPORT, MARITIME AFFAIRS
AND
COMMUNICATION
Accident Investigation Board

**Marine Safety Investigation Report on the Maritime Accident
Caused by the Collision of Vessels**

LILIAN Z
and
MURADIYE

Izmit Bay/Off the Coast of Eskihisar
14TH JANUARY 2015

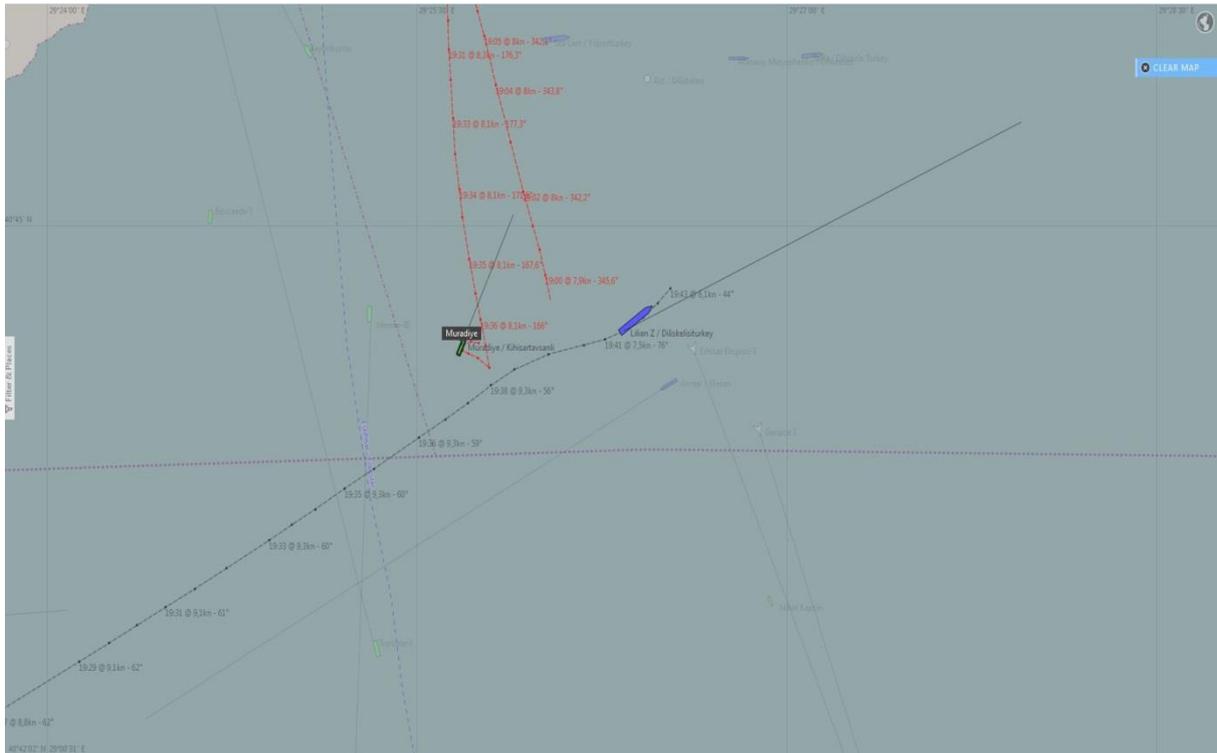
Image 2: AIS Image of Both Vessels After the Collision

Thereupon, following his own assessment, he ended the conversation by stating, “I guess, we are passing starboard-to-starboard”. However, at that time, the pilot on the bulk carrier LILIAN Z confirmed the passing by starboard-to-starboard by saying “OK” without checking the exact location and course of the ferry MURADIYE from radar or AIS and without questioning the real intentions of MURADIYE. Below are the call logs from the VHF about three minutes before the collision.

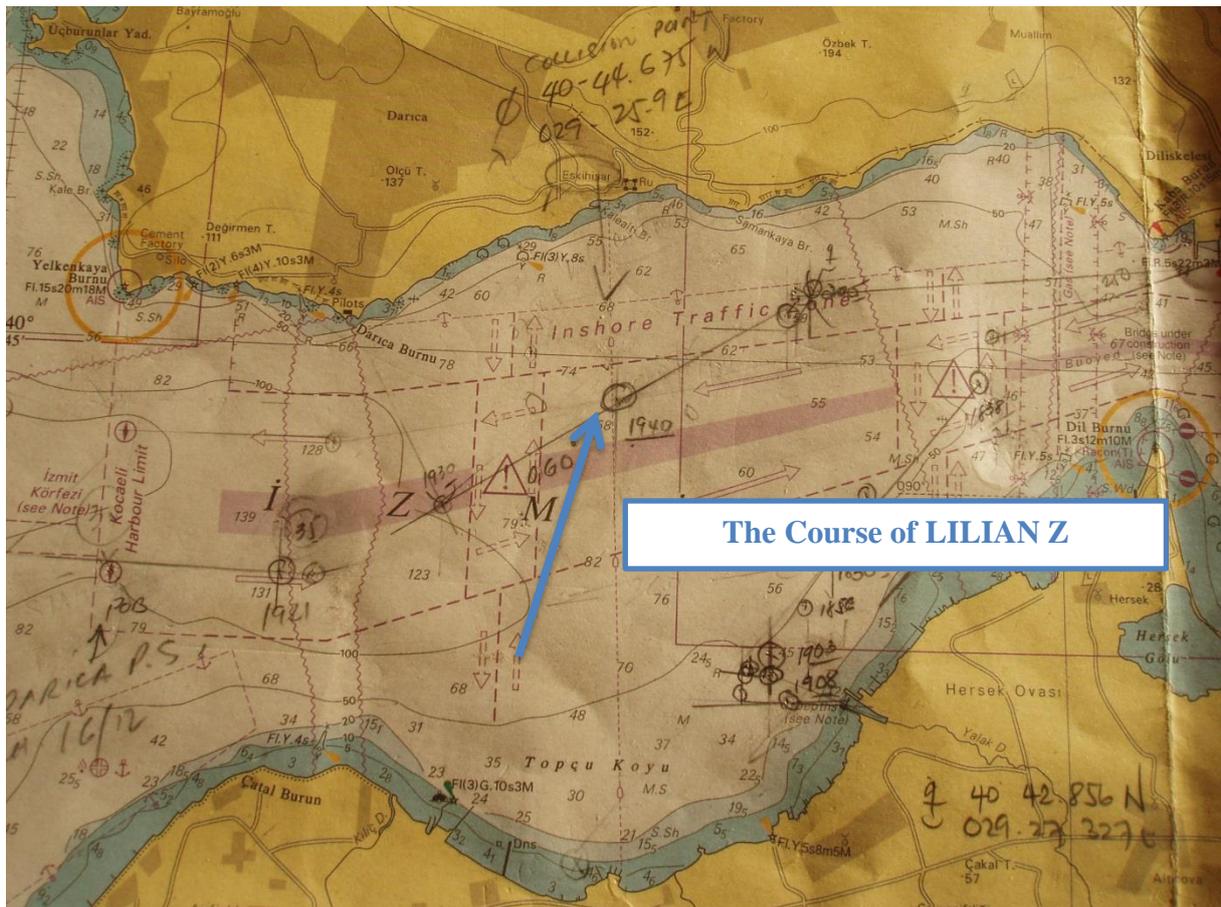
Image 3: The Course of the Bulk Carrier LILIAN Z

The Master of MURADIYE, who stated that he had realized the danger after his conversation with the pilot of LILIAN Z, said that he immediately operated the engine full astern and set the rudder hard to starboard to avoid the collision. Nevertheless, his manoeuvre couldn't avoid the collision. After the accident, the Master of MURADIYE discovered no serious condition on board and passengers and continued to his trip and safely transported the passengers and the vehicles to Tavşanlı Pier while LILIAN Z anchored at the Eskihisar Anchorage.

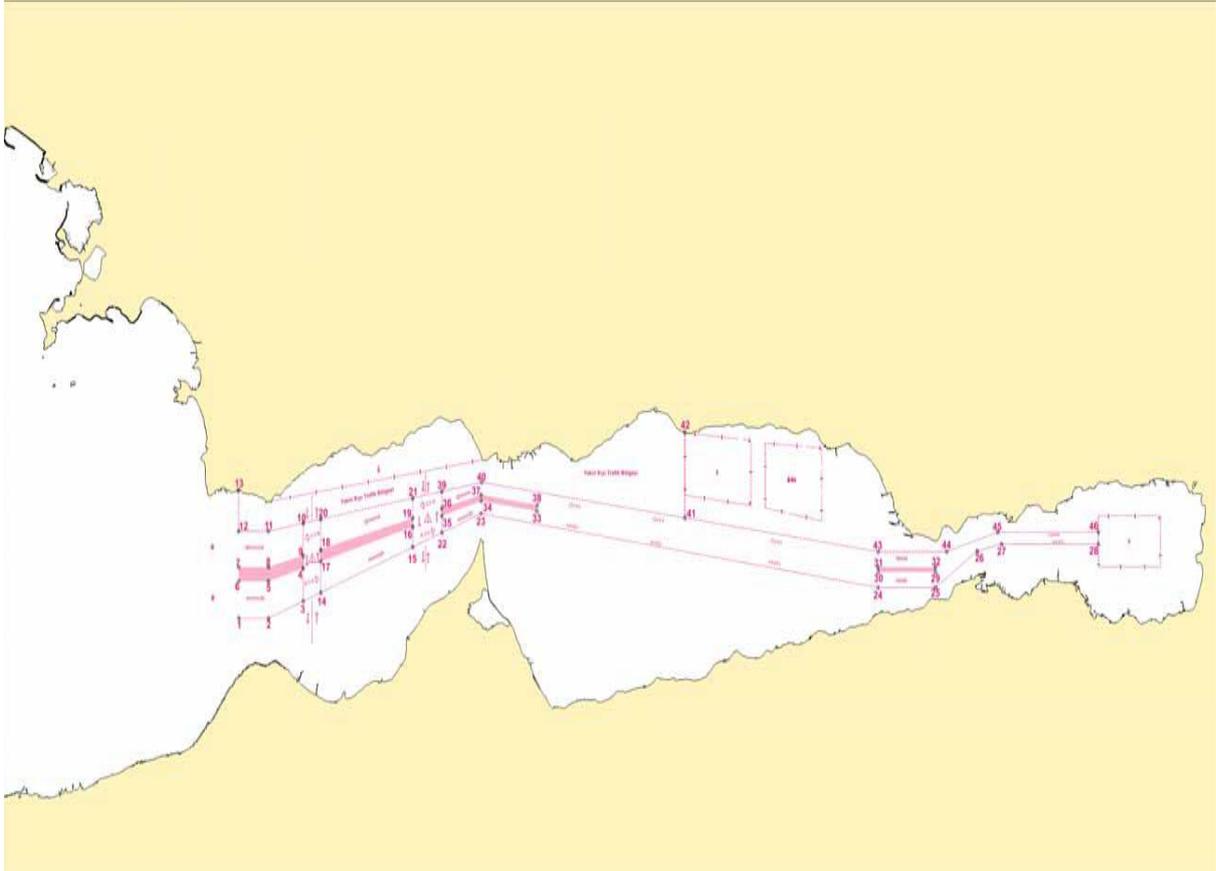
Image 10: Traffic Separation Scheme of Izmit Bay

Article 21, “Navigation within Traffic Separation Scheme” of the Instruction sub-paragraph (a) states that ships that will join or subsequently leave TSS must navigate in a traffic lane at traffic flow direction, while sub-paragraph (b) states that ships that cross TSS shall do so in accordance with the COLREGS.

The Ports Regulation, which sets the limits of the traffic separation scheme (TSS), the separation lines of the traffic lanes, near coastal traffic area, areas to be considered carefully in TSS and pilot boarding/disembarking locations in Izmit Bay, entered into force upon its publication in the Official Gazette No. 28453 of 31.10.2012.

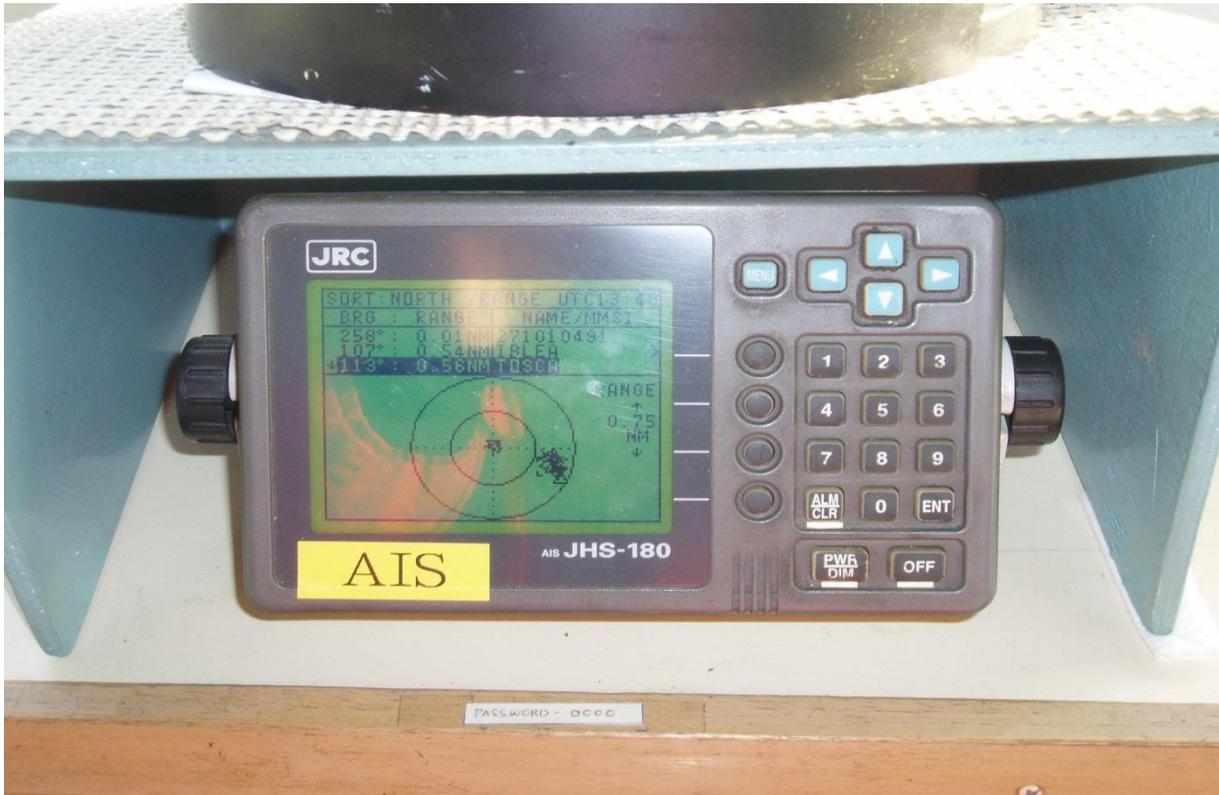
Image 12: AIS Monitor of the Bulk Carrier LILIAN Z

safe manoeuvre to avoid the collision. Since he was aware that pilotage was usually mandatory for ships entering or leaving Izmit Bay, he first called Darica Pilotage Station at 19.34 and asked whether LILIAN Z had a pilot on board. In the meanwhile, the pilot on board LILIAN Z, who was listening to VHF dialogues, was involved in the conversation and informed that Pilot A was on board and heading to the anchorage with the large bulk carrier. The Master of MURADIYE thought that it was Darica Pilotage who spoke to him, called the Pilot A on LILIAN Z this time and stated that he was heading towards Tavşanlı, and wanted to confirm that LILIAN Z was also proceeding to the anchorage; and the pilot on the bulk carrier LILIAN Z confirmed that he was proceeding to the Eskihisar anchorage. Thereupon, following only his visual assessment, he said that “I guess, we are passing by starboard-to-starboard”, without any consultation with the pilot on LILIAN Z and also agreeing on a common manoeuvre. Whereas he is expected to make necessary checks on the radar or AIS to determine whether he would cross ahead of the LILIAN Z, and then make a similar talk. This assessment without based on any detection and agreement is considered to be one of the factors that contributed to the accident.

The pilot on board LILIAN Z also confirmed the passing by starboard-to-starboard by only responding “OK” without checking the exact location and course of the ferry MURADIYE in addition to such a wrong assessment by the Master of MURADIYE. When the pilot on board LILIAN Z was asked why, the pilot said that he had believed that MURADIYE was the vessel that was approaching from on her own starboard, in other words from Topçular-Tavşanlı direction, and confirmed the passage solely based on his instincts (without observing any radar or AIS). The primary reason for the collision is considered to be that the pilot on board LILIAN Z confirmed the request of the ferry MURADIYE without personally checking the position, course and speed of the vessel, which spoke to him, by the navigational aids on the vessel (ARPA radar, AIS) or by the vessel crew.

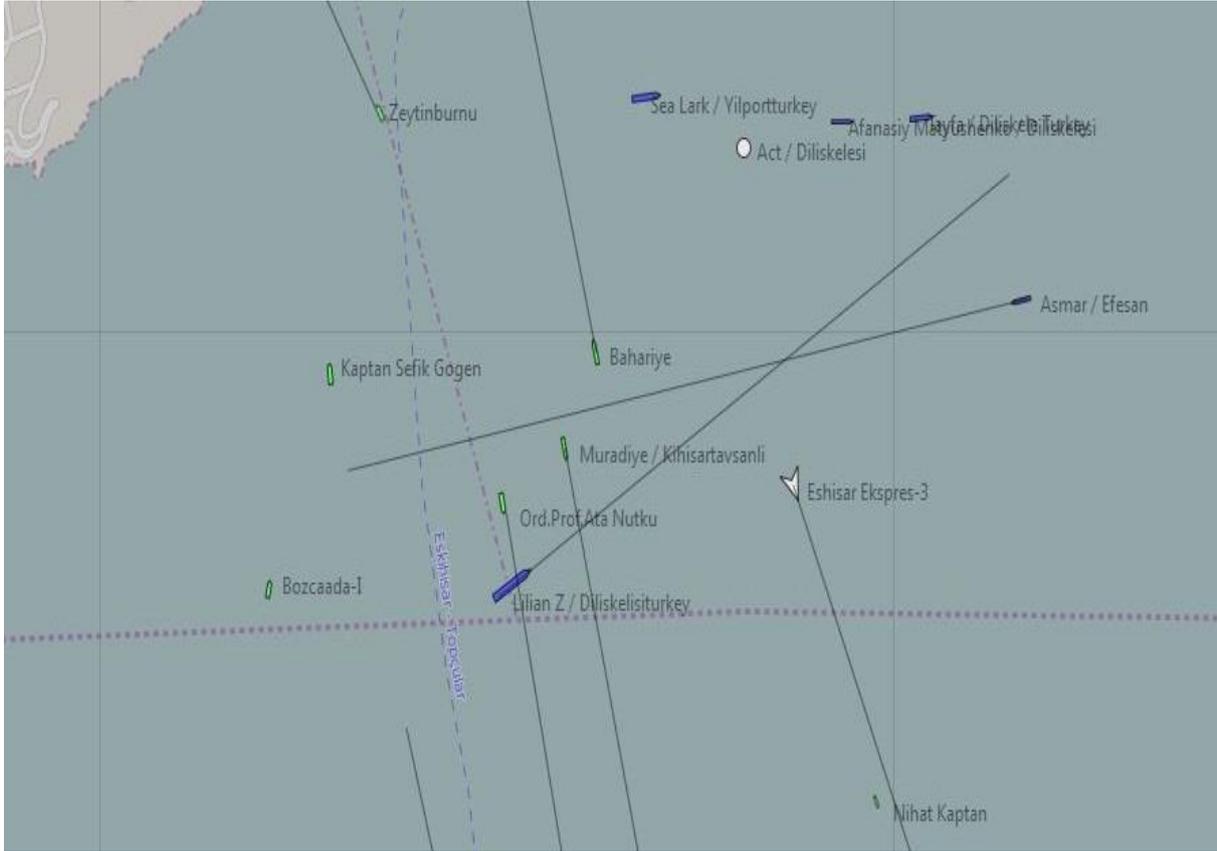
Image 13: AIS Image Just Before the Collision

Also, it is considered that the request by the Master of the MURADIYE as “we are passing by starboard-to-starboard,” prevented the pilot on board LILIAN Z from understanding his request clearly and it is possible that the pilot would not have provided the reflexive “ok” answer if he had asked, as “I intend to cross ahead of your ship”.

After the first dialogue with the Master of the MURADIYE, the pilot on board LILIAN Z had a long conversation with the pilot on vessel ASMAR, which was leaving the Izmit Bay, on seeing each other and giving way. During this time, it is considered that the pilot on board LILIAN Z was focused on this conversation, and thus failed to notice the dangerous approach of the ferry MURADIYE for a long time.

Due to these conversations with the pilot on the vessel ASMAR, the pilot on LILIAN Z realized 1 minute 15 seconds before the collision that MURADIYE had approached dangerously close to him. As soon as he realized the situation, he immediately called on the VHF to warn MURADIYE. Based on the response of the Master of the MURADIYE, who had until that time proceeded peacefully without altering her speed or course and thought he would be crossing ahead of LILIAN Z, as “We agreed with the Pilot A on passing by starboard-to-starboard”, The pilot on LILIAN Z stated that that was not the manoeuvre they agreed upon by saying, “What do you mean starboard-to-starboard?” (the Master of the MURADIYE stated that he stopped following LILIAN Z due to the conversation he had with LILIAN Z and focused on the other vessels due to the intense sea traffic). Upon this statement, the Master of MURADIYE immediately ran the engines full astern to avoid the

collision. However, approximately one minute was not enough for the Master of MURADIYE to do the necessary manoeuvre, and the ferry MURADIYE crashed into the port side of LILIAN Z.
