FINAL MARINE SAFETY INVESTIGATION REPORT

NAME AND TYPE	: MEDSUN - Primitive Wooden Vessel
FLAG	: Turkey
LOCATION OF ACCIDENT	: Killebükü – Göcek / MUĞLA
DATE OF INCIDENT	: 16.09.2019 / 05:00
CASUALTIES	: 1 Dead, 4 Injured
DAMAGE AND POLLUTION	: Fire and Sinking / No Pollution

Committee Decision No: 29 / DNZ-04 / 2020

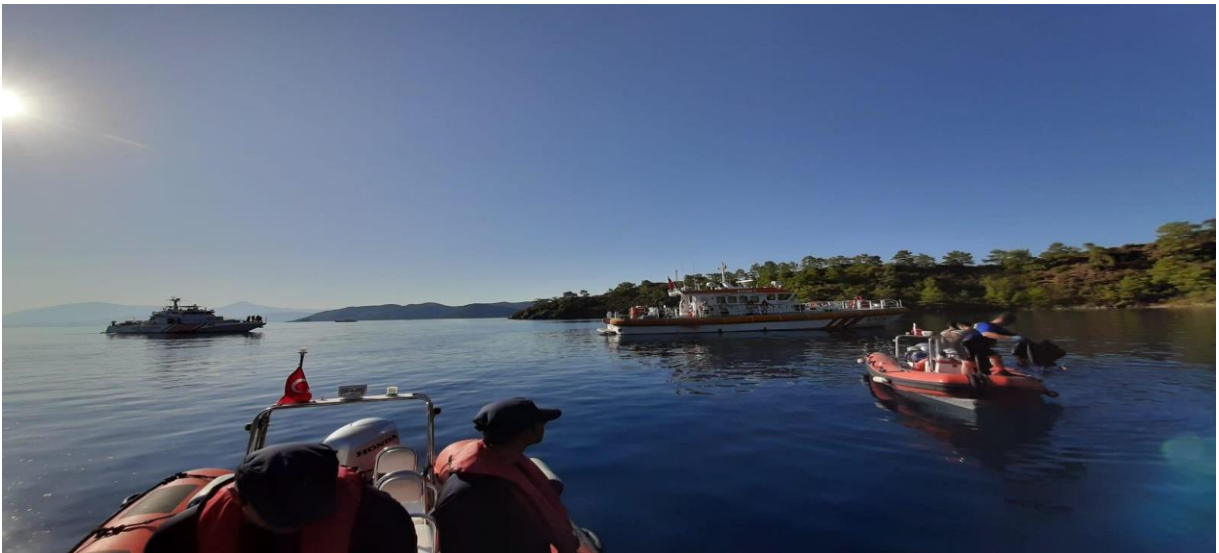
Picture 6: Post-Fire Search and Rescue Works

In the vessel named MEDSUN, the evacuation of passengers and crew was carried out by breaking the portholes on the side and aft of the vessel. All but one passenger of foreign nationality, 70 years old, and crew were rescued. The corpse of the passenger who could not be rescued was found as burned out on the surface of the sea near the sinking vessel at around 9: 10.

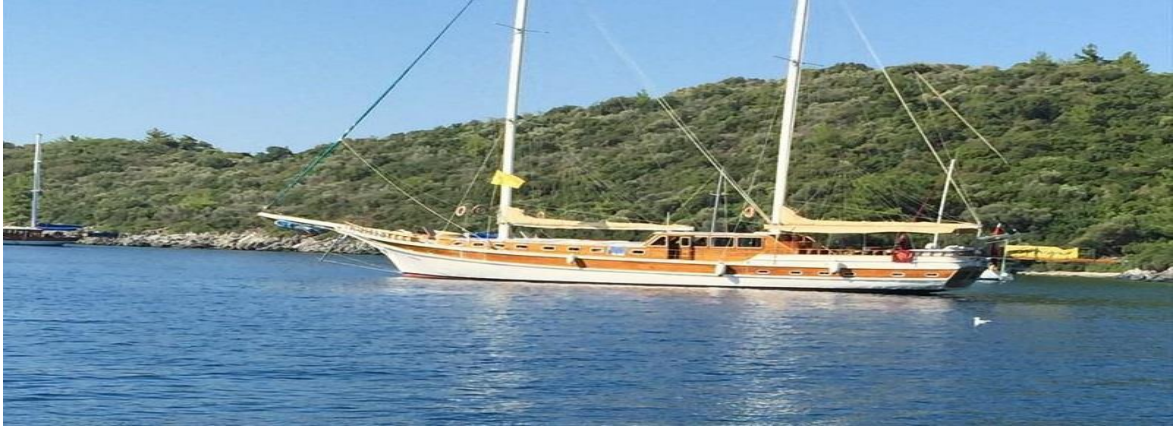
Picture 12: MEDSUN

As a result of the inspections carried out on 08.05.2019; 1 fire pump, 17 portable fire extinguishers and smoke sensitive fire alarm system are available concerning the fire. Besides, there are 1 service boat for 6 people, 2 life rafts for a total of 20 people, 6 lifebuoys and 20 adults 4 children life jackets for emergencies. There are two emergency exit doors, one on the fore and one on the aft, in the corridor where the vessel's cabins are located.

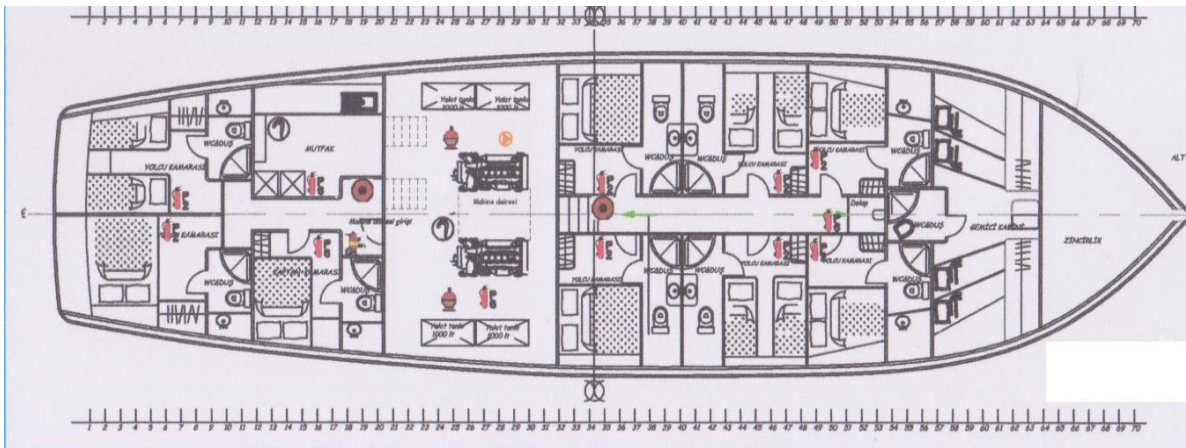
Picture 13: General Layout Plan of MEDSUN Vessel

As can be understood from the above layout plan, there are 8 passenger cabins, 1 captain's cabin and one kitchen on the same floor of the vessel.

There are five refrigerators in total, three in the kitchen section, one in the bar and one in the wheelhouse, as the equipment that will cause fire onboard. One cabinet in the kitchen has a deep freeze feature. There is also an electric water heater in the kitchen. However, there are three tubes in the kitchen, one gas cooker operated by tube, two of which are full and one of which is empty.

Again, the occurrence of explosions in the future suggests that it may have been caused by the tube in the kitchen. Considering that the kitchen onboard is in front of the captain's cabin, the captain waking up with the sound of an explosion reinforces this claim. It has been evaluated that the explosions occurred in the later period may have been caused by the spare tubes stored under the wheel.
