**MARINE SAFETY INVESTIGATION REPORT ON
VERY SERIOUS MARINE CASUALTY**

VESSEL NAME : M/V OLMA
IMO NO : 8004806
FLAG OF THE VESSEL : Honduras
LOCATION OF ACCIDENT : Port of Mersin Anchorage Area No. 2
DATE and TIME OF ACCIDENT : 09 February 2022 / 09:17 (UTC+3)
FATALITY/INJURY : 1/-
DAMAGE CONDITION: : None
ENVIRONMENTAL POLLUTION : None

Board Decision No: 01 / D-01 / 2023

Date: 16/01/2023

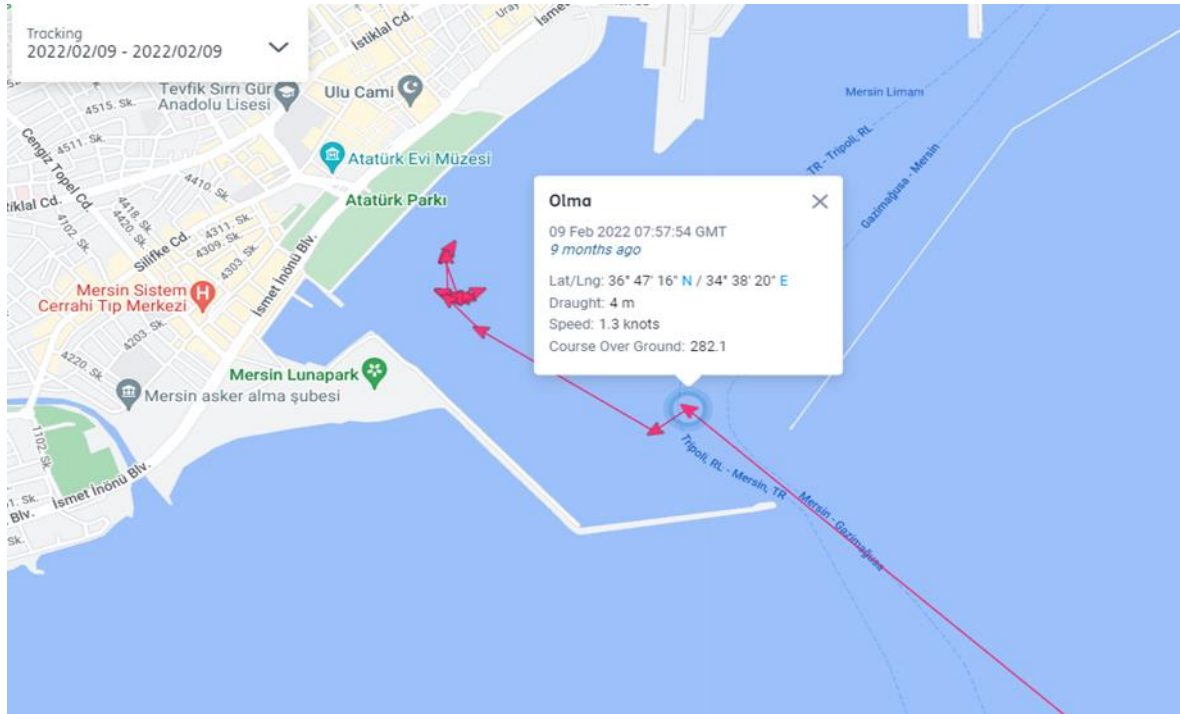
Image 7 Casualty Delivery Point

The Master informed the Harbour Master Office and Vessel Traffic Services Center about the accident and requested an ambulance through the ship's agency. Since the weather conditions were not suitable for transferring the casualty from the vessel to the pilot boat, it was requested from the vessel to move into the breakwater of the port. The pilot boat that approached to the vessel M/V OLMA, which had moved into the breakwater, took the casualty as unconscious at 10.45.
