MARINE SAFETY INVESTIGATION REPORT

VESSEL NAME : PALLADA
IMO NO : 8866931
FLAG OF THE VESSEL : Cameron
PLACE OF ACCIDENT : Port of Karadeniz Ereğli
DATE and TIME of ACCIDENT : 19 November 2023 - 09:51 (GMT+3)
FATALITY/INJURY : -/-
DAMAGE DEGREE: : The vessel broke into two pieces and grounded
ENVIRONMENT POLLUTION : None

Board Decision No: 17/D-05/2024

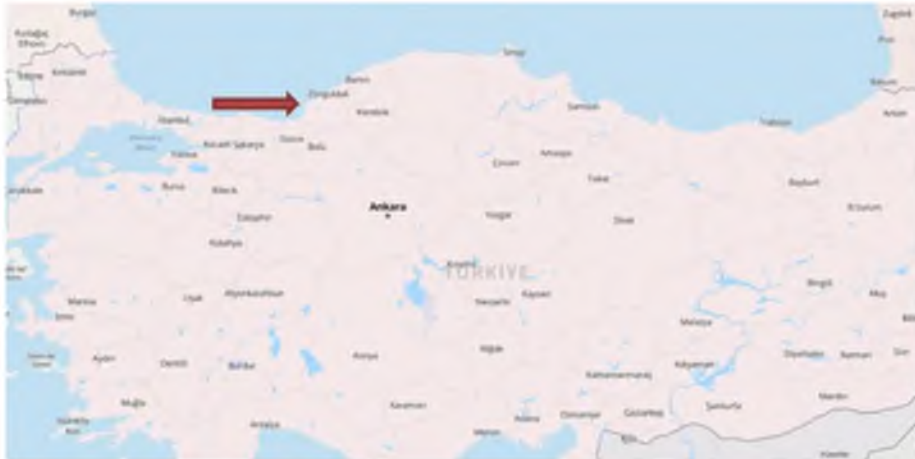
Image 1 Place of the Accident

On 19 November 2023, the vessel failed to endure the bad weather and sea conditions, and it was understood that the noise heard at 09:51 was caused by the breakage of the vessel, and the crew issued a distress call at around 10:00. Soon after, the vessel broke into two separate pieces, bow and stern, and drifted and grounded on the shore (Image 1). All 13 crew members aboard were safely rescued from the vessel.

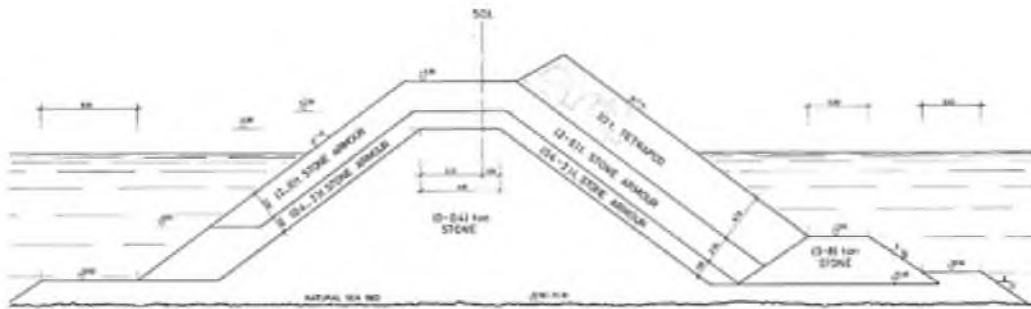
Figure 3 Breakwater Type Cross Section

The South Breakwater of the New Port of ERDEMİR is 1417 m long, and the structure is protected by two rows of tetrapod⁶-coated blocks weighing 20 tonnes. The slope of the body of the structure is 1:4/3 on the offshore side and 1:3/2 on the roundhead side. The breakwater was designed and constructed at crest elevation + 6.0 m⁷.

During the 2010 inspections, it was determined that the tetrapods were not in their original positions, as described in the project, due to shifts and collapses in the upper rows of the 20-tonne tetrapods, built as a protective layer in the above-water part of the breakwater structure at the South Breakwater of the New Port of Erdemir. Divers and specialised staff inspected all cross-sections, heel sections, underwater conditions, and above-water conditions of the structure during the field inspection. During the underwater inspections, cross-sections of the structure were prepared at a distance of 10 meters along the structure using a side scan sonar system, and the cross-sections were compared with the projects and evaluated. During the maintenance works, tetrapods that were broken and cracked due to displacement were identified, removed, and replaced with new tetrapods. All above-water tetrapods and locally underwater tetrapods were removed and replaced with new tetrapods in order to be able to remove and reinstall the tetrapods that were broken, cracked, and with their project layouts disrupted. The stabilisation of the structure was restored in the areas where maintenance works were carried out, and the structure was brought into a state in accordance with the approved projects.

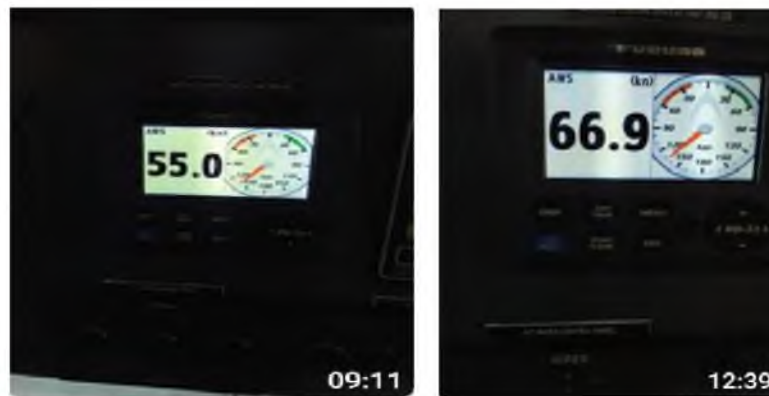
Image 12 Meteorological Measurements of the Tugboat at the Time of Accident

Although the vessel PALLADA was at anchor in the inner harbour of Bozhane during the accident, the vessel PALLADA started to drift by dredging anchor and asked for rescue help. The tugboats moored at the berth in the inner harbour of Ereğli received the calls but could not respond due to the storm.

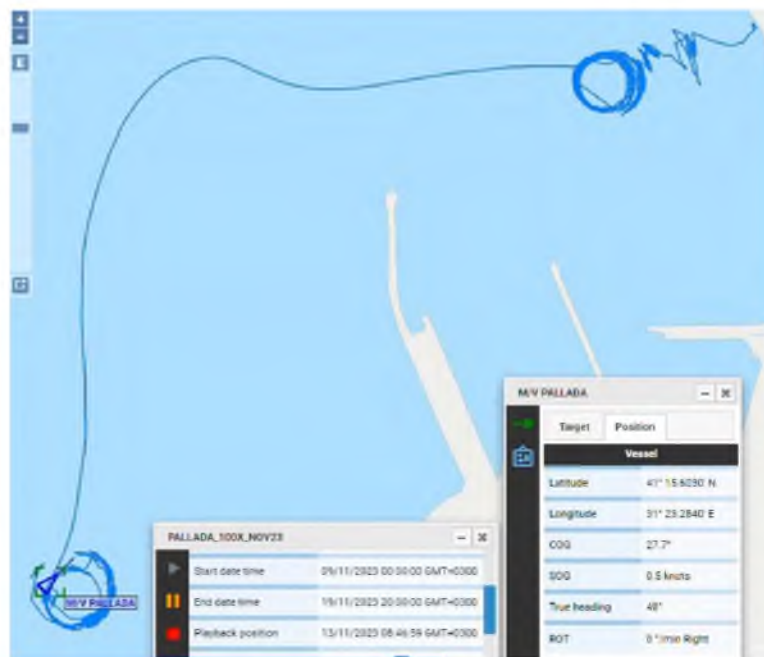
Image 13 First and Second Anchorage Site of PALLADA

The vessel PALLADA started her voyage from the Port of Odessa, Ukraine, to the Port of Karadeniz Ereğli in ballast with the voyage No. 7/23 and anchored at the Anchorage Site No. 1 of the port on 08 November 2023 at 19:40. It was understood that while she was awaiting a port order to come alongside and load 3100 m/t of salt, the weather conditions would aggravate, and the Port Authority allowed the vessel to anchor at Anchorage Site No. 4 (BOZHANE) inside the breakwater on 13 November 2023 at 09:10 (Image 13).

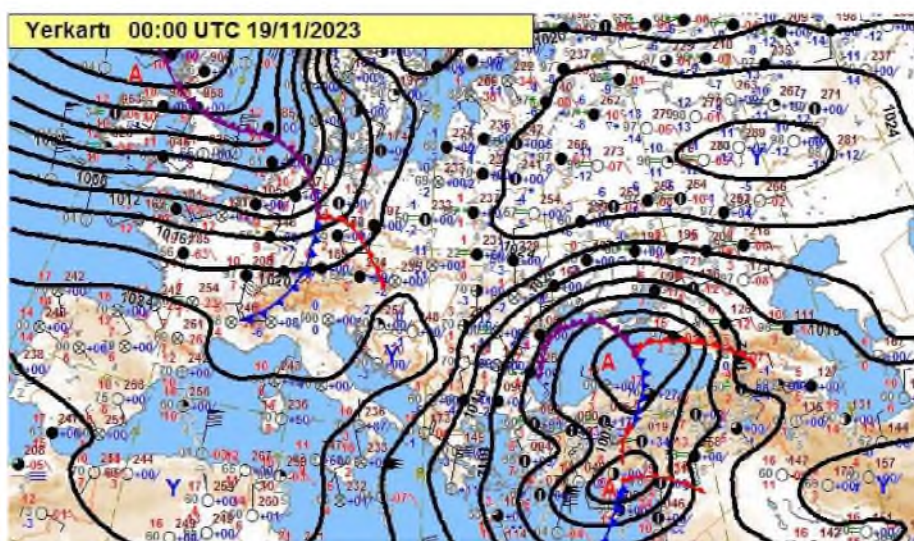
Image 17 Meteorological Observation Chart at Ground Level (19/11/2023, 00.00 UTC)

On 19 November 2023, the pressure value in the low-pressure centre that moved from Thrace towards the Central Black Sea dropped below 1000 hPa¹⁶. Consequently, the value of the horizontal pressure gradient from the low-pressure centre towards the periphery rose. Due to these effects, wind speeds in the low-pressure circulation at the accident location reached the storm force. However, the low centre at 500 hPa also strengthened in accordance with the pressure system at ground level, and the said frontal system was positioned over the Marmara Region with a centre value of 540 hPa, making the frontal system even stronger compared to the day before (Images 17 and 18).

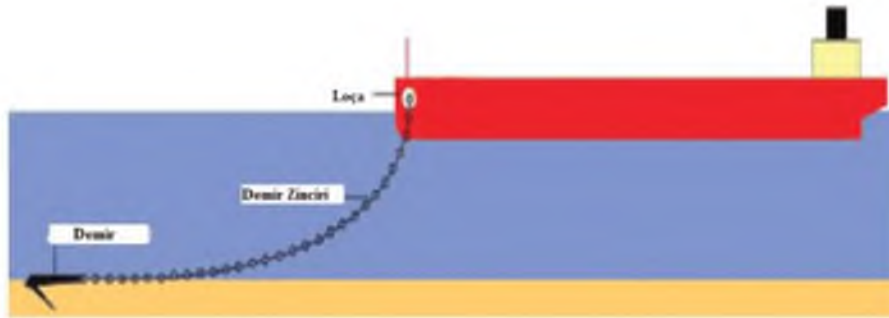
Figure 6 An Image of an Anchored Vessel

To maintain safe anchoring at the location of the vessel, it is of utmost importance that the anchor holds effectively. Therefore, it is necessary to calculate the correct length of the anchor chain to be slacked away¹⁸ at the anchorage site. (Figure 6)

Upon realising that the weather conditions would aggravate, the vessel PALLADA, which was allowed to anchor inside the port breakwater, was anchored in front of Bozhane inside the breakwater on 13 November 2023, with the starboard anchor set in water at 1.5 shackles. However, since the morning hours of 19 November 2023, the vessel, which was exposed to strong winds and heavy seas, first dredged the anchor and dragged ashore, then broke, and immediately afterwards began to call for help.
