### VERY SERIOUS MARINE CASUALTY FINAL REPORT

| NAME OF THE VESSEL | : EPHESOS / POLATBEY 1 |
| LOCATION OF ACCIDENT | : Off the Port of Karataş - MEDITERRANEAN |
| DATE OF ACCIDENT | : 11/11/2020 / 05.46 LT |

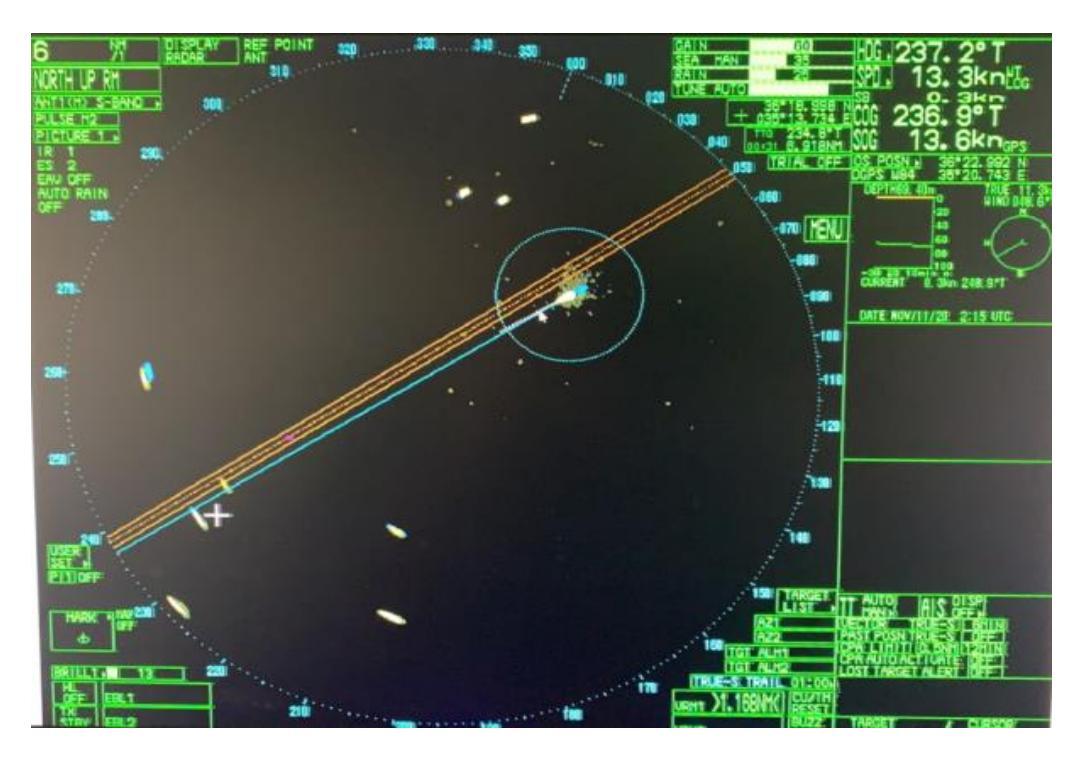
Image 6: Information on the Course/Speed of Tanker and the Targets

According to the screenshot extracted from the VDR of the tanker, the course and speed of EPHESOS (Image 6) was consistent with Voyage plan at 5:15 AM.

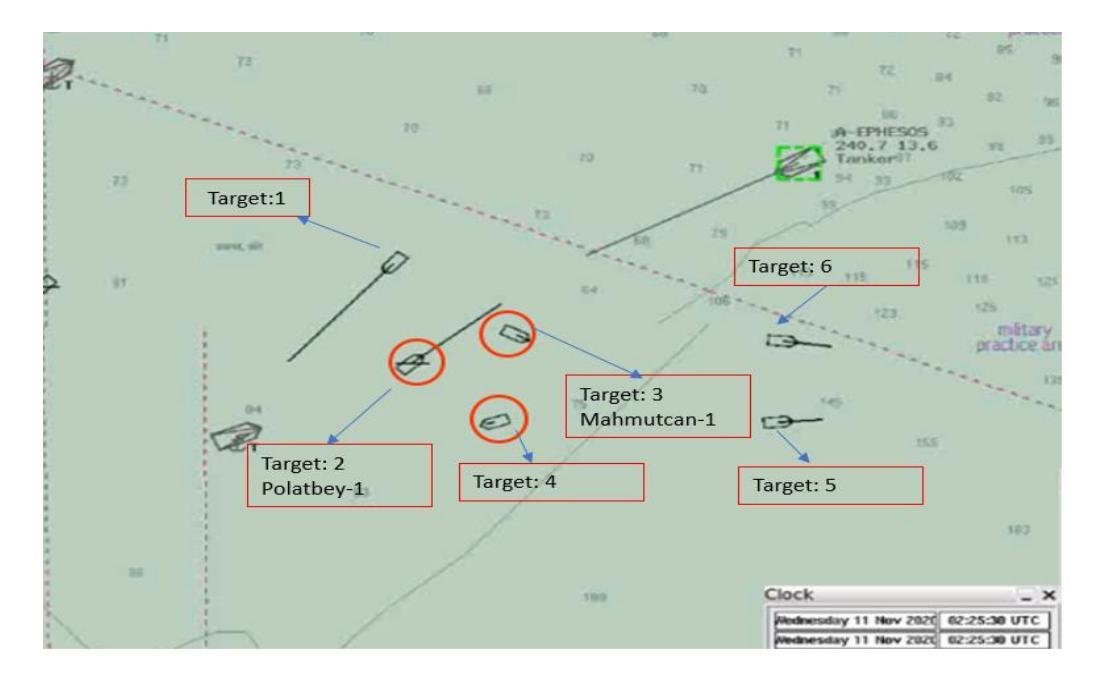
Image 7: Positions of The Tanker and Fishing Vessels Relative To Each Other

Image 7 displays a screenshot of the courses and speeds of the targets at 5:25:30 AM based on VTS data of Sector Mediterranean.

**Target No. 5 & 6:** Targets 5 and 6, which are positioned roughly 40-50 degrees on the port side of the tanker and at a distance of 3 and 4 miles, respectively, are considered to be engaged in fishing due to their fixed course and low speed.

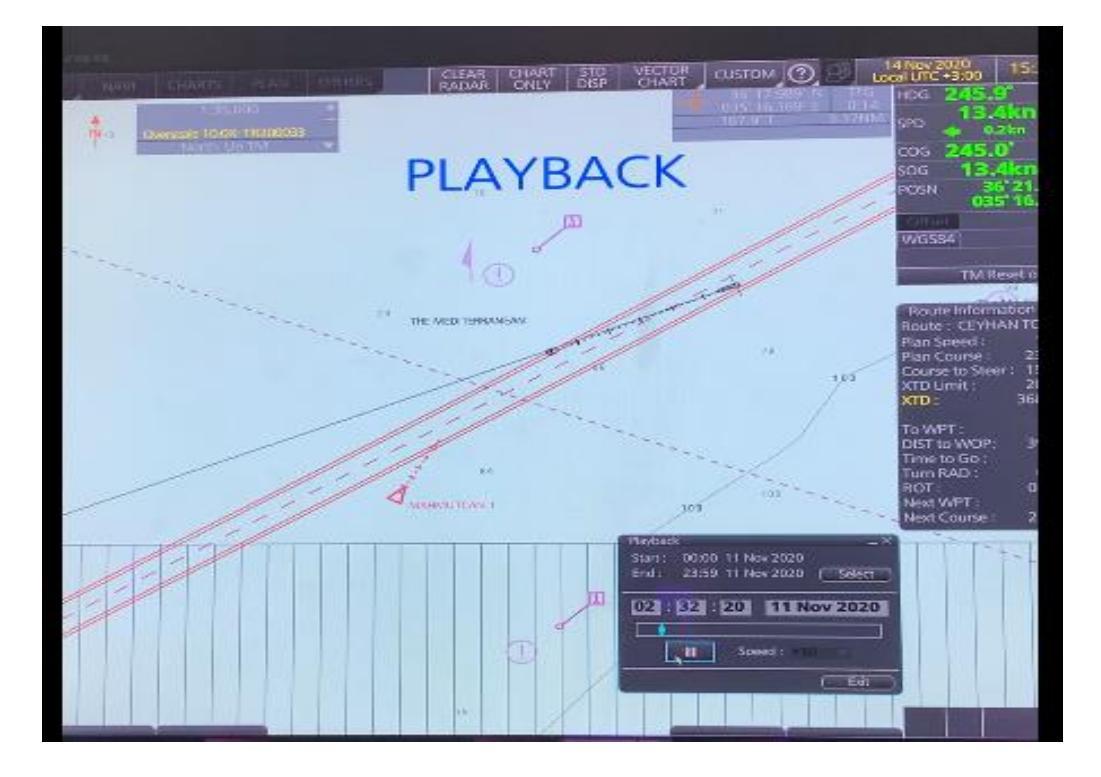
Image 9: The Estimated Course 020 Degree and Speed of 6 Nautical Miles of MAHMUTCAN-1

According to the screenshot (Image 9) captured from the ECDIS of the tanker EPHESOS at 5:32 AM, while the tanker was sailing at a speed of 13.4 nautical miles on the course 245.9, the fishing vessel, MAHMUTCAN-1 was sailing on the port bow of the tanker on approximately the course 020 and at an estimated speed of 6 nautical miles. No image of the course and speed of the fishing vessel, POLATBEY-1 is available during this time period.

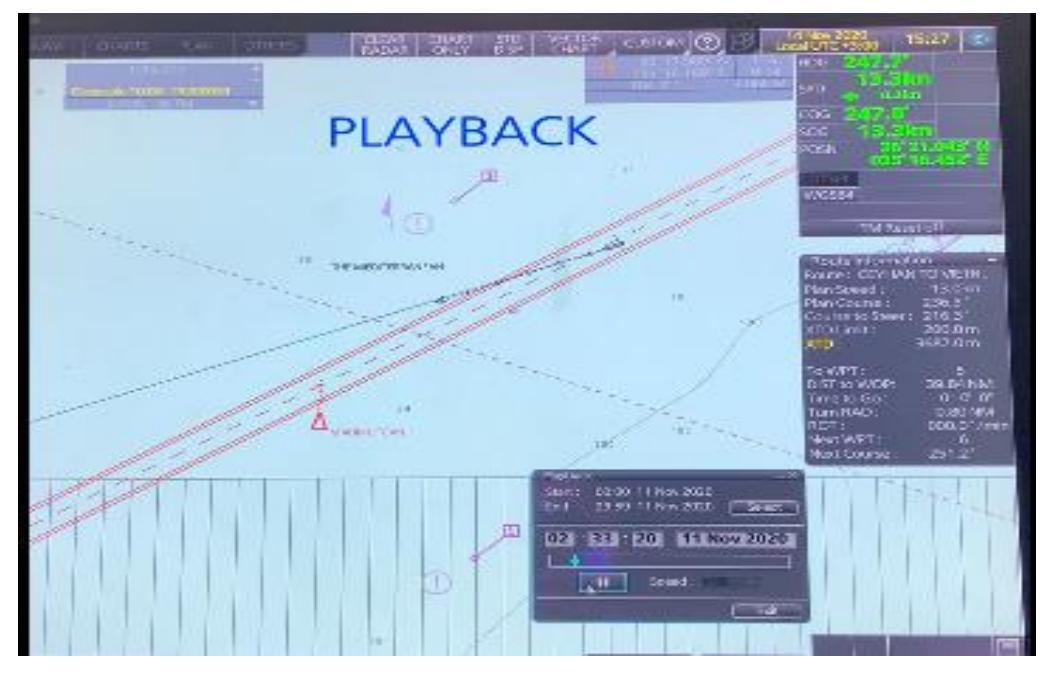
Image 10: ECDIS Image from the Fishing Vessel, MAHMUTCAN-1

At 5:33:20 AM (Image 10), while M/T EPHESOS was sailing on her course 247 and at a speed of 13.3 nautical miles, MAHMUTCAN-1 set her course at 15 degrees towards the port side and began to sail on her course 005 and at a speed of 6 nautical miles per hour. Meanwhile, the distance between the tanker and the MAHMUTCAN-1, which was positioned approximately 10 degrees on the port bow of the tanker, decreased to approximately 2 miles.

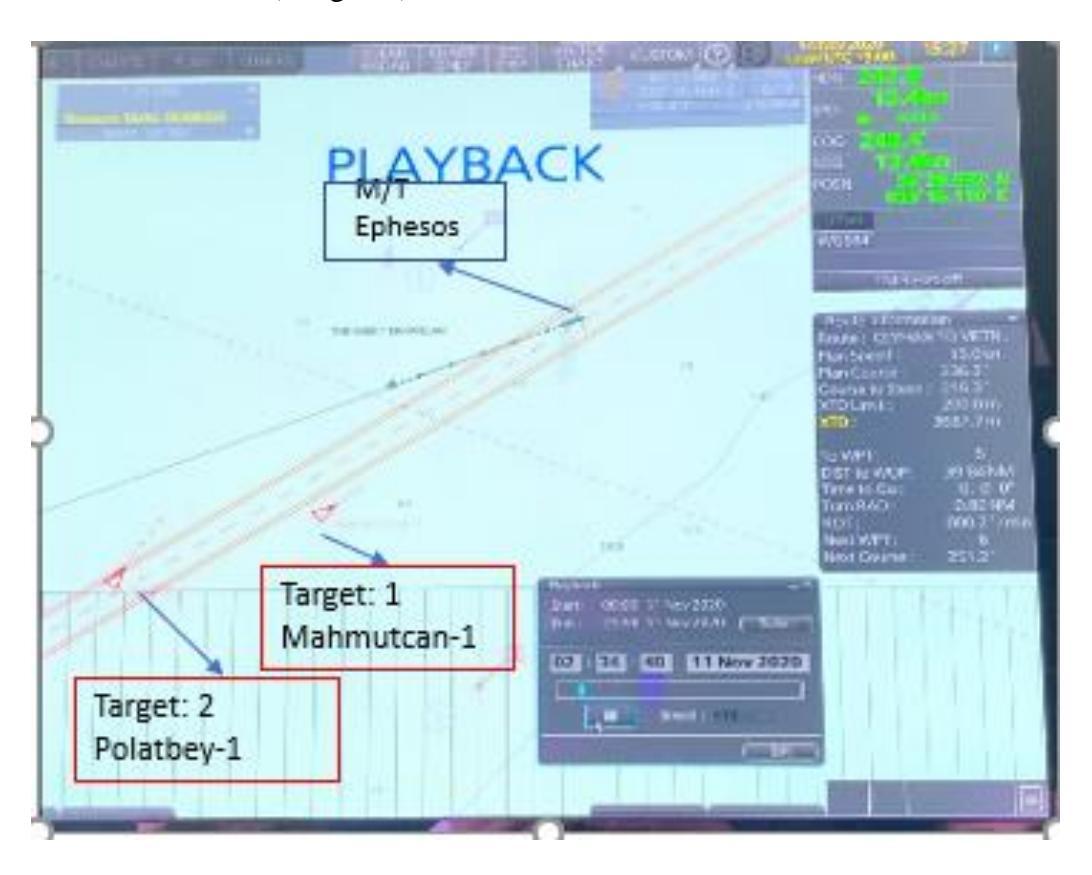
Image 12: Screenshot Captured from ECDIS of EPHESOS

Based on the screenshot of the tanker captured from ECDIS (Image 12) and the screenshot of the tanker captured from ARPA (Image 13), it was found that while M/T EPHESOS was sailing at a speed of 13.4 nautical miles on her course 247.9 with an autopilot, according to the vector length, F/V MAHMUTCAN-1 slowed down to 3 nautical miles and altered her course to the starboard side at 5:34 AM. This was also recorded in the image captured from the Mediterranean VTS (Image 14).

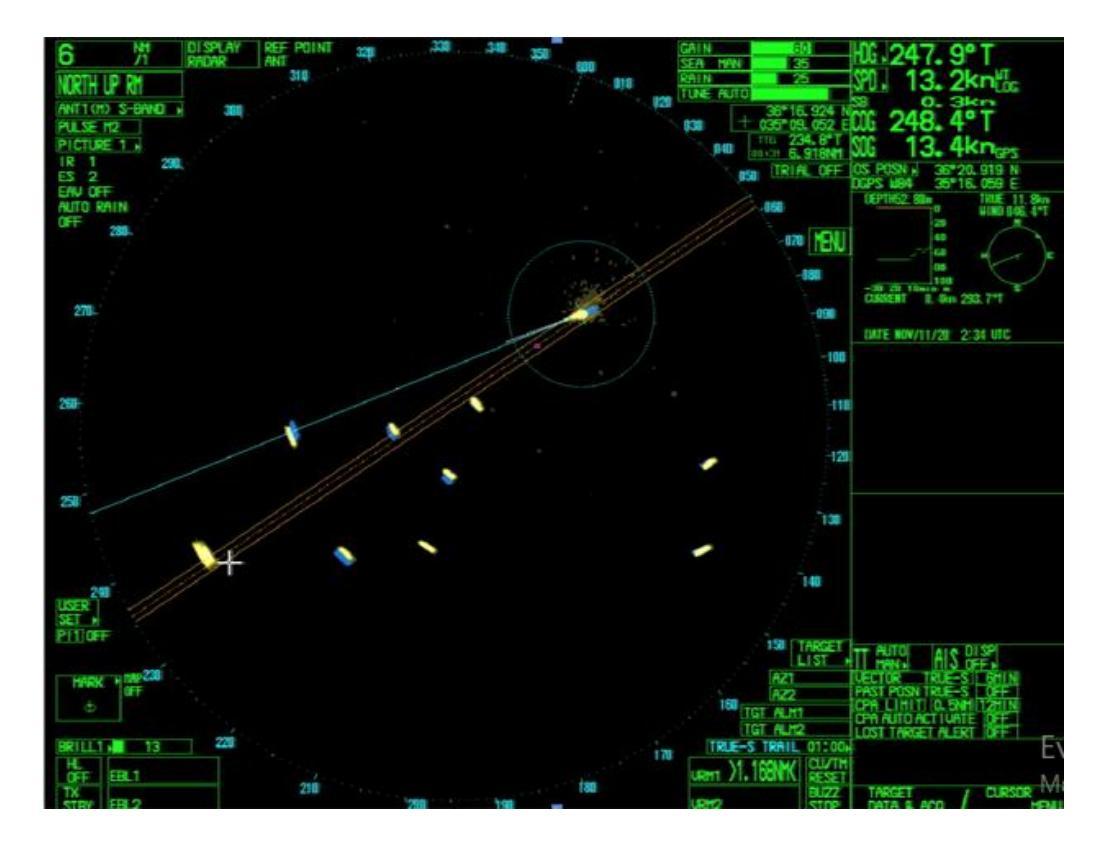
Image 13: ARPA Screenshot from EPHESOS

According to the ARPA screenshot from EPHESOS below (Image 13), it was set at 1.168 nautical miles, and according to the VRM, the distance between the F/V Mahmutcan and the Tanker decreased below 2 nautical miles.

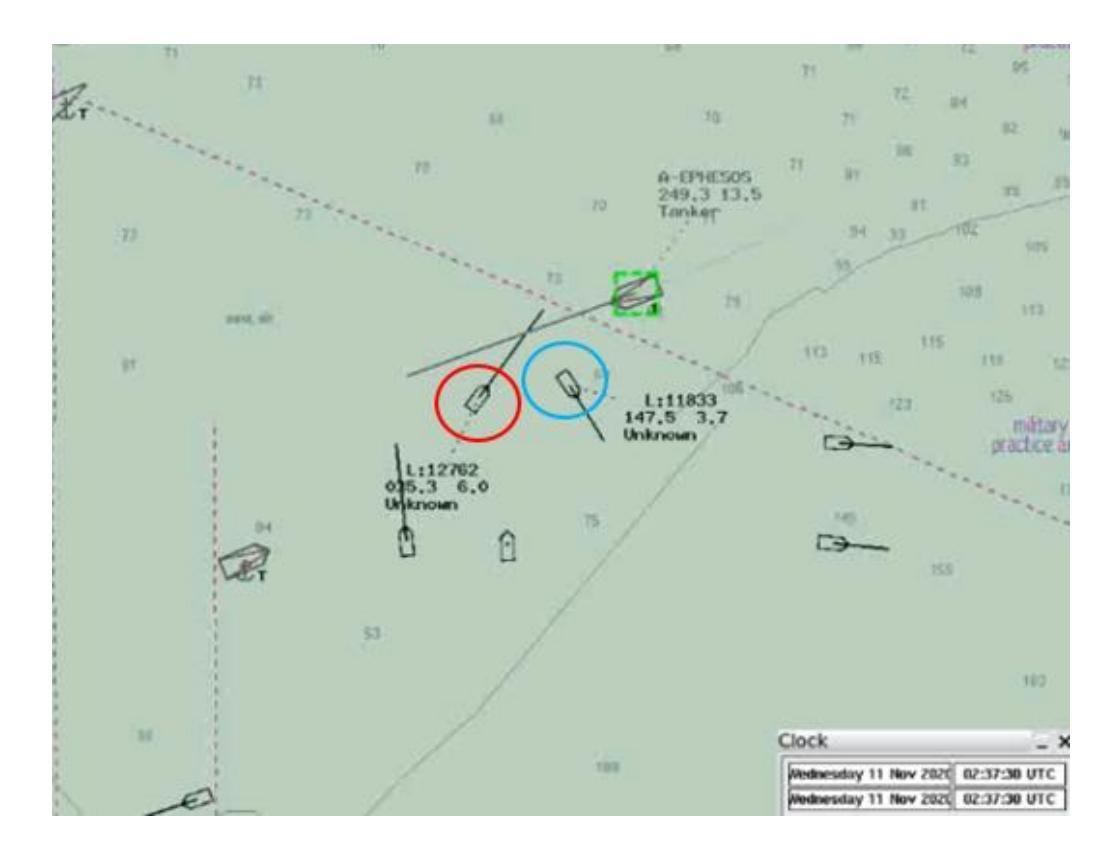
Image 16: VTS Image

According to a screenshot captured from Mediterranean VTS at 5:35:31 AM (Image 16), POLATBEY-1 was sailing at a speed of 06.2 nautical miles on the course of 35.3 degrees. While M/T EPHESOS was proceeding at a speed of 13.4 nautical miles per hour on her course 248-degree, the tanker's Officer of the Watch wanted to communicate with POLATBEY-1 by VHF to assess the situation and ascertain her intentions but received no answer.

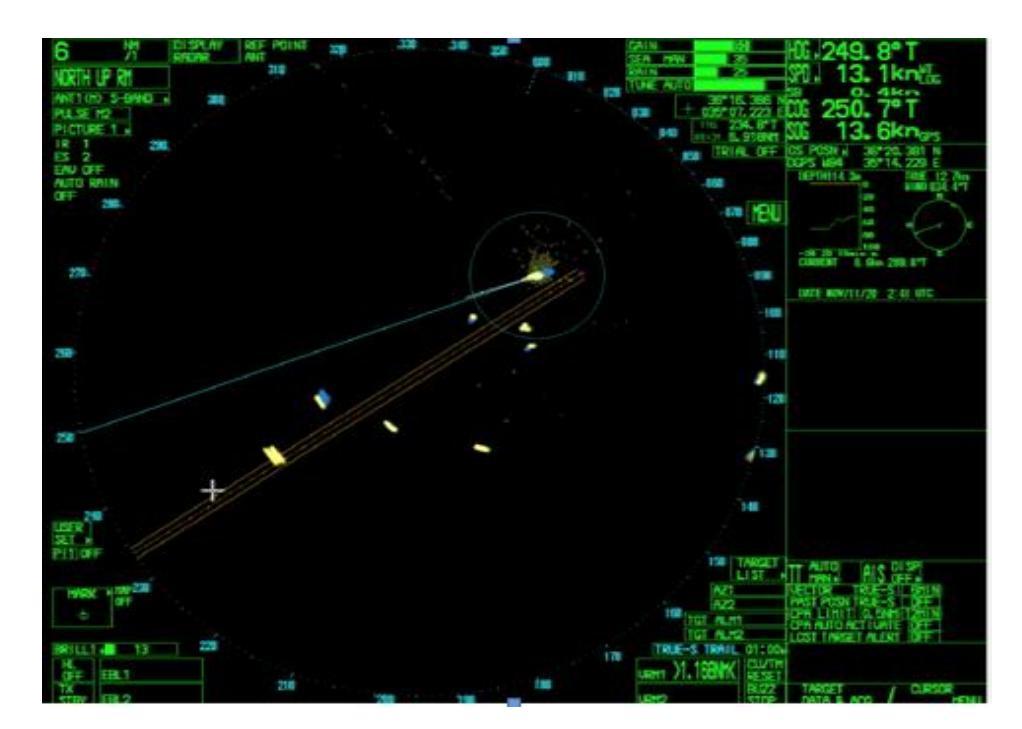
Image 17: ARPA Image 12: At 5:42 AM

Upon noticing four minutes before the collision that the fishing vessel, POLATBEY 1 had altered her course to the port, the Officer on Watch ordered the look-out to take the helm. At 5:42 AM, when the Officer on Watch executed the port 5 order, the distance between the tanker and POLATBEY-1 was 1.1 miles.

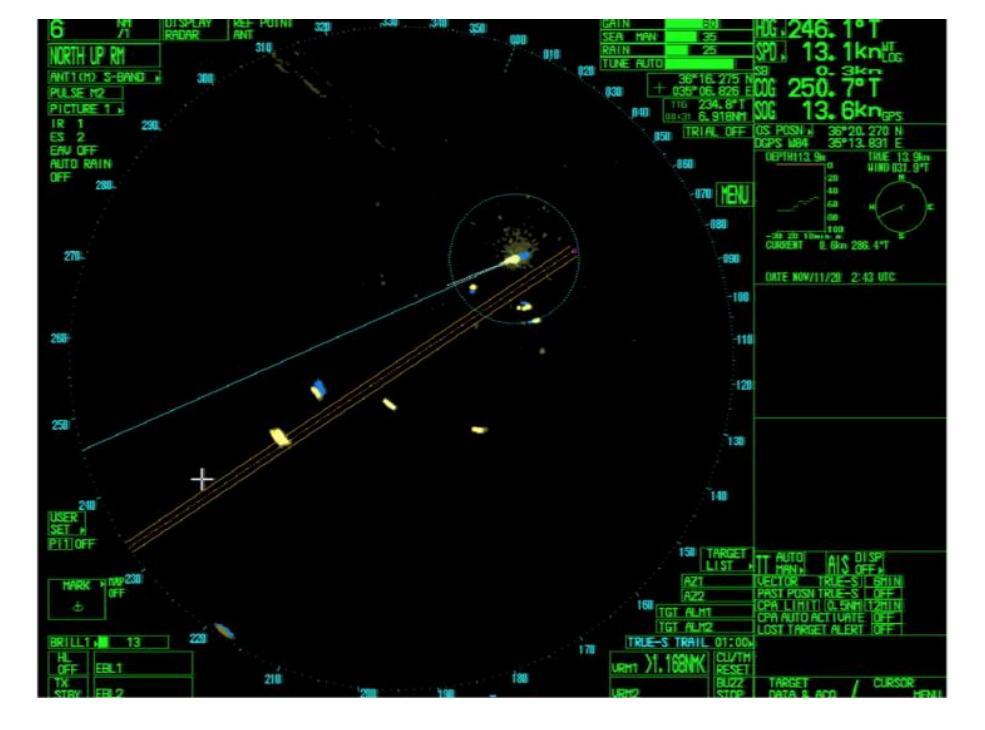
Image 18: Navigational Positions When the Tanker Executed Port 10

At 5:43:46 AM, when the Officer on Watch executed the port 10 order (Image 18), the distance between the tanker and POLATBEY-1 was 0.7 miles.

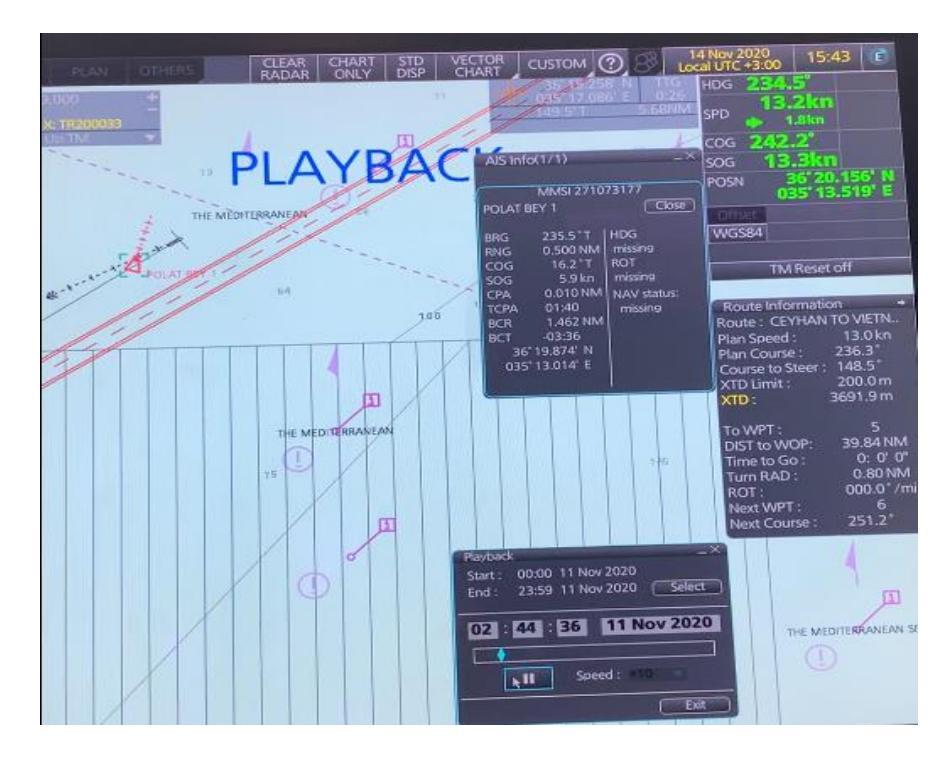
Image 21: Detailed Image Extracted from the ECDIS of the Tanker for The Crossing Of POLATBEY-1 Ahead of The Tanker

At 5:44:36 AM, 1.5 minutes before the collision, the tanker was executing port 20 degrees and POLATBEY-1 crossed ahead of the tanker to starboard (Image 21). Meanwhile, as the tanker headed towards the port, her course was 234.5 and her speed was 13.2 nautical miles. At that time, the course of POLATBEY-1 was 16.2, and her speed was 5.9 nautical miles, with a distance of 0.5 miles between both ships.

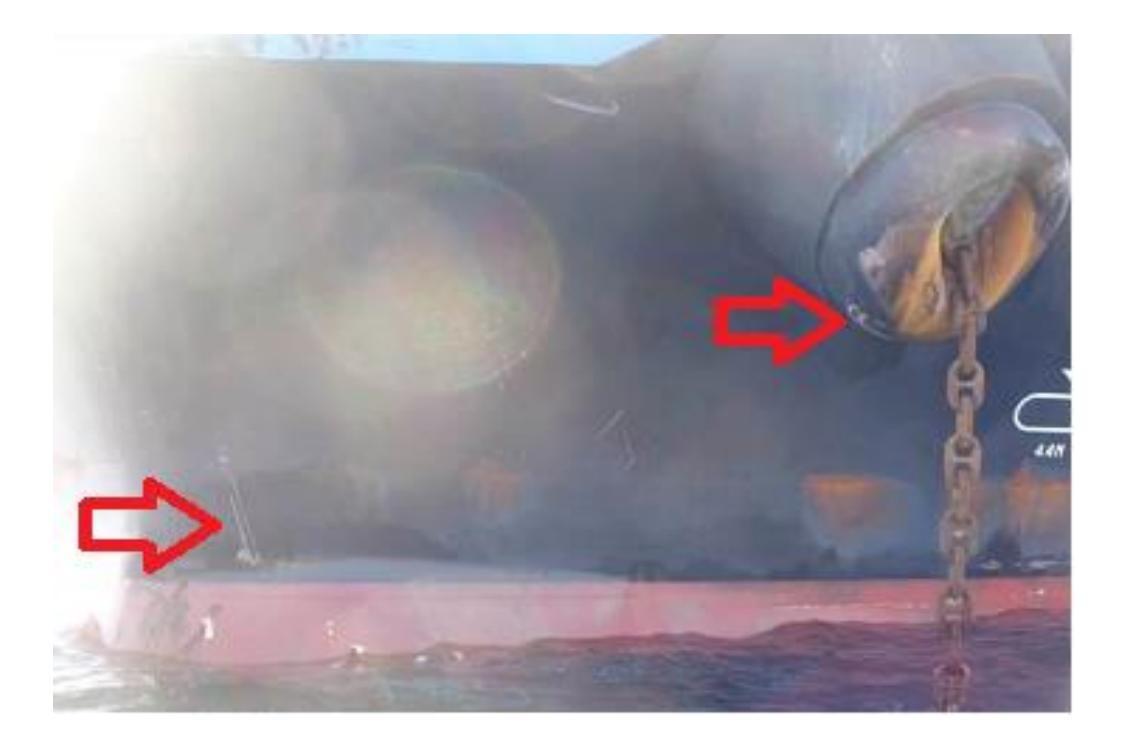
Image 23: Front View of The Tanker, Ephesos

During the accident investigation on the tanker, EPHESOS, which was anchored, a paint scratch was noticed below the hawse pipe of the port anchor. However, as the tanker anchored by the port anchor instead of starboard, the location of the impact was not been clearly identified in the examination of damage at the anchor site.

The damage on the standard compass deck of the fishing vessel, POLATBEY-1 and the ECDIS images later indicated that the tanker collided with the fishing vessel with her port anchor. As a result of the collision with the port hawse pipe of the tanker, the fishing vessel, POLATBEY-1 was severely damaged and capsized and became unusable. (Image 23-31)

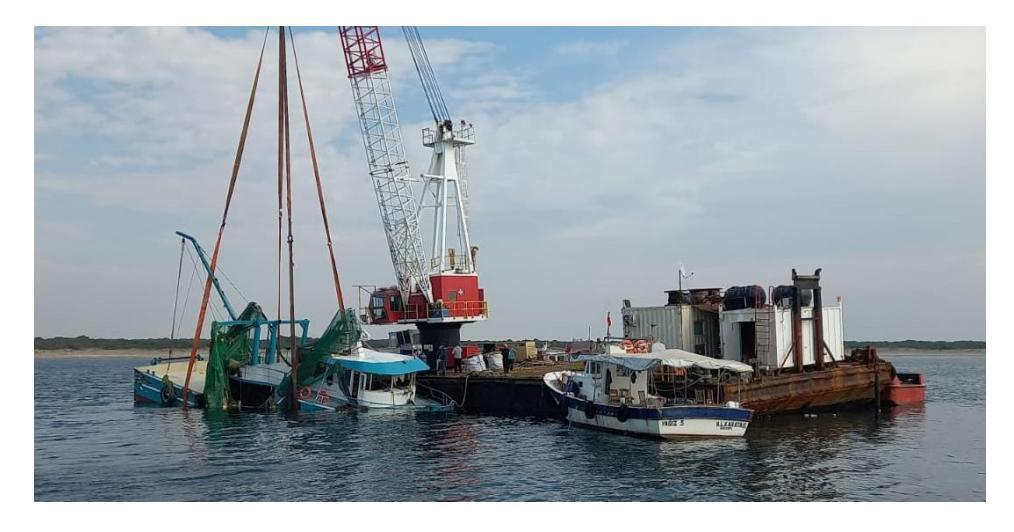
Image 28: Floating Operation of the Fishing Vessel, POLATBEY-1

It was detected that the port side, starting from the standard compass deck up to the midship of the main deck, was deformed and ruptured; the bridge windows exploded; the net davit on the port side was broken; the crane net on the port side was detached; there was still water in the engine room and the engine and navigation devices were inoperable. (Images 29, 30, and 31)

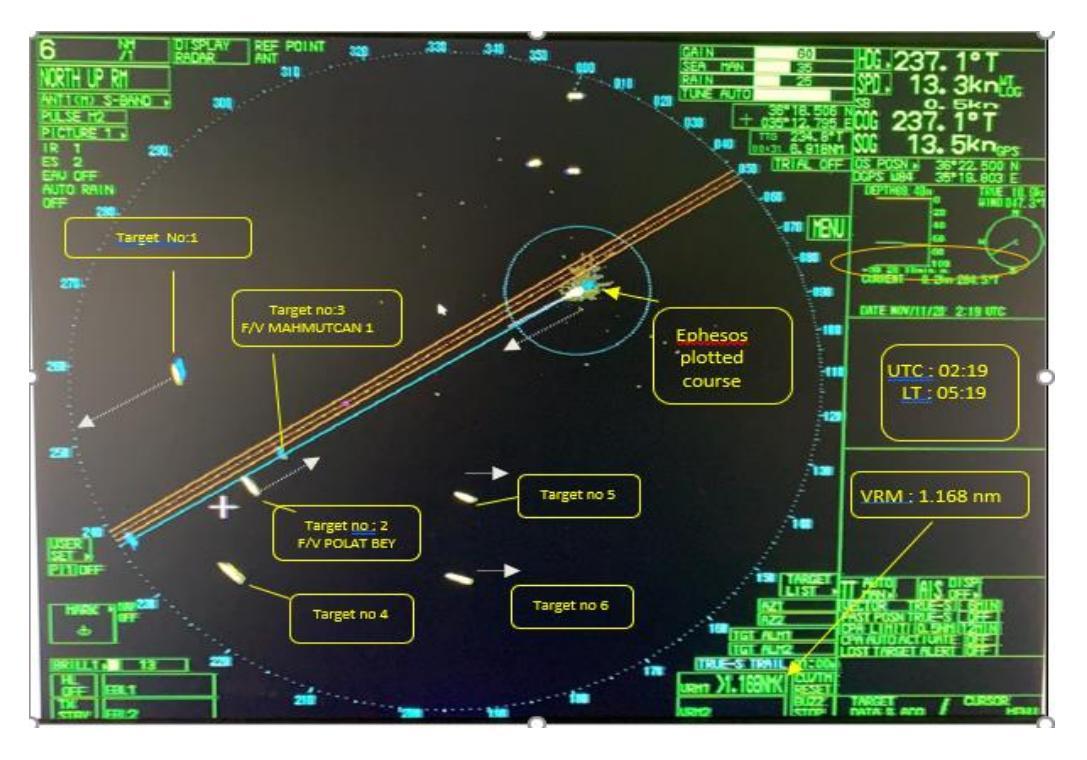
Image 32: The Tanker and the Marine Traffic Around Her

The screenshot captured from the VDR of EPHESOS (Image 32) indicates the marine traffic as well as the positions of other vessels around the tanker, EPHESOS at 5:19 AM.

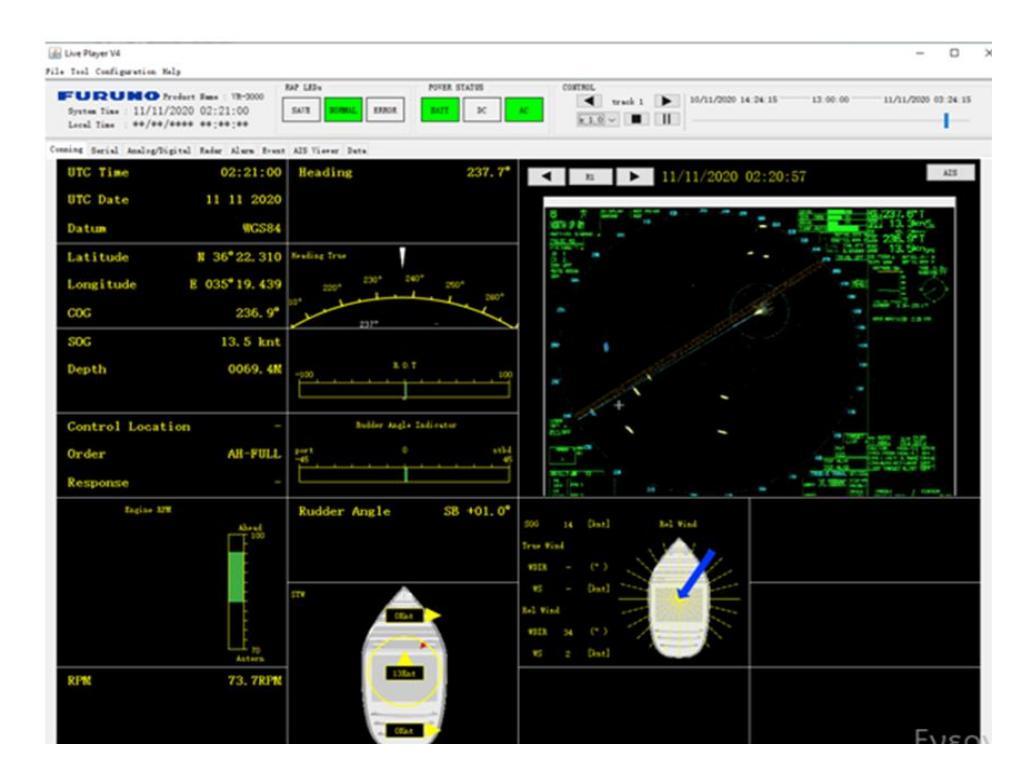
Image 33: The Officer on The Watch Began Altering Her Course to Starboard At 5:20 AM

As shown in the screenshot (Image 33) captured from the VDR of EPHESOS, at around 5:20 AM, the Officer on the Watch evaluated the marine traffic that was growing on the port side as well as the six targets displayed in ARPA in more detail, and began progressively altering her course 1 degree to starboard with the autopilot course adjusting function in order to clear off those targets; and at 5:20 AM, her course was 237.5 and her speed was 13.5 nautical miles.

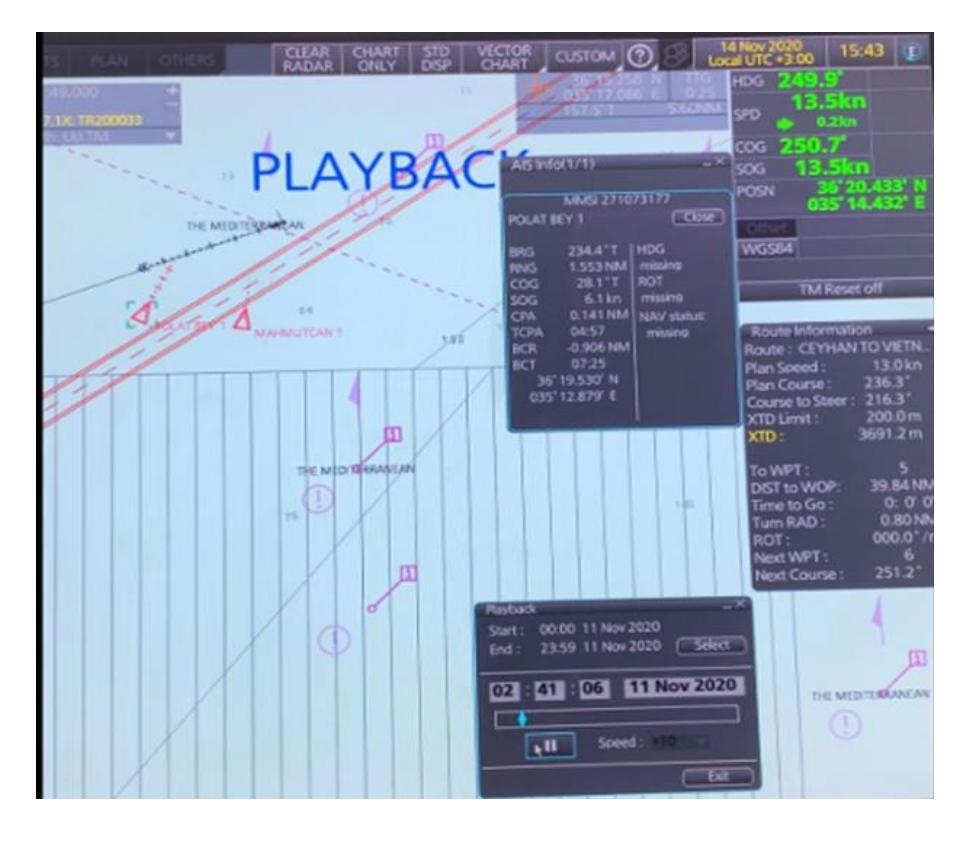
Image 34: Screenshot from ECDIS

At 5:41:06 AM (Image 34), the fishing vessel was sailing on course 028 at a speed of 06.1 nautical miles.

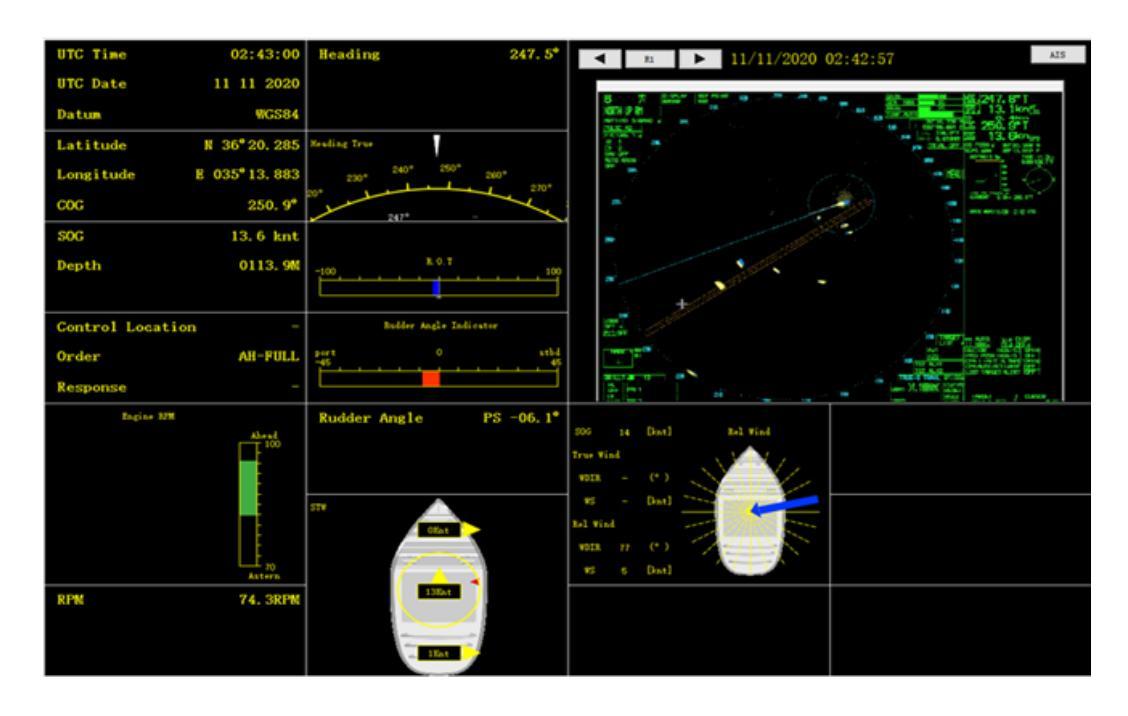
Image 35: Screenshot from VDR When Port 5 Order Was Executed

At 5:42 AM, when the Tanker's Officer on Watch executed the port 5 order (Image 35), the distance between the tanker and POLATBEY-1 was 1.1 miles. Meanwhile, POLATBEY-1 was sailing on her course 16.2 and at a speed of 6.2 nautical miles, while the tanker had a course of 249.8 and a speed of 13.1 nautical miles.

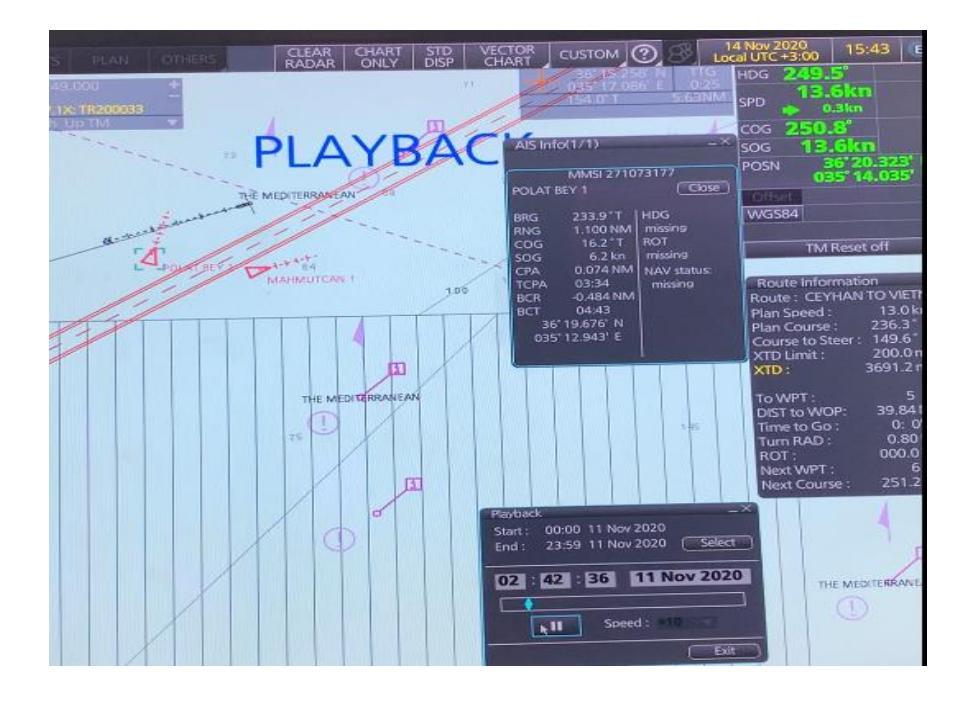
Image 36: Screenshot from ECDIS

The screenshot captured from ECDIS (Image 36) displays that POLATBEY-1 was sailing on her course of 16.2 and at a speed of 6.2 nautical miles, while the tanker had a course of 249.5 and a speed of 13.1 nautical miles at 5:42:36 AM

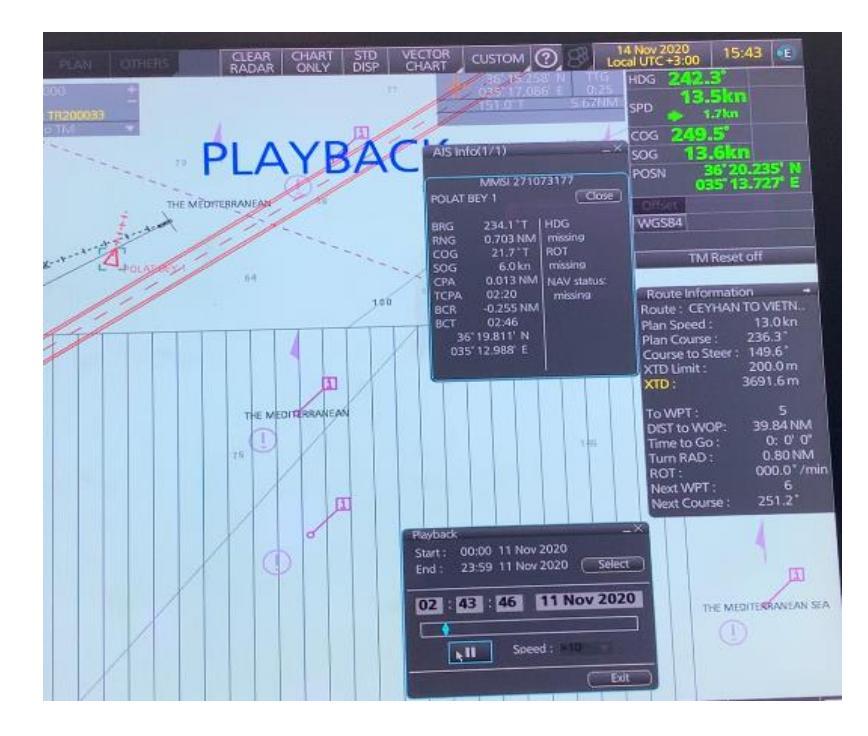
Image 37: Screenshot from ECDIS

The screenshot captured from ECDIS (Image 37) displays that when the Tanker's Officer on Watch executed port 10 at 5:43:46 AM, the distance between the tanker and POLATBEY-1 was 0.70 miles. Meanwhile, POLATBEY-1 was sailing on her course 21.7 and at a speed of 6.0 nautical miles, while the tanker had a course of 242.3 and a speed of 13.5 nautical miles.

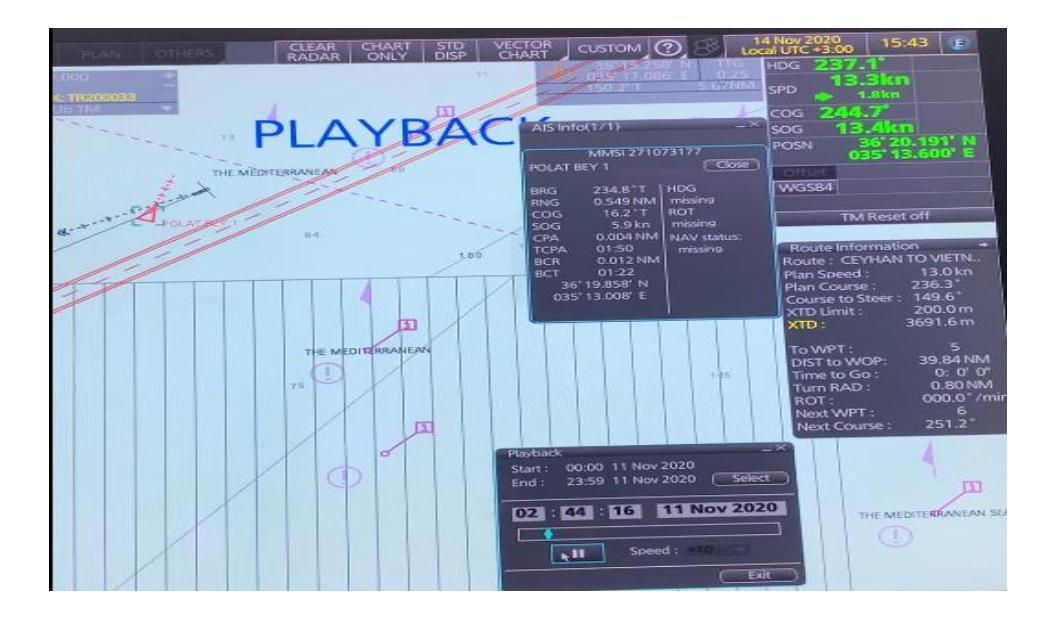
Image 38: Screenshot from ECDIS

The screenshot captured from ECDIS (Image 38) displays that when the Tanker's Officer on Watch executed port 15 at 5:44:16 AM, the distance between the tanker and POLATBEY-1 was 0.549 miles, and POLATBEY-1 was crossing ahead of the tanker to starboard. Meanwhile, POLATBEY-1 was sailing on her course 16.2 and at a speed of 5.9 nautical miles, while the tanker had a course of 237.1 and a speed of 13.3 nautical miles.

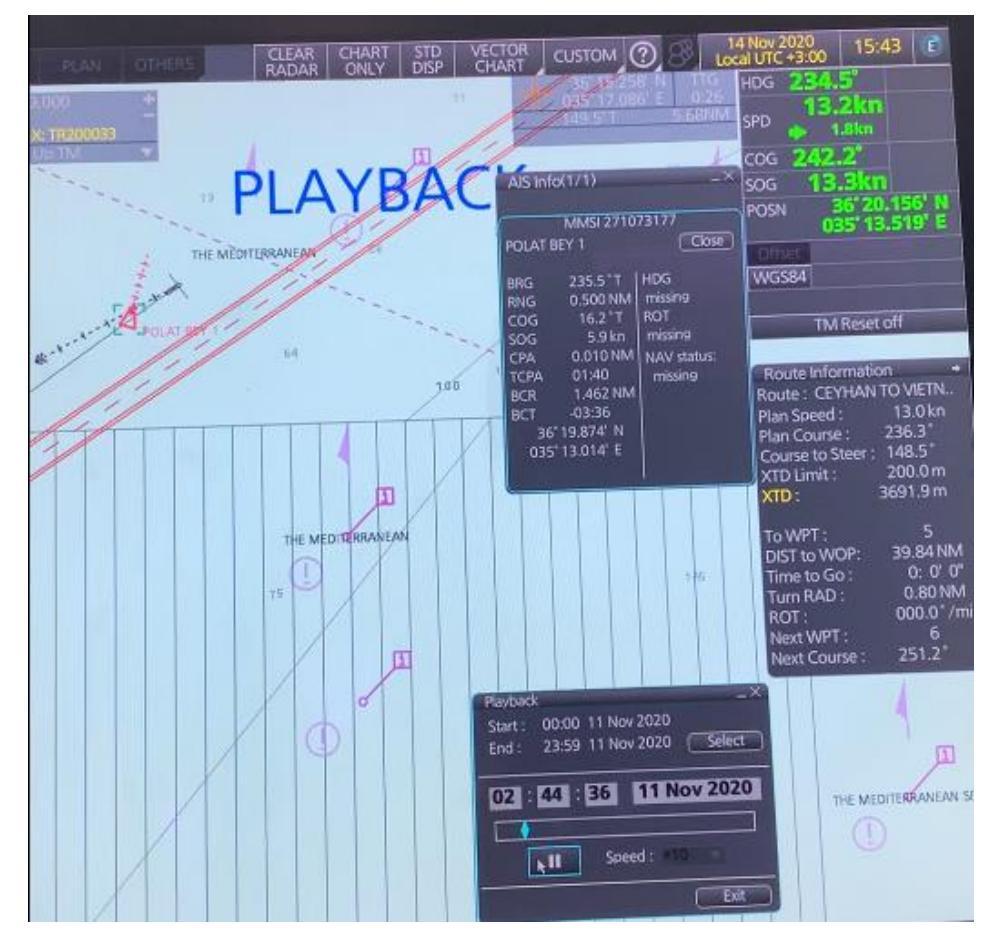
Image 39: Screenshot from ECDIS

The screenshot captured from ECDIS (Image 39) displays that when the Tanker's Officer on Watch executed port 20 at 5:44:36 AM 1.5 minutes before the collision, POLATBEY-1 crossed ahead of the tanker. Meanwhile, the tanker was heading towards the port, with her course 234.5 and her speed 13.2 nautical miles. POLATBEY-1 had her course 16.2 degrees and a speed of 5.9 nautical miles. The distance between them was 0.50 miles.

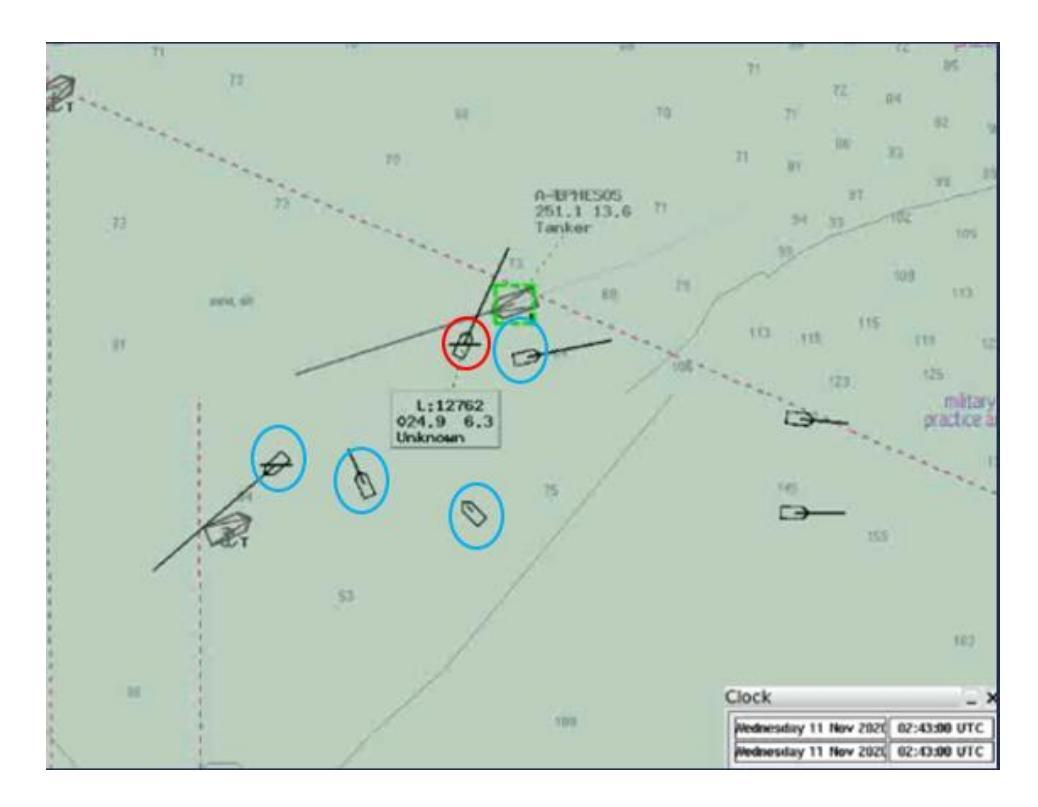
Image 42: Fishing Vessel and Other Fishing Vessels Around at 5:43 AM

VTS and VDR data extracted from the tanker, EPHESOS indicates that the fishing vessel was noticed by the tanker on the port side and fishing vessel was expected to move out of the tanker's way. However, since there was a group of fishing vessels with limited manoeuvre capacities around the fishing vessel up until 4 minutes before the collision (Image 27), it is considered that fishing vessel might have started to manoeuvre late to avoid a collision as she expected for the manoeuvre from the tanker.
