**SAFETY INVESTIGATION REPORT
OCCUPATIONAL ACCIDENT ON RO-RO VESSEL UND ATILIM**

VESSEL NAME and IMO No : UND ATILIM - 9242388
FLAG OF THE VESSEL : Turkey
LOCATION OF ACCIDENT : Port of Mersin/MERSİN
DATE OF ACCIDENT : 10.03.2020/16:35 LT
CASUALTIES : 1/-
DAMAGE and POLLUTION : -/-

Board Decision No: 14/DNZ- 04/2021

Date: 12/07/2021

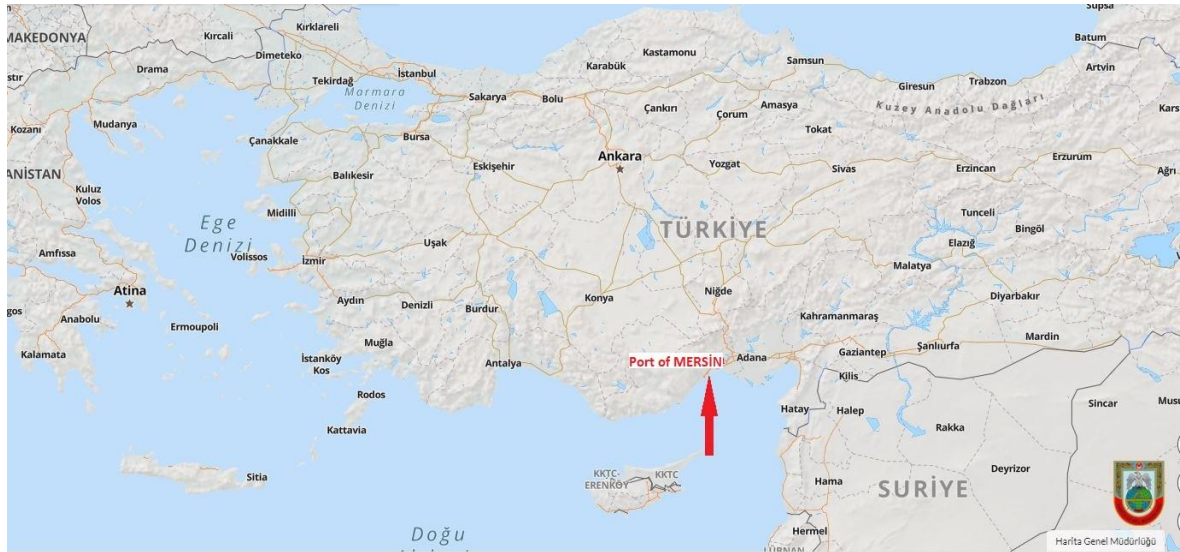
Picture 1: Accident Location

At 16.35, the trailer that was tracked by the loading MAFI crushed into the mobile scaffold and caused the worker on the mobile scaffold to lose his balance and fall from a height of 5 meters onto the main deck ground. Immediately following the accident, the medical practitioners arrived at the scene in a short span of time and delivered the initial intervention, and the casualty was referred to the hospital. However, the casualty passed away despite all attempts to save him.

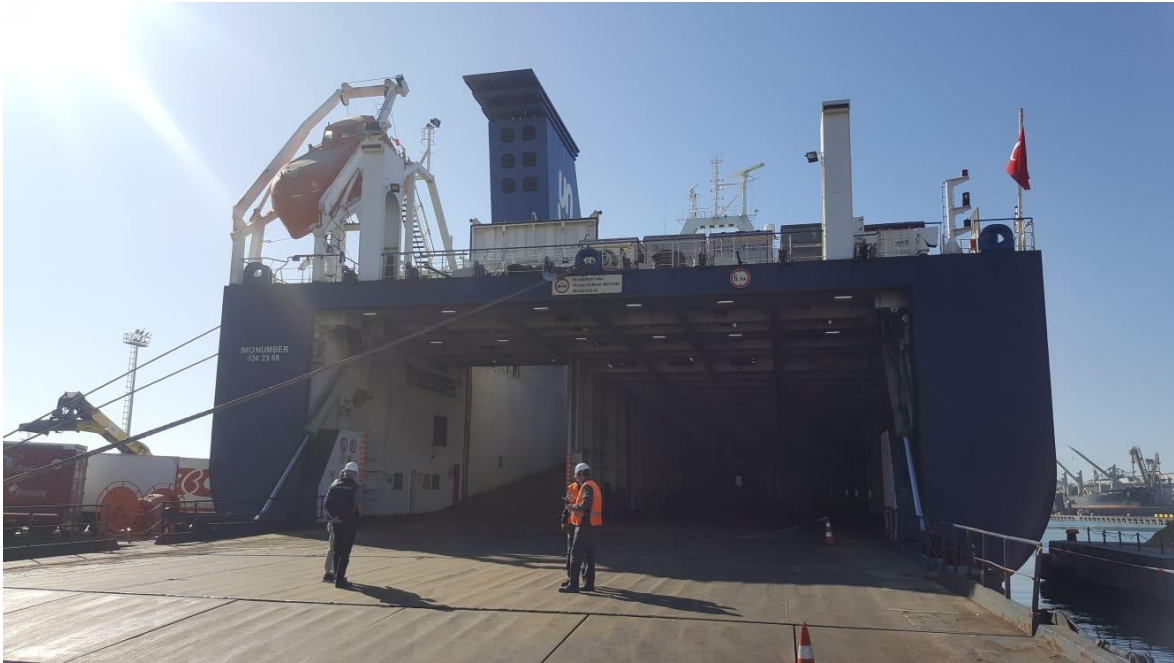
Picture 3: UND ATILIM Boarding Ramps

Meanwhile, the mobile scaffold was being displaced and the sprinkler nozzles were being replaced and circuits were being maintained on the main deck. Around 16:35, the trailer that was tracked by the loading MAFI and boarded the main deck from the ship's ramp touched the mobile scaffold, , and caused one of the two workers on the mobile scaffold to lose his balance and fall from a height of 5 meters onto the ground. The other worker was hanged by holding the pipe at the moment and narrowly escaped from falling (*Photo 3 – 4 – 5 - 6*).

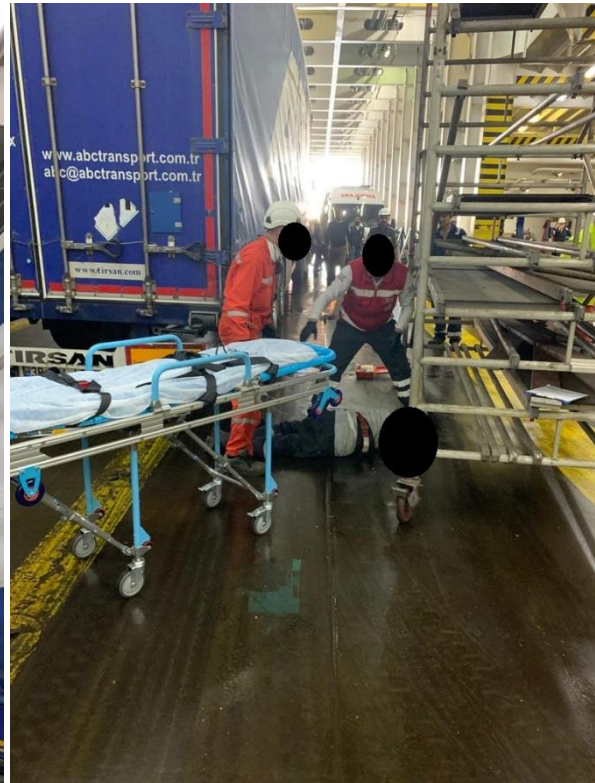
The port operation unit immediately called for the workers who fell on the ground and requested an ambulance. The ambulance stationed in the port arrived at the scene in a short time around 4:40 PM and transported the casualty to the hospital following the first intervention. (*Photo 7 - 8*)

Picture 8: Photo of the Initial Intervention to the Casualty

The statements and photographs also show that the helmet came off the casualty's head after the fall and was broken. The chin straps of such helmets keep them balanced and prevent them from coming off easily in cases, such as trips, overturns, and falls. Although there is no evidence of how the casualty utilized his helmet throughout the operation, the discovery of a broken helmet indicates that it did not come off during the fall.

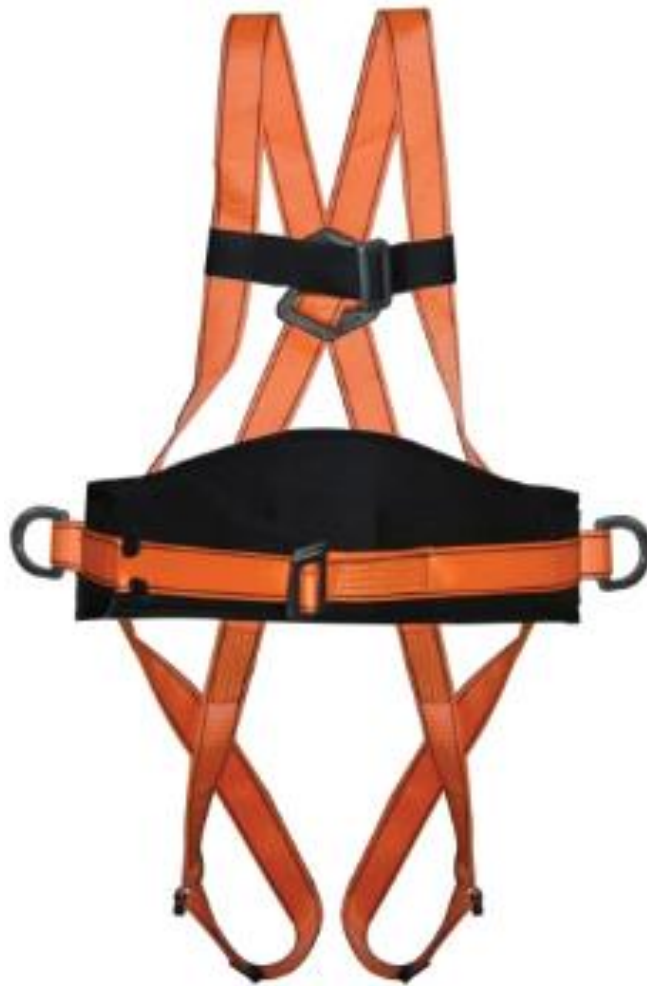
Picture 12: Parachute Type Safety Harness
