**REPUBLIC OF TURKEY**  
**MINISTRY OF TRANSPORT, MARITIME AFFAIRS AND**  
**COMMUNICATIONS**  
**Accident Investigation Board**

**Accident Investigation Report On**  
**The Collision Between TANAIS DREAM & SULTANAHMET**

**Istanbul Strait / Sarayburnu**  
**18<sup>th</sup> of December 2014**

**Report Number: 04/2015**

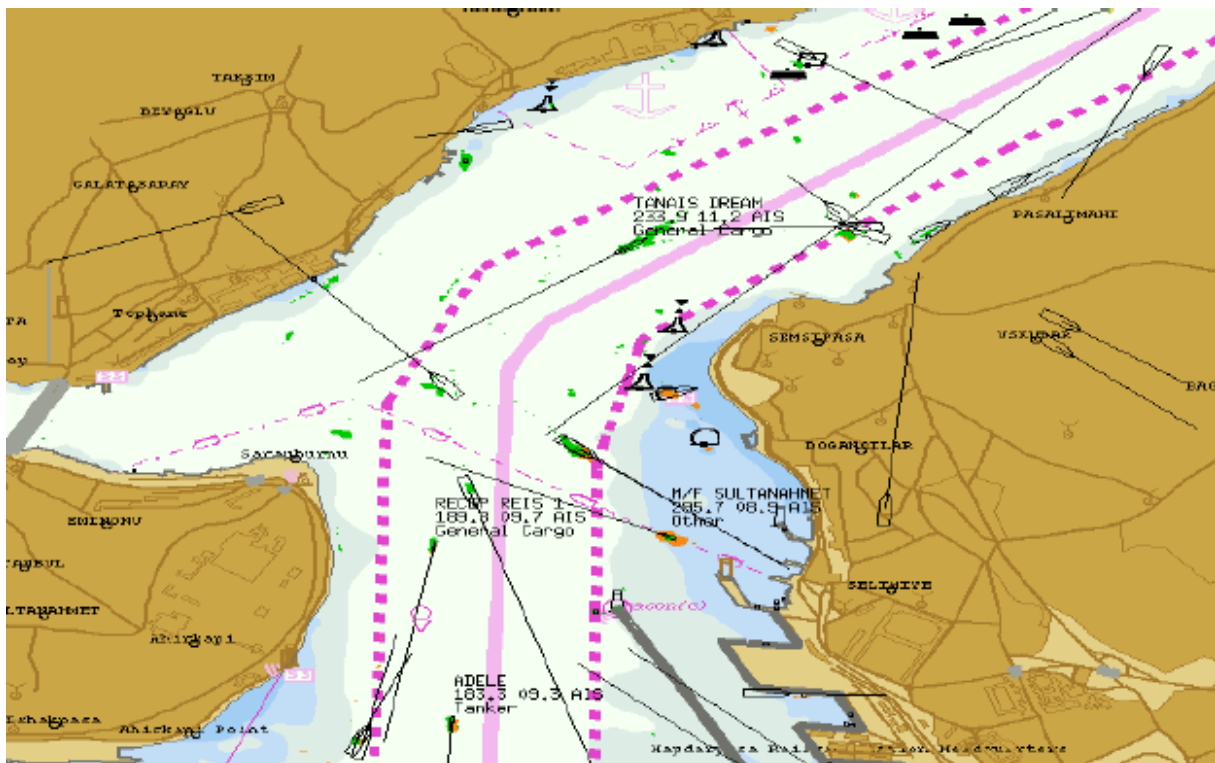
Figure 2: AIS snapshot at 19:35:41

As TANAIS DREAM was proceeding in its traffic lane at 11.1 knots on route 234, heading to Beyazit Tower, when the Maiden's Tower was at abeam at 19:37, the master ordered "port 10" to the helmsman for turning to port side. In the meantime, SULTANAHMET was proceeding at 8.2 knots to the route 329. At 19:37:19, as TANAIS DREAM was continuing to turning to the port side, its' bow headed to 224. At 19:38:10, TANAIS DREAM headed to 211 and in the meantime, SULTANAHMET was heading to 315.

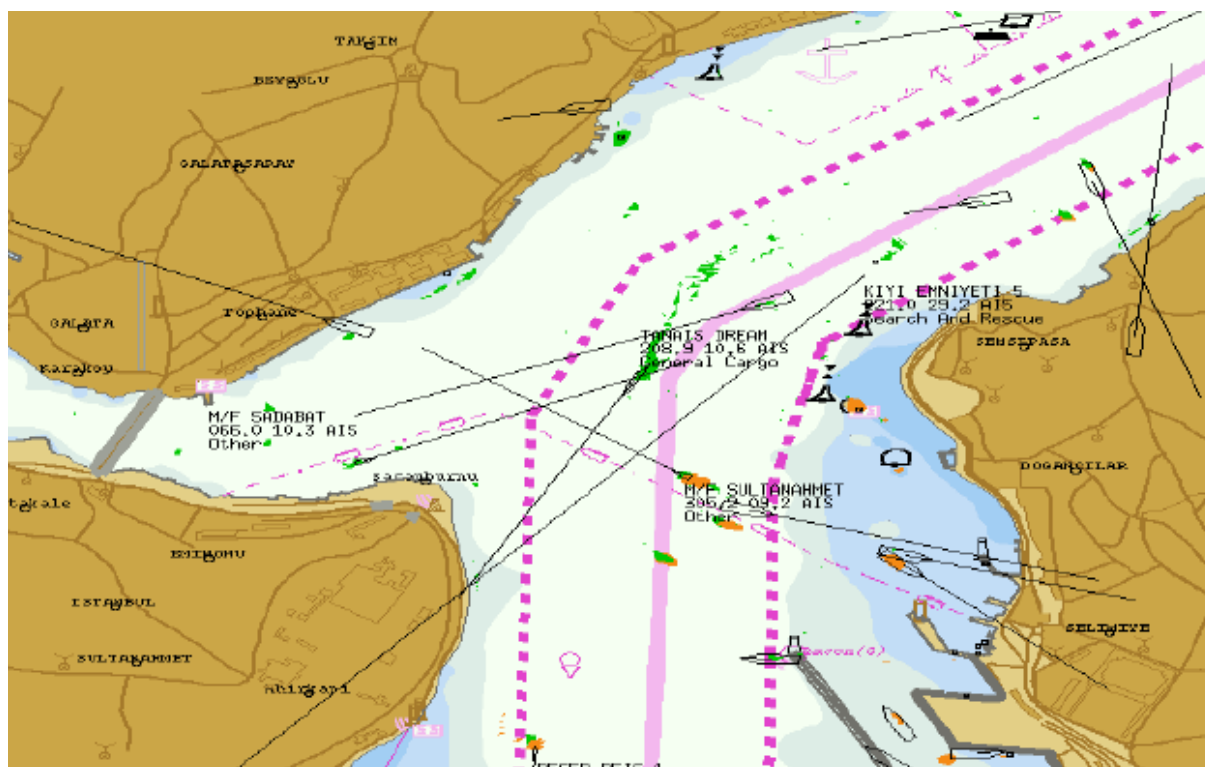
Figure 5: AIS snapshot at 19:38:38

At 19:38:38, as TANAIS DREAM was continuing to turning to the port side at 10.6 knots, SULTANAHMET was navigating to Sirkeci Port on the route 305 at 9.2 knots.

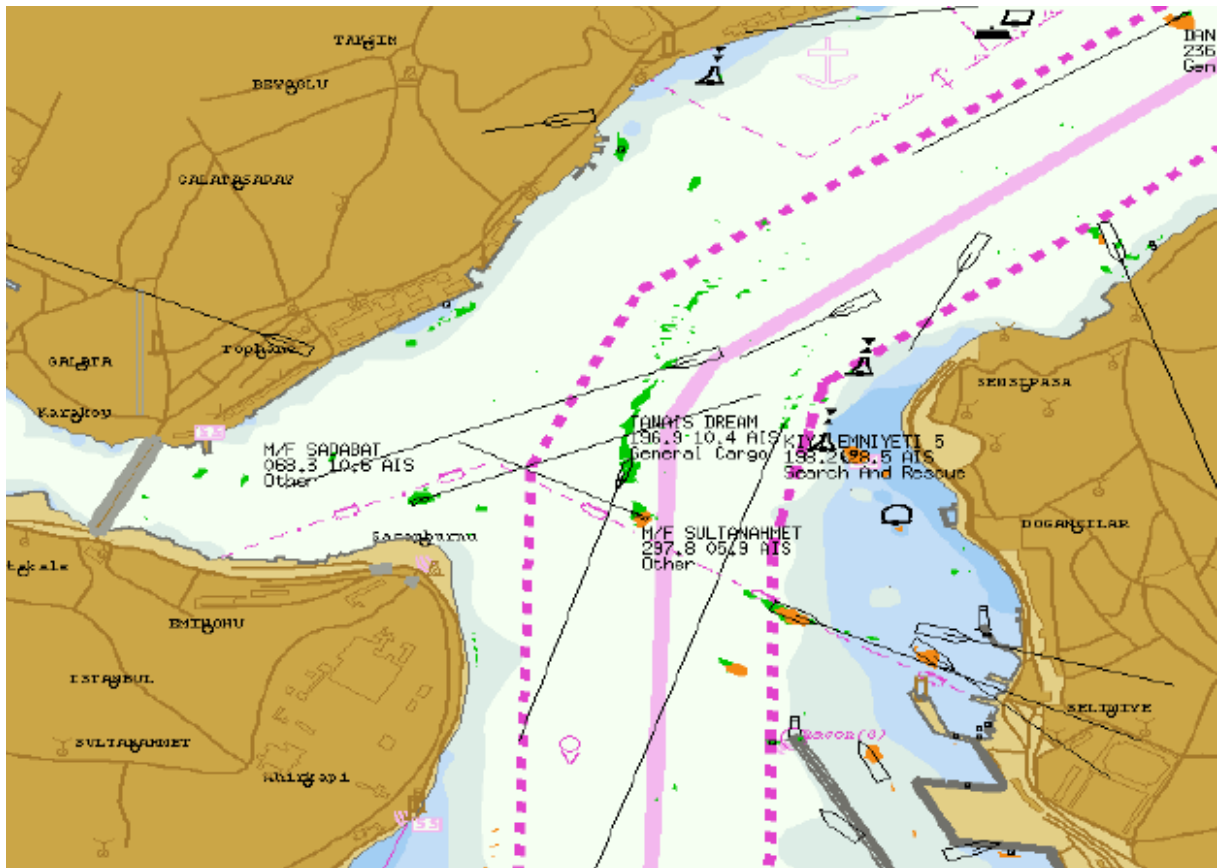
Figure 6: AIS snapshot at 19:39:20

At 19:39:20, as TANAIS DREAM was continuing turning to the port, it headed to 197 and its' speed was 10.4 knots. The master of SULTANAHMET realized the vessel in about 40 seconds from 19:38:38 to 19:39:20, but as the distance between TANAIS DREAM and his own vessel was considerably short, he decided to alter its' course to starboard to keep clear from the head of TANAIS DREAM as soon as possible. In the meantime, the master of TANAIS DREAM, who realized that the collision with SULTANAHMET was unavoidable, gave the instruction "engine astern at full speed, helm midships" and tried to warn SULTANAHMET with 5 short whistles/horns.

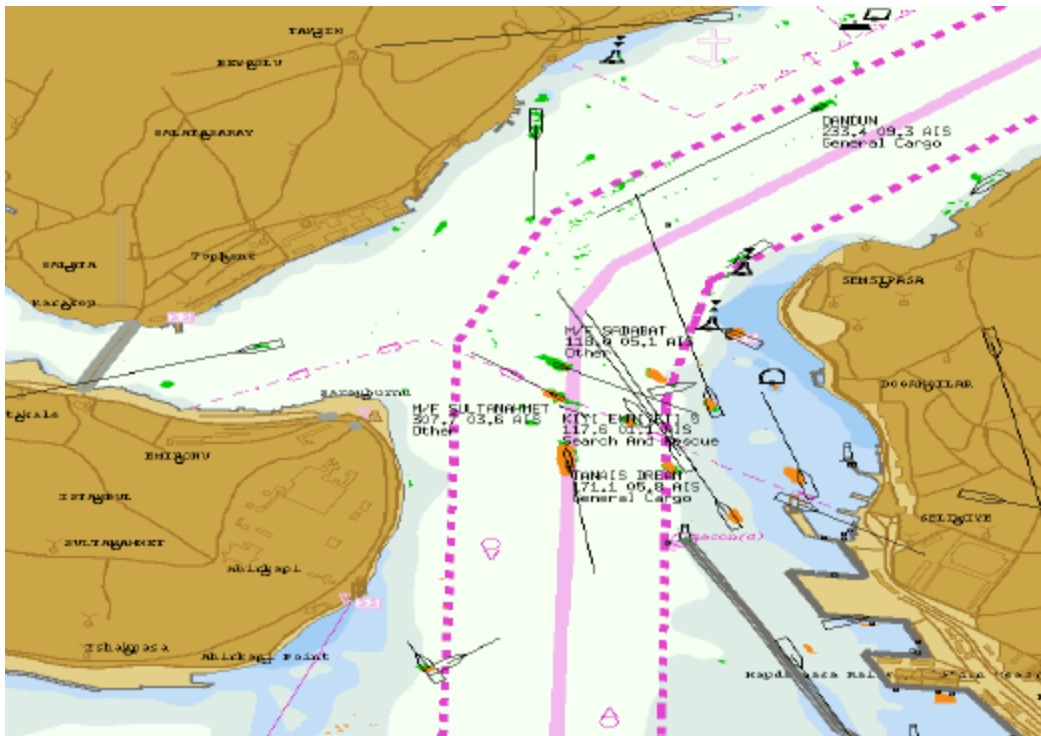
**Figure 9:** AIS snapshot at 19:42:50

After the collision, the master of the TANAIS DREAM stopped the engines, which were running astern at full speed before the collision. In the meantime, with the inertia of the vessel during the accident, the vessel headed up to 169 from 179 and its speed decreased to 7 knots. The master gave the instruction "hard to starboard" to the helmsman and make the engine run at dead slow ahead. Meanwhile, he instructed the chief officer to inform Sector Marmara from VHF and he asked the boatswain, who was at the forecastle deck at the time, to check the fore peak and other tanks. He dropped anchor in front of Yenikapı according to the instruction from Sector Marmara.

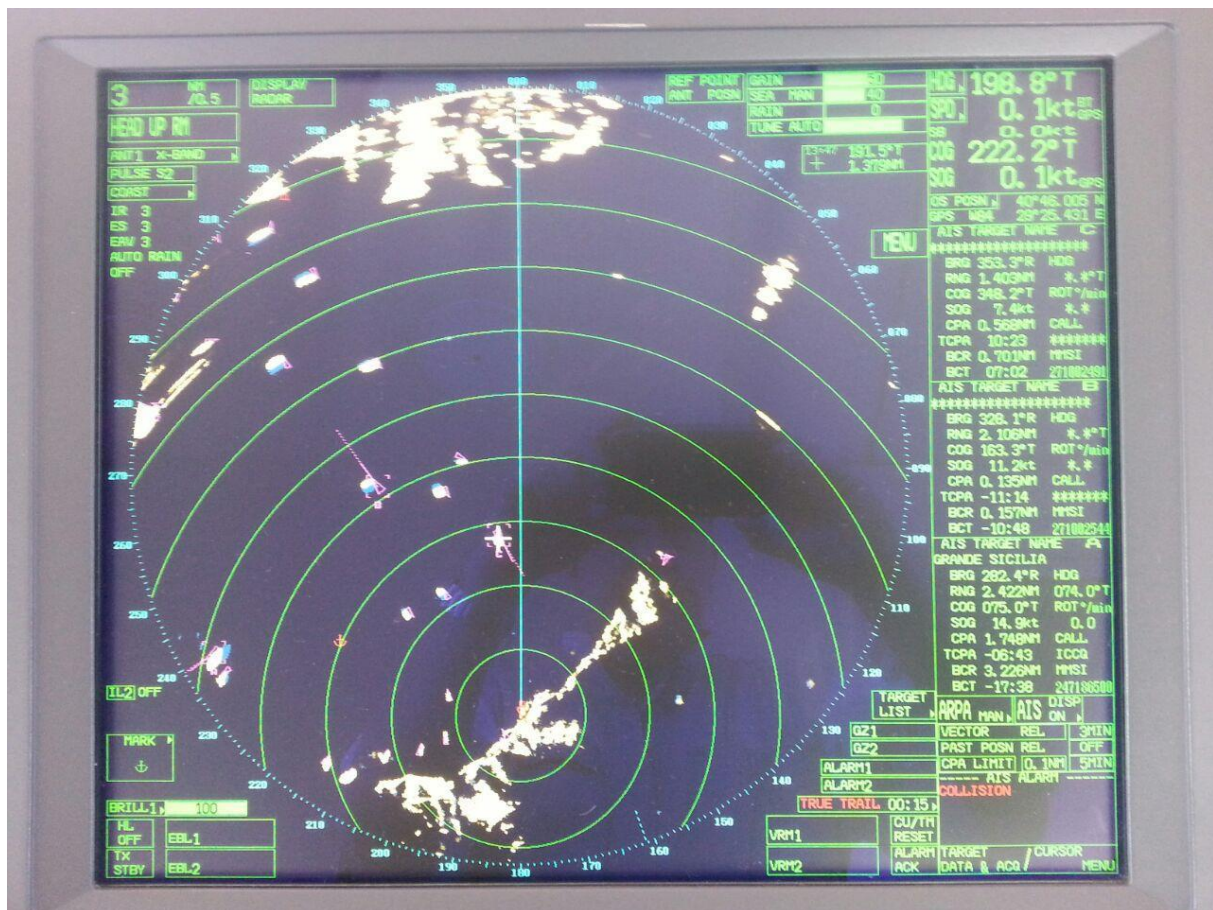
**Figure 12:** The Radar Display onboard SULTANAHMET

The bridge of SULTANAHMET was built as completely closed and can be controlled from two separate console in head-stern direction, thus is a section where all kinds of navigational equipment are in pairs. Voith-schneider propeller system is present onboard and the vessel's both propulsion and starboard-port movement are provided with this system, and thus there is no standard steering system, steering engine etc. There is a self-steering (autopilot) system onboard. When the vessel is on autopilot, the autopilot is designed to be deactivated immediately as soon as any intervention is made to the control levers of the vessel. On the bridge, there is one X-band arpa radar and a repeater on both two consoles. The use of AIS combined with arpa radar is possible. When the desired vessel is selected in the radar display, the information from the AIS can be displayed.

In addition, both two consoles have an AIS monitor with a screen width of 30 cm. The monitor has a touch screen and the location, speed and course of the selected vessel can be seen on the screen.

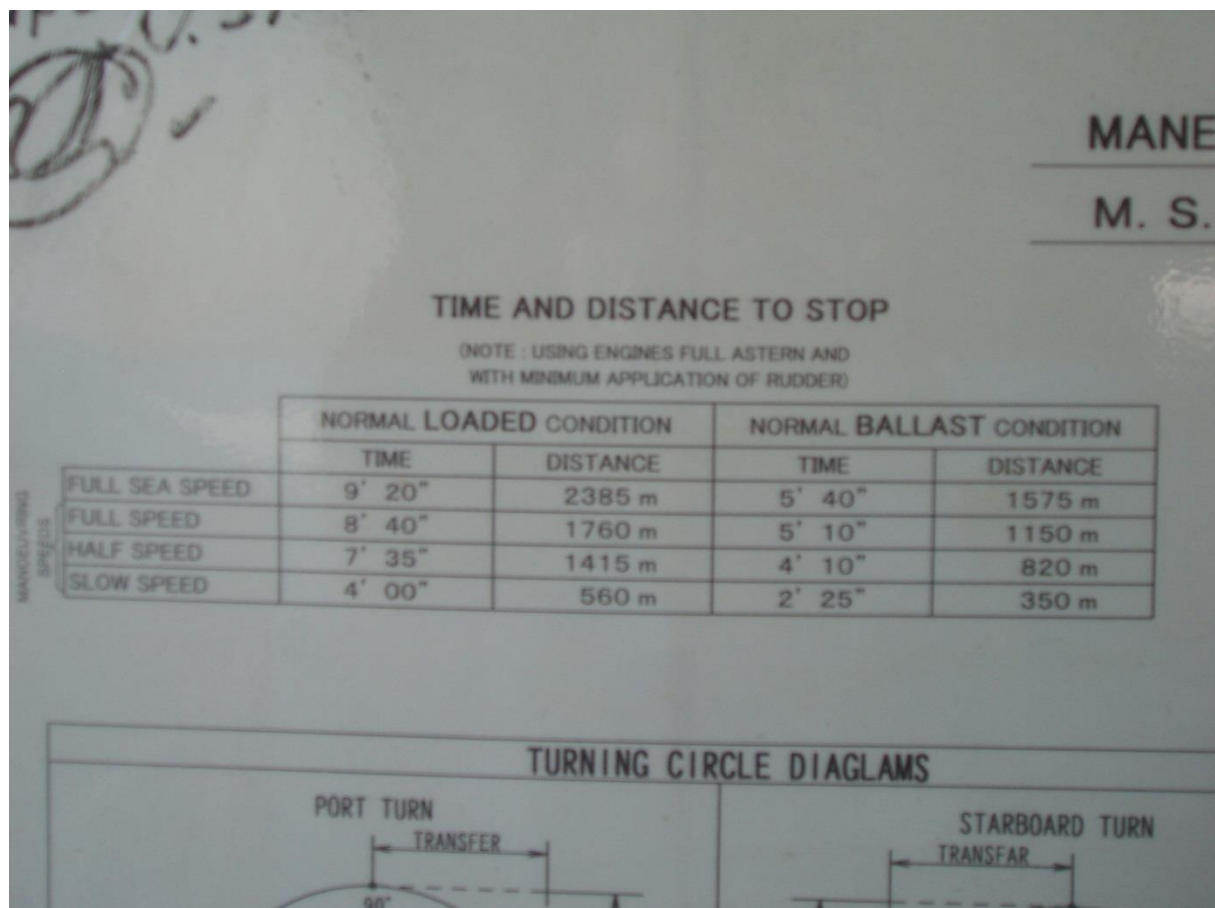
**Figure 15:** A Part from the Maneuver Diagram of TANAIS DREAM

The maneuver diagram of TANAIS DREAM is affixed to the wing on the bridge. The time necessary to stop while proceeding at various speeds and when the instruction of full astern is given on loaded or ballast condition and the distance to be covered before stopping are given separately. For example; it should be understood that when proceeding full ahead on fully loaded condition and full astern instruction is given, the vessel will stop in 8 minutes 40 seconds and 1760 meters away.

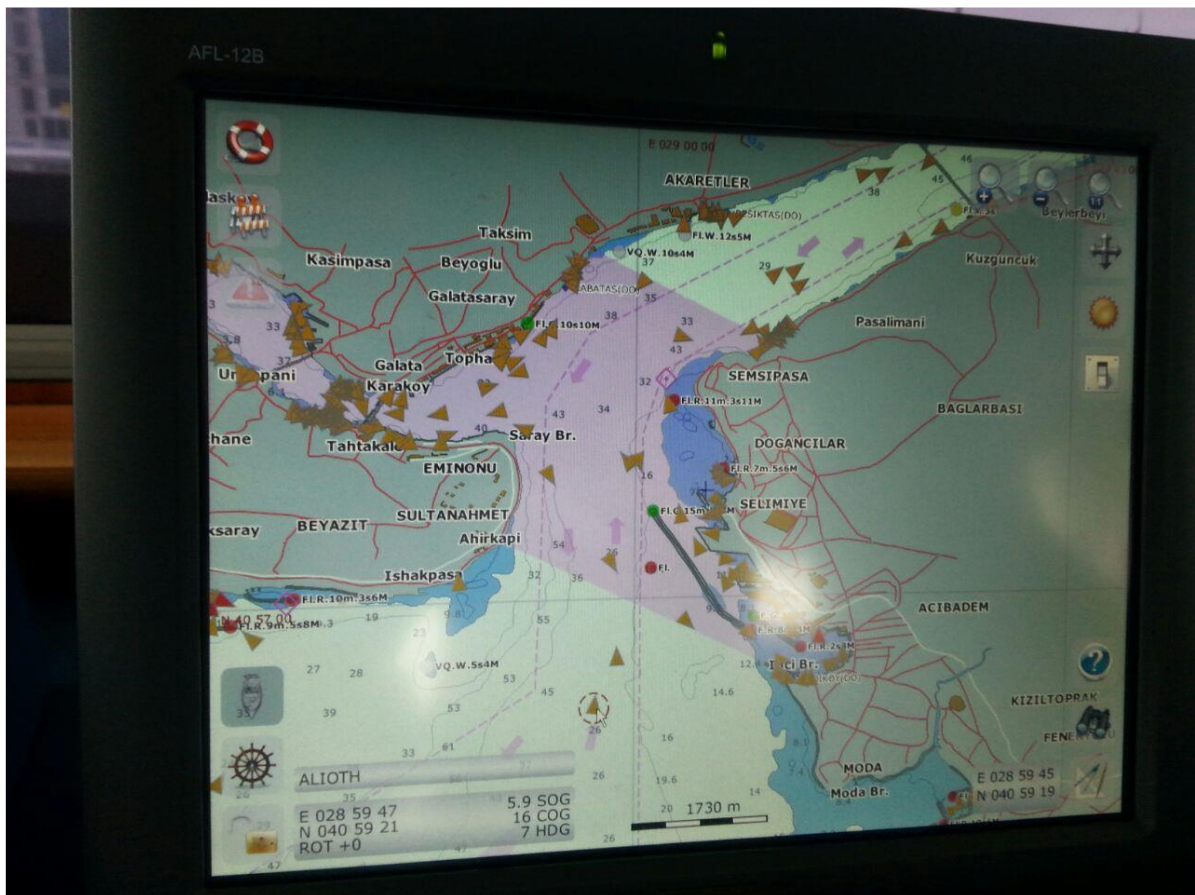
**Figure 23:** AIS Display of the Vessel SULTANAHMET

Once again, it is considered that the master did not carry out his radar observation, which he stated that he does routinely carry out before each voyage, before the Harem-Sirkeci voyage in which the collision occurred. This is because it was determined that there was no major change made for the course, which the vessel SULTANAHMET was on after departing from Harem, during the navigation until 1 minute before the collision. In this context, it is considered that if the vessel SULTANAHMET's master had realized the vessel TANAIS DREAM before the departure from Harem or from the radar or AIS during navigation, he would have carried out the proper maneuver so early to prevent the collision and the collision would have been avoided.
