**REPUBLIC OF TURKEY**  
**MINISTRY OF TRANSPORT, MARITIME AFFAIRS AND**  
**COMMUNICATIONS**  
**Accident Investigation Board**

**Marine Casualty Safety Investigation Report**  
**The Collision Between M/V TOLUNAY and**  
**the Coast Guard Boat TCSG-25**

**Istanbul Strait South Entrance**  
**17<sup>th</sup> August 2016**

**37/DNZ-06/2017**

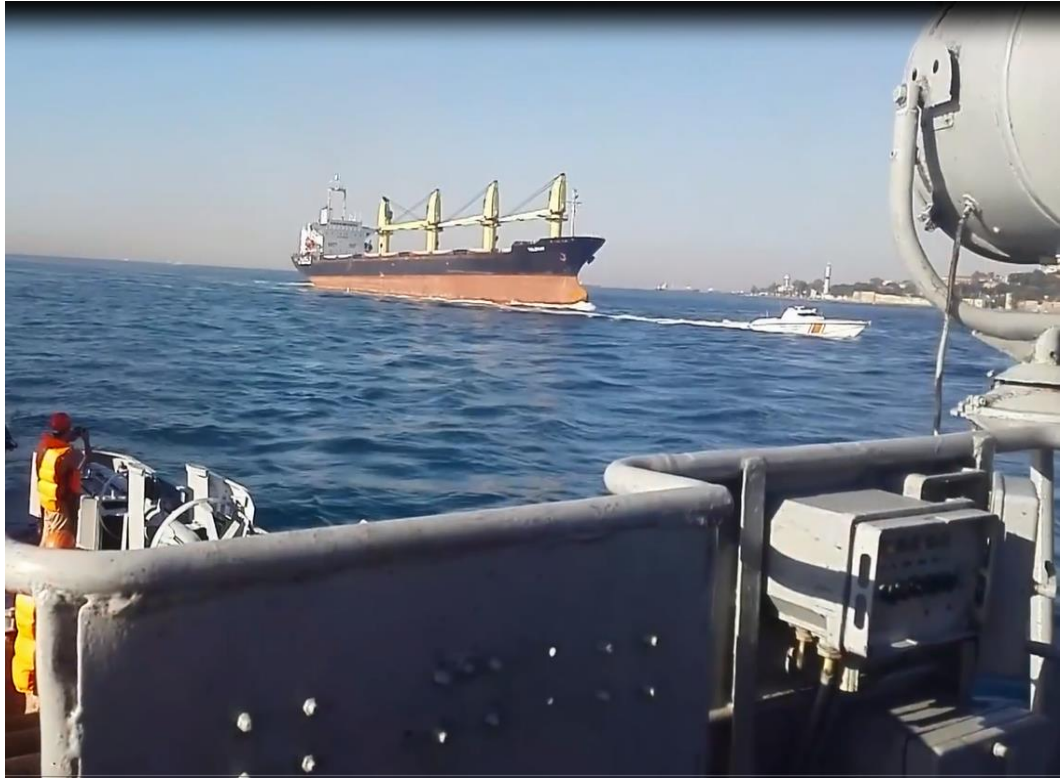
***Picture 4: Before TOLUNAY collided with TCSG 25 Boat***

At 08:17:36, when TOLUNAY was proceeding on the course 002 degrees at 9,9 knots speed, TCSG 25 Boat was proceeding at 015.75 degrees true bearing at a distance of 504.2 metres ahead of TOLUNAY. At 08:19:42, while TOLUNAY was proceeding on the course 001.3 at 9,8 knots speed, TCSG 25 Boat was navigating at 009 degrees true bearing at a distance of 326.8 metres ahead of TOLUNAY. Last position information received from TCSG 25 Boat (41° 00' 47,74"N-28° 59' 47,11"E) was at 08:21:14. A few seconds later, TOLUNAY collided TCSG 25 Boat on her port quarter, as a consequence TCSG 25 Boat went down under the bulbous bow of TOLUNAY and came out of the water as she capsized, from the port side of TOLUNAY (Pictures: 4, 5, 6). One ship whistle blast was heard, simultaneously with the time of the collision.

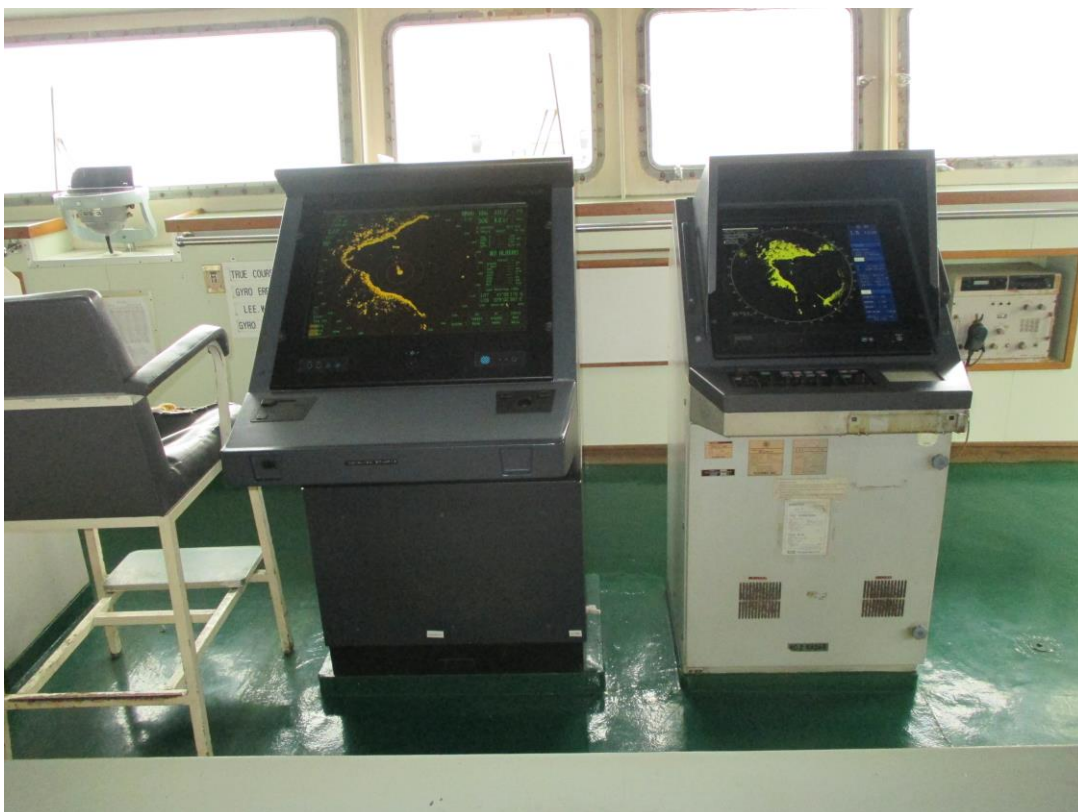
**Picture 17:** *MV TOLUNAY's Radars*

There are two radars right on the starboard side of the centre line of the bridge(**Picture 17**). The Chief Officer told that he was next to the chart room right before the accident and that

It is found that, only the speed and courses of MV TOLUNAY and the Russian Federation navy ship VALENTIN PIKUL could be detected from the VDR records (**Annex-4**), whereas voice and radar screen pictures could not be recorded due to a defect in the VDR. Therefore, no recorded information could be reached regarding the ship's radars' operation range and their mode of use (Head Up/North Up/Course Up) at the time of the accident.

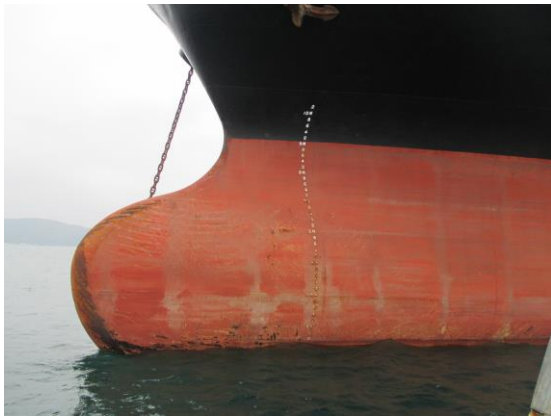
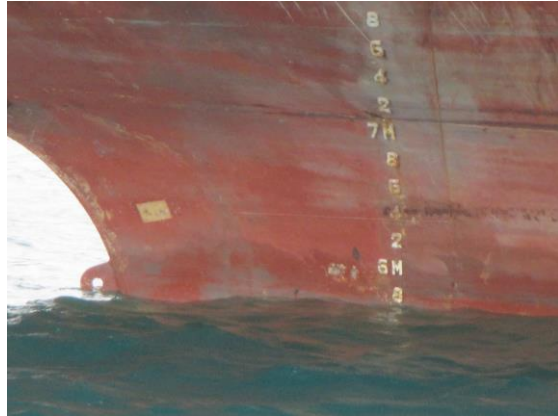
**Picture 18:** MV TOLUNAY's Forward Draft **Picture 19:** MV TOLUNAY's Aft Draft

Upon investigation of MV TOLUNAY, both the trim to aft caused by the ballast condition of the ship and the blind sectors caused by the ships' cranes were among the contributing factors of the accident.

In order to calculate the blind sector at the forward area of TOLUNAY, the draft values of the ship at the time of the accident need to be known. The draft values according to the pictures taken during the accident investigations on 26th August 2017 (*Pictures 18,19,20*) were as follows ;

Aft Draft: 5.8 metres,

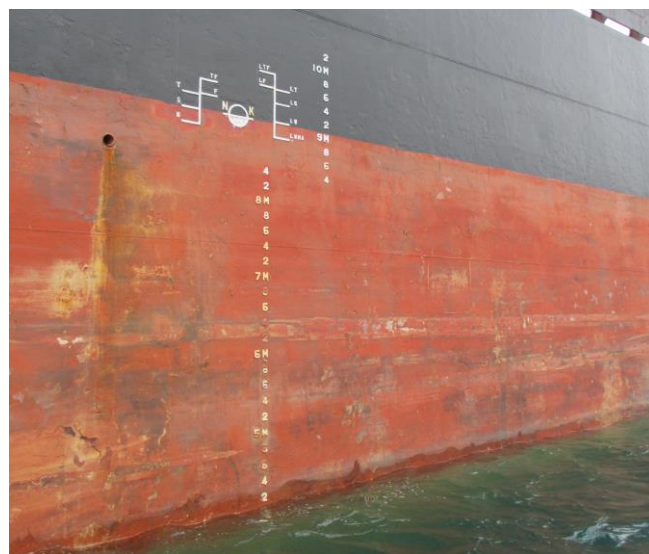
**Picture 20:** MV TOLUNAY'S Mean Draft

Mean Draft : 4.2 metres.

In view of the present draft values, it is observed that the ship was trimmed 2,8 metres to aft. From the table which is drawn for the calculation of the blind sector starting from the ship's bow due to the draft difference (Annex-3:Table of Obscured Distance) when the mean draft and trim value is entered and after the necessary corrections are applied, it is determined that there is a blind sector of **332,28** metres starting from the bow of the ship. It is obvious that this value is going to increase even more according to the pictures taken on 26th August 2016. In SOLAS Part 5, Regulation 22 "Ships of not less than 55 m in length, as defined in Regulation III/3.12, constructed on or after 1 July 1998, shall meet the following requirements:

Turkish Straits" states in subparagraph 13 of paragraph b that "The vessel shall be trimmed and loaded in such a way that the area on her bow and further will be readily visible." As it is understood from this regulation, in order to provide a clear field of view on their bow, the vessels navigating in the straits must pay attention to their trims and loading conditions. However, it is evaluated that MV TOLUNAY's 2.8 meters trim to aft and the 332.28 meter blind area due to this trim when entering the Strait is in contradiction with the regulation of TBDDTDT.

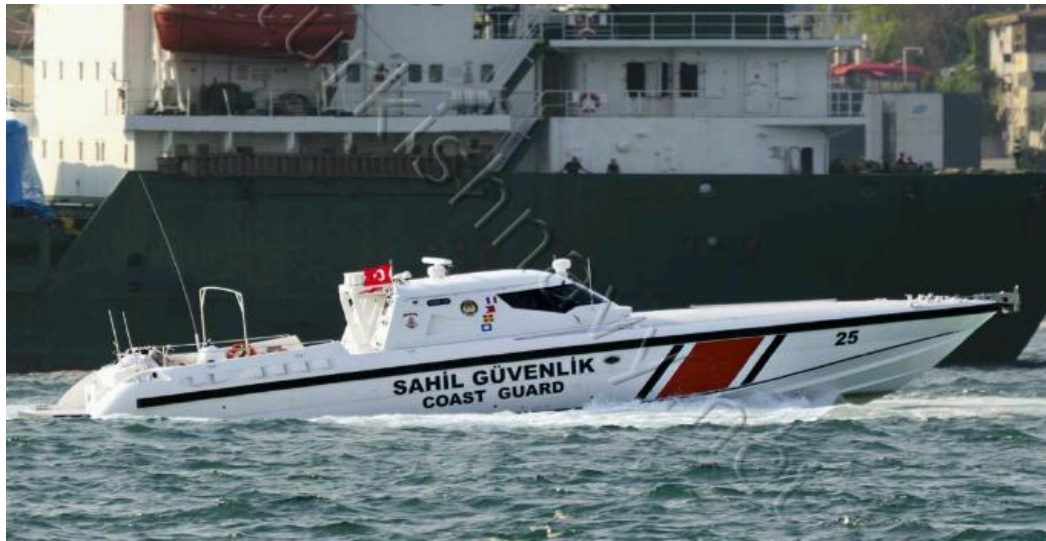
**Picture 24:** TCSG 25 Boat

As TCSG 25 Boat is shorter than 45 meters and it is built for military purposes, it is not obliged to meet the requirements of the above-mentioned Rule. Moreover, it also has an angle of view of 225 ° thanks to the portholes located on the starboard and port sides (**Picture 24**). But, during the fulfillment of specific tasks such as guard and escort missions, taking additional precautions should be considered to prevent the recurrence of similar accidents.

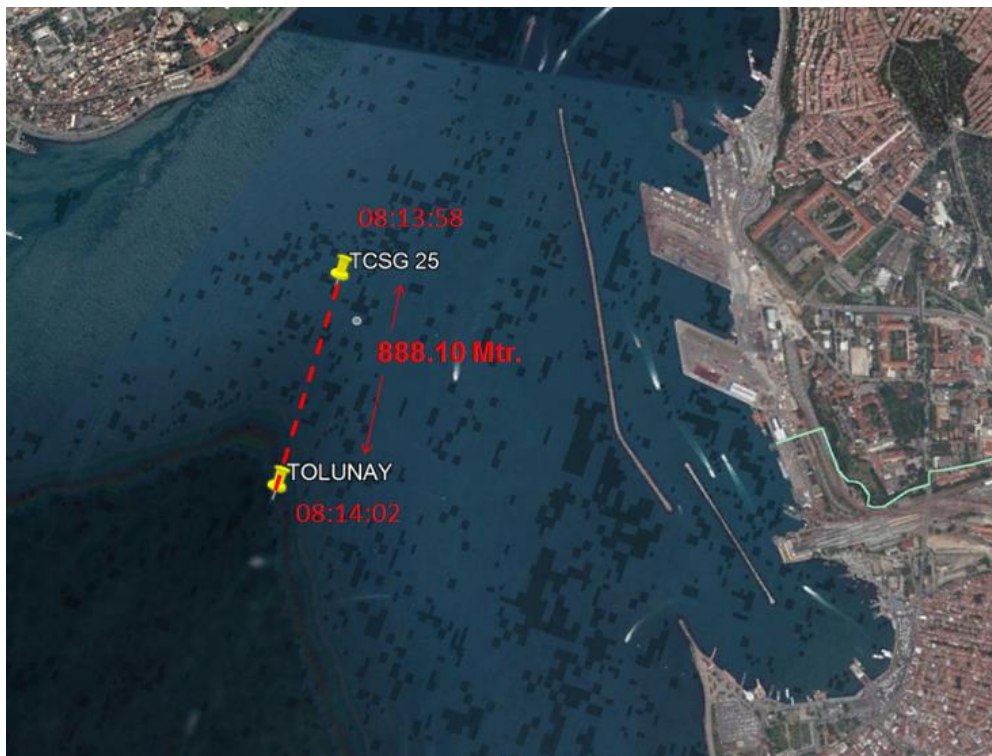
**Figure-3:** Distance between the two vessels at the time of the U-turn of TCSG 25 Boat

TCSG 25 Boat made a U-turn at about 10,8 knots speed and placed herself at the aft of navy vessel VALENTIN PIKUL to carry out her duty to escort and guard her at 08:13:58, while she was at a distance of 4,8 cables (891.10 meters) from the bow of MV TOLUNAY **(Figure 3)**

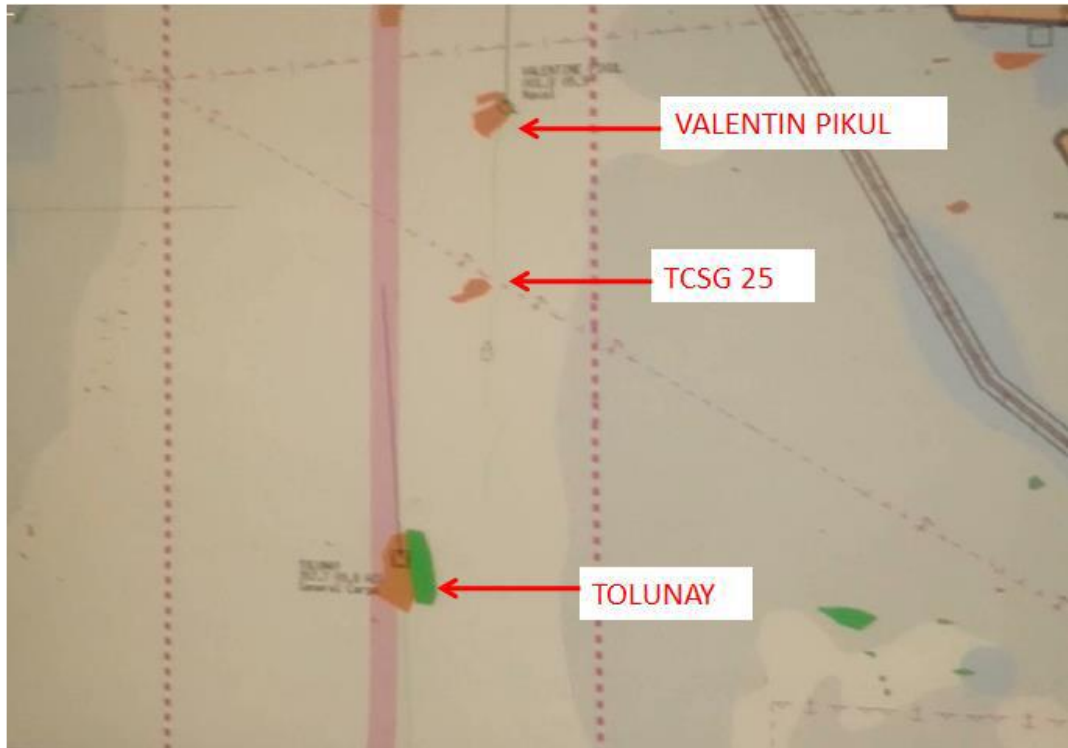
**Figure-4:** Ships' Positions Relative to One Another at 08:15:00

In addition to this, it is seen from the VTS records that, MV TOLUNAY was proceeding on the course 357.7 degrees at 08:15:00 (**Figure 4**) whereas her course at 08:21:14, which is the time of collision, was 004.1 degrees (**Figure 5**). And when TCSG 25 Boat made the U-turn at 08:14:00, TCSG 25 Boat was at a relative bearing of 10.9 degrees to starboard side from MV TOLUNAY and the distance between the two ships was 771.3 meters. Despite this, TOLUNAY's altering her course 6.4 degrees to her starboard, towards TCSG 25 Boat in other words, within the 7 minute period before the time of collision (**Figure 6**), proves that MV TOLUNAY did not see TCSG 25 Boat.

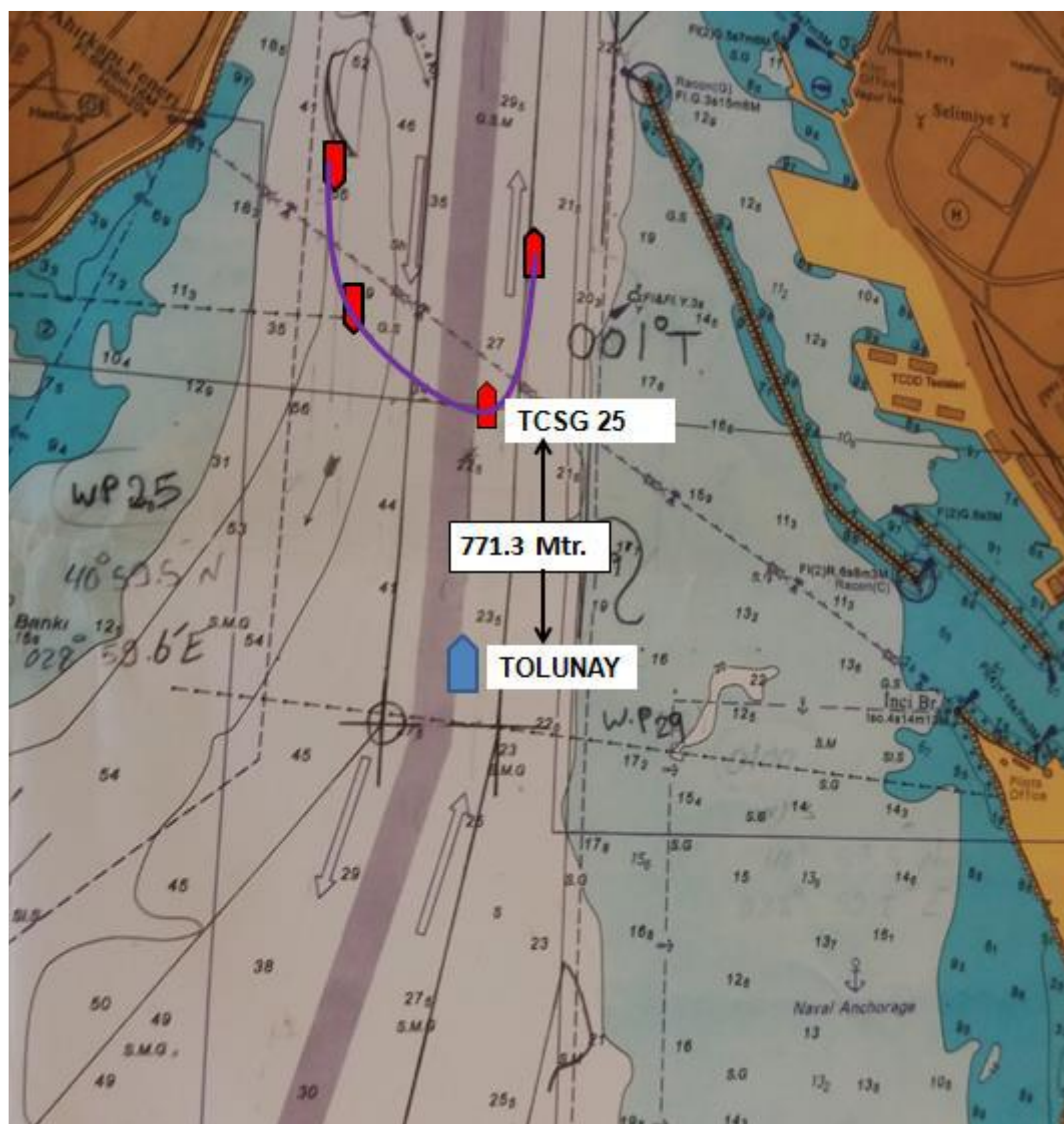
**Figure 9:** Distance between the vessels after the U-turn of TCSG 25 Boat

TCSG 25 Boat made a U-turn before the bow of MV TOLUNAY at 08:14:30 and placed herself at the aft of the Russian Federation navy vessel VALENTIN PIKUL to carry out her duty to escort and guard the vessel. At this time, there was a distance of 771.3 meters (approximately 4 cables) between MV TOLUNAY which was proceeding at 9.7 knots speed and TCSG 25 Boat which was proceeding at 8.6 knots speed and TCSG 25 Boat was positioned 10.9 degrees (relative bearing) to starboard side from the bow of MV TOLUNAY. (Figure 9)

In the 7 minute period before MV TOLUNAY collided with TCSG 25 Boat, MV TOLUNAY was 22.5 degrees abaft of the beam of TCSG 25 Boat. In the light of these data, it is determined that MV TOLUNAY was the overtaking vessel.

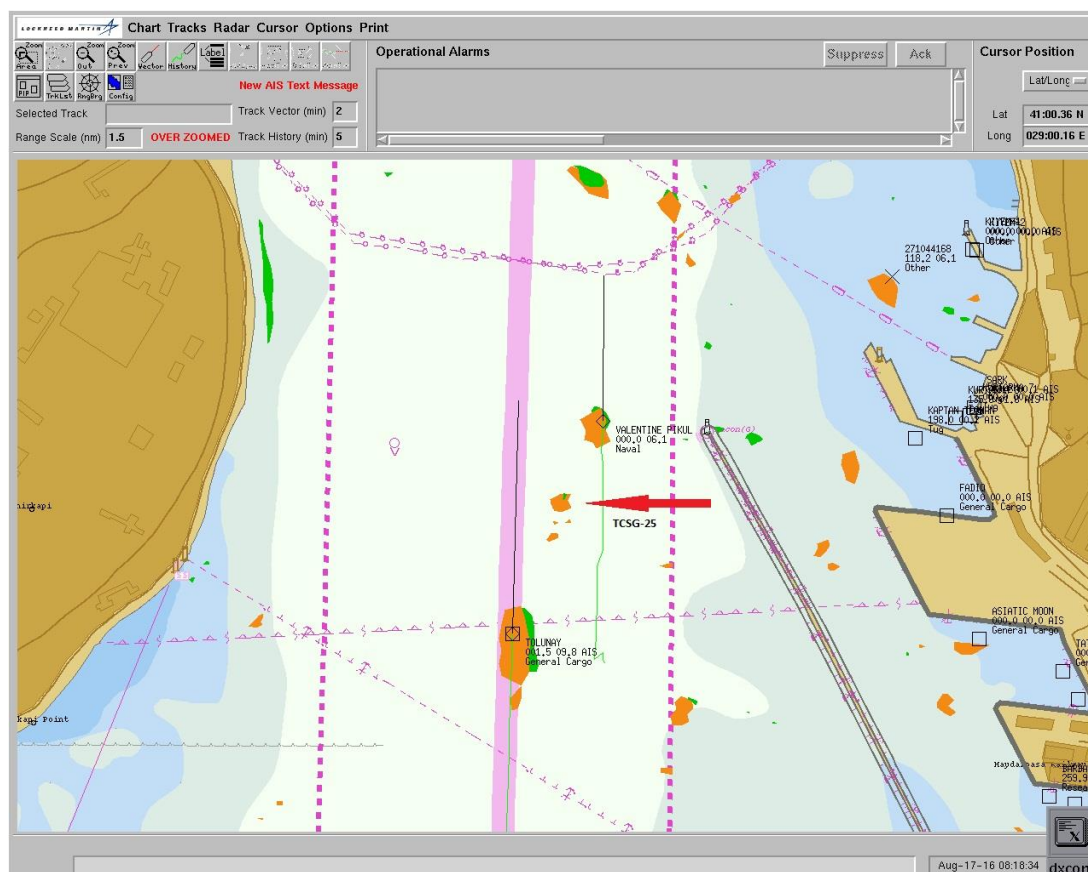
**Figure 10:** View of the Radar Screen of Istanbul VTS Before the Accident

It is considered that, if a good lookout could be established using these radar or proper use of radars could be made, TCSG 25 Boat which was proceeding ahead of TOLUNAY could be detected by radar even if it could not be seen with a visual lookout and the necessary manoeuvre could be performed so as to avoid collision. Indeed, from the radar information screen of İstanbul VTS, in the radar screen shot 3 minutes before the collision at 08:18:34, it is seen that TCSG 25 Boat was giving a clear echo (**Figure 10**).

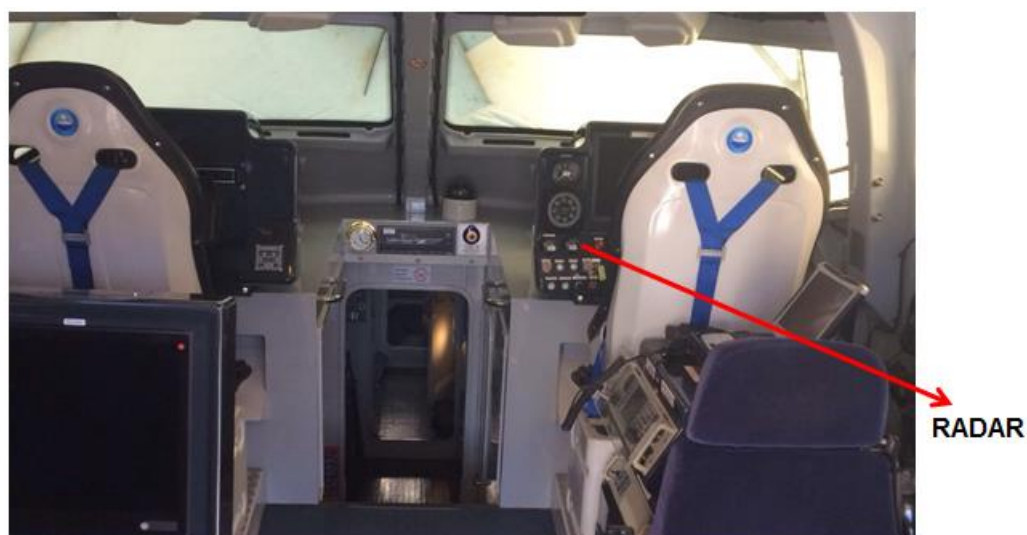
**Picture 27:** TCSG 25 Boat's Radar

There was one radar right on the starboard side of the bridge centre line of TCSG 25 Boat (Picture 27).

In the investigation on TCSG 25 Boat after the collision, it is observed that the power unit on the panel which shows the electric current that feeds the electronic devices on the bridge was green (**Picture 28**) and therefore it is concluded that TCSG 25 Boat's radar was not out of order. Although there is not a clear information about whether TCSG 25 Boat's radar was operating actively during her navigation, from the video display that was recorded by the Russian Federation navy ship which shows the last one minute before the collision, it is observed that TCSG 25 Boat's radar antenna was not rotating and therefore it is considered that it was not operational.

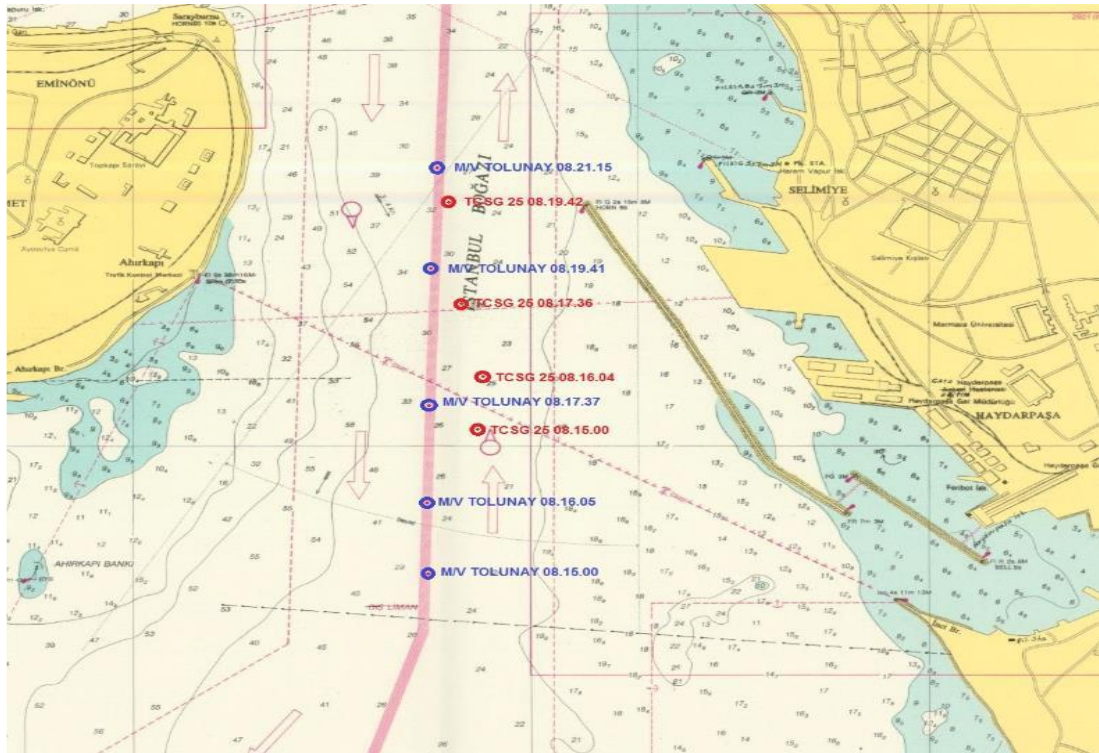
**Figure 11: TCSG 25 Boat Moving Towards Port Side After Her U-Turn**

The course and speed of MV TOLUNAY and VALENTIN PIKUL and the speed of TCSG 25 Boat in the time period from when TCSG 25 Boat started her mission to guard and escort the Russian Federation navy ship VALENTIN PIKUL at 08:14:30 until the time of the accident at 08:21:14, are shown in Table 2. As the course of TCSG 25 Boat was not recorded at SAHMUS which recorded the Boat's speed, her course could not be shown at the Table. However, it is determined that TCSG 25 Boat moved approximately 123 metres towards her port side from the time when she started her guard and escort mission until the time of the accident (**Figure 11**).
