**REPUBLIC OF TURKEY**  
**MINISTRY OF TRANSPORT AND INFRASTRUCTURE**  
**Accident Investigation Board**

**Accident Investigation Report On**  
**The Foundering of TINAZTEPE S**

**Bay of Sirte / Libya**  
**16<sup>th</sup> of March 2017**

**04/DNZ-01/2018**

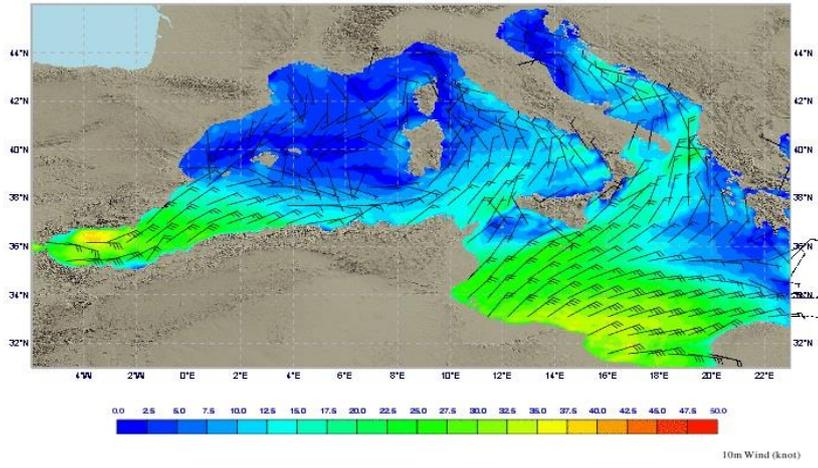
Figure 3: Wind Model Derived for the Accident Day

Wind and wave models derived from the internet site of Turkish Meteorological Service for the day that incident happened is shown on Figure 3 and 4. As it is seen from the figures, on 16<sup>th</sup> of March 2017, on accident scene within the Gulf of Sidra, wind was blowing as 30 knots and above and the wave height was 2 meters and above.

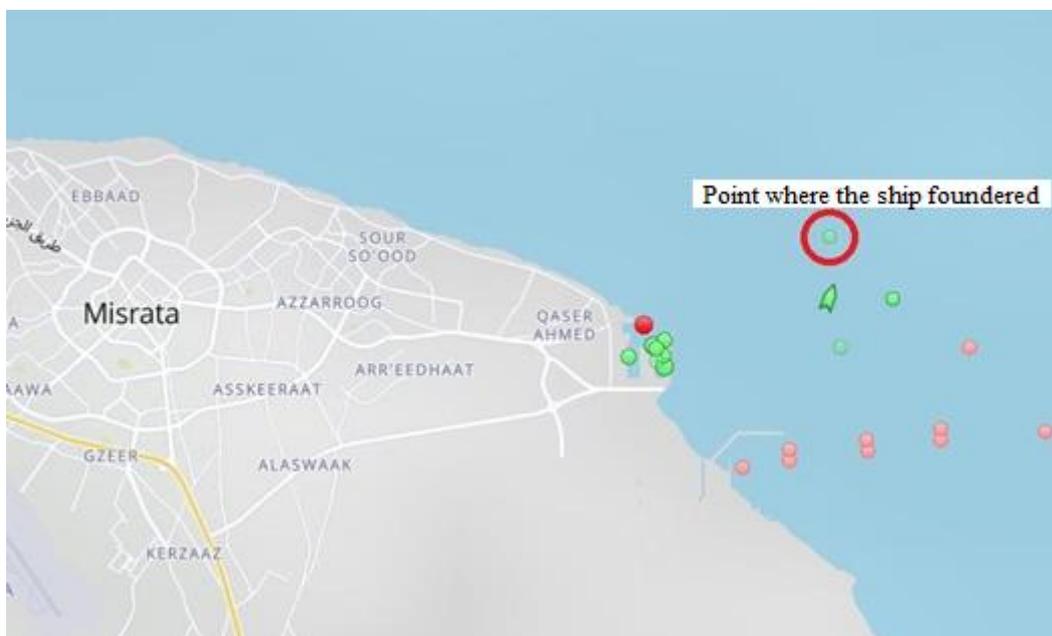
*Figure 7: Position Where the Ship Foundered*

approximately 2 nautical miles off the Misurata port around 11.50 after a short while following the crew abandoning the ship. (**Figure 6 - 7**)

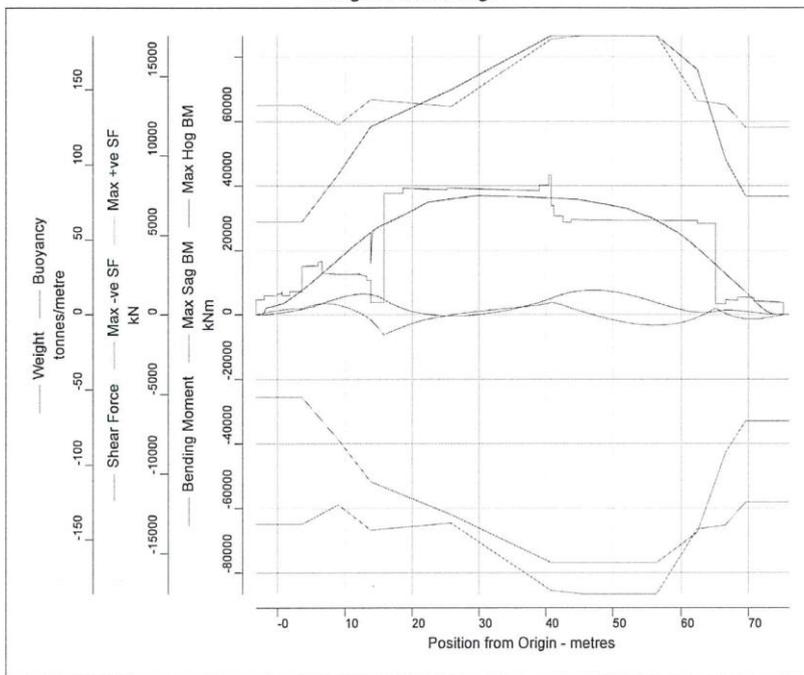
Shearing Force and Bending Moments

Assuming that cargo distribution inside the holds of TINAZTEPE S is at the condition observed in **Figure 15**, as a result of ships' hull form to be regenerated according to the new software used by Turkish Lloyd and taking the allowable maximum longitudinal strength values from the "Bulk Cargo Loading Booklet", it was observed that inside hold number 1 between frame number 68 and 111, 1300 tons of dolomite and inside hold number 2 between frame number 23 and 68, 1820 tons of dolomite was loaded and under these loading conditions, the ship was inside the limits of allowable shearing force and bending moments. (*Annex-3*)

However it is assessed that, the cargo was dispersed near midship section and when taking into account the condition and age of the ship, the weather conditions forced the ship to experience structural stresses and created additional stresses on ships' structural integrity and consequently ship was deformed close to the midship section and was broken.
