**VITASPIRIT  
Marine Safety Investigation Report**

**Due to the Striking Mansion on the Eastern Bank of the Strait**

**Strait of Istanbul**

**07 April 2018**

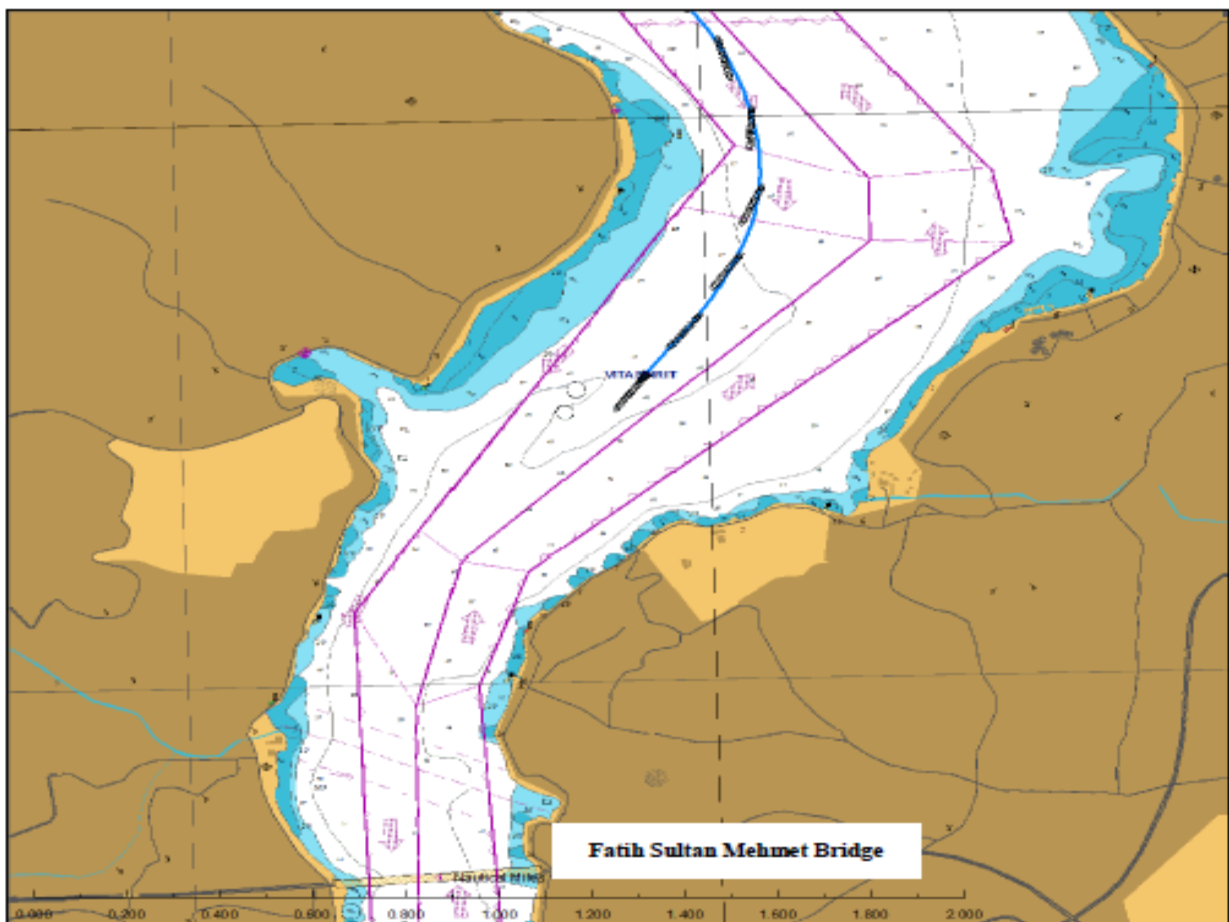
**Figure 6: Position of *Vitaspirit* 1524**

At about 1520, when *Vitaspirit* was passing Yeniköy Point close to starboard, the pilot ordered a 10° starboard helm to commence a 70° turn. At about that time, the duty oiler in the engine-room detected a fresh water leak on main engine cylinder no. 5 cooling water jacket and informed the chief engineer. The chief engineer, along with the third and fourth engineer, left the ECR to investigate. On discovering the leak, the chief engineer instructed the engineers to top up the expansion tank with fresh water. About four or five minutes later, he called the bridge and informed the master that the vessel had a problem with the main engine. The master instructed him to try and rectify the problem since *Vitaspirit* was in the approaches to the second bridge - Fatih Sultan Mehmet (Figure 6).

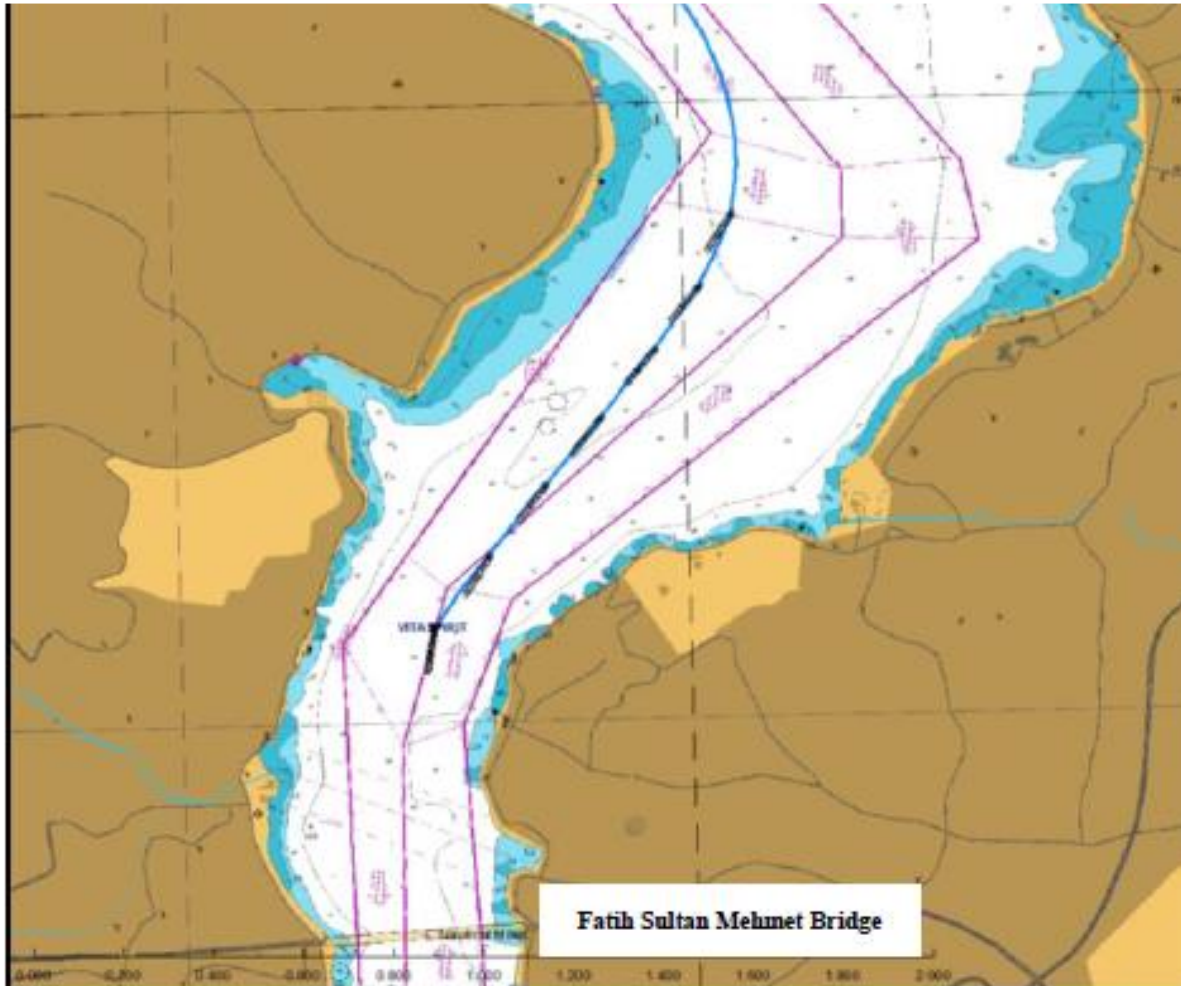
**Figure 7: Position of *Vitaspirit* at 1528**

an alarm sounded on the bridge. The alarm, which had also activated in the ECR, indicating a jacket cooling water low pressure. The RPM automatically dropped to 44 (Figure 7). The pilot enquired whether there was any problem. He reacted by ordering maximum starboard helm to arrest the rate of turn, ‘stand-by the anchor’ and called VTS for tug assistance.

The chief engineer heard the main engine slowing down and rushed to the bridge to give the master a full appraisal of the situation. He then returned to install a blank into the outlet of cylinder no. 5 and close the fuel inlet. Shortly afterwards, another alarm – high temperature of cooling water outlet activated.

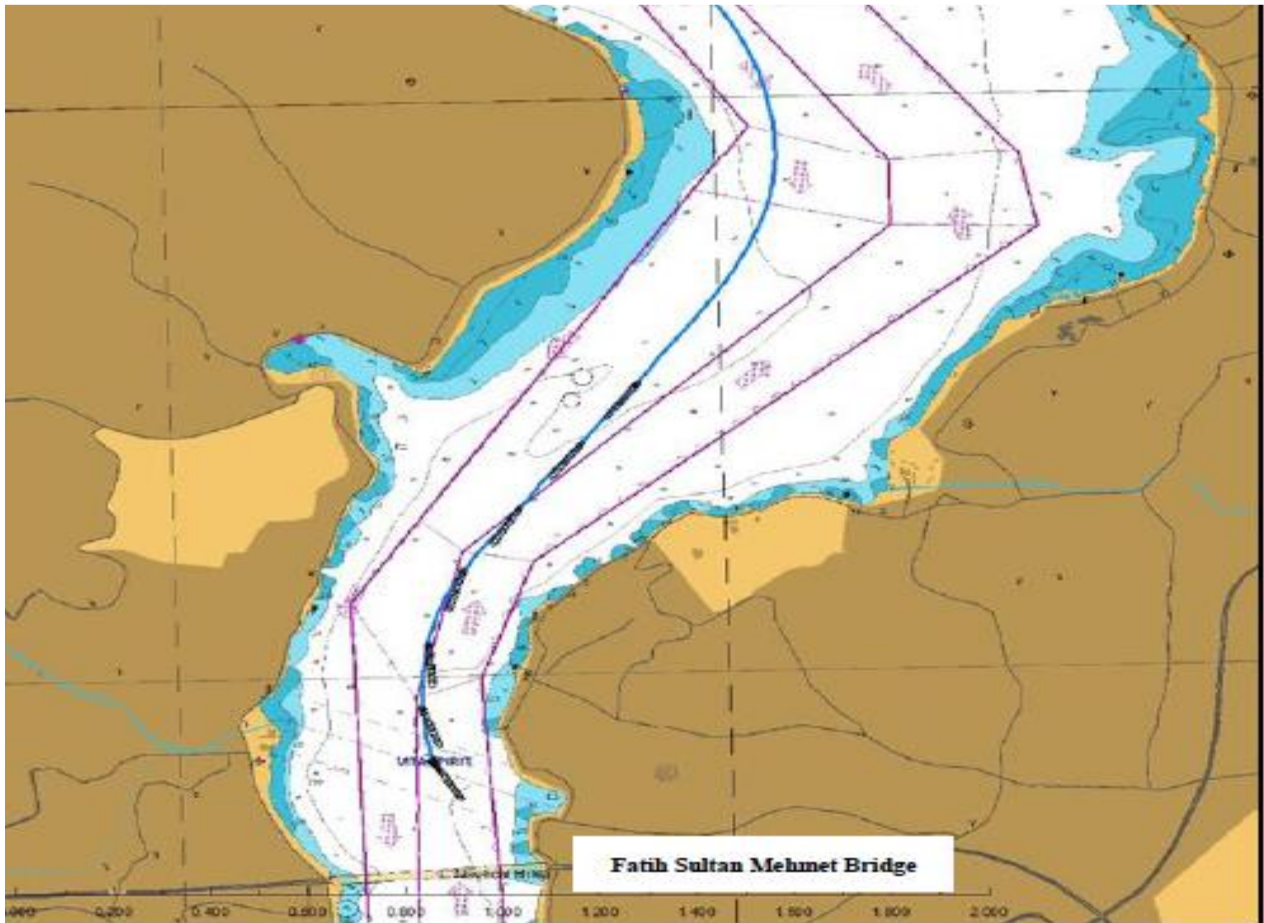
**Figure 8: Position of *Vitaspirit* at 1531**

Over the next two minutes, *Vitaspirit* was slowly moving ahead under her own momentum and gently veering to port (Figure 8). The pilot repeatedly told the master to 'let go both anchors', who in turn ordered the bosun on the forecastle to release the anchors, It was strongly recommended by the Strait pilot to the master of the vessel to drop anchor. However, the master, who was in constant communication with the engine room, avoided to drop the anchor as he hoped the engine would operate again. The captain gave instruction to drop the anchor just before crashing into the coastal structure but both anchors couldn't be let go.

The pilot pushed the ship's whistle to warn the people on the bank. The whistle did not work and no anchor was dropped. At 1533:23, *Vitaspirit* struck and demolished Hekimbaşı Salih Efendi Mansion on the Eastern bank of the Istanbul Strait in position 41° 05.51' N 029° 03.86' E. The position of allision corresponds to the vessel's GPS position where the bow made contact with the mansion.

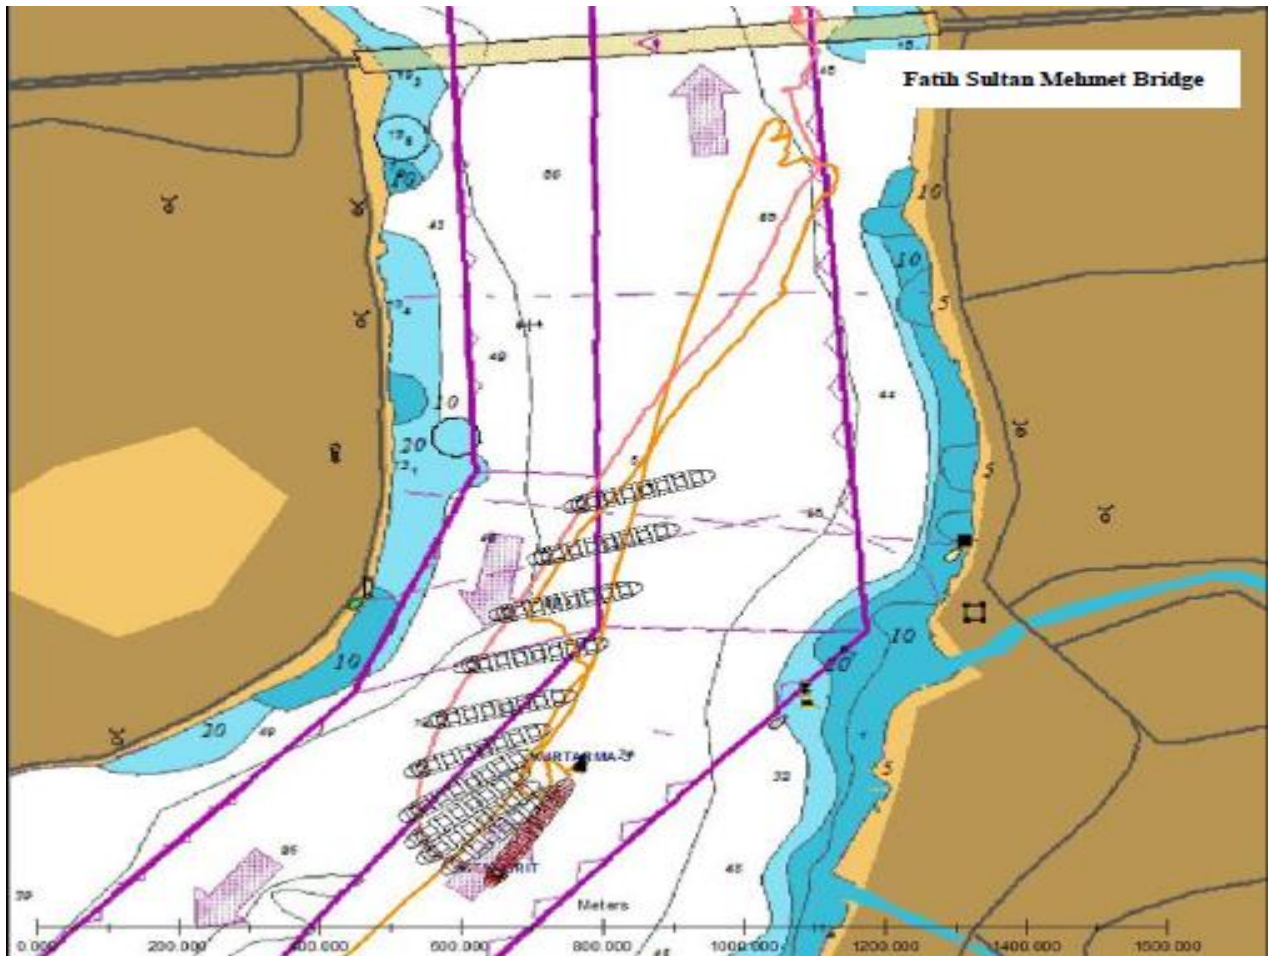
**Figure 9: *Vitaspirit* coming-up to port and starboard anchor midstream.**

The master initiated the Company's SMS post-grounding checklist and checked all tanks and cargo holds. The ship stayed upright and her draughts remained unchanged. There were no reported pollution and injuries. Meanwhile, the chief engineer had installed a blank flange into the outlet of cooling water jacket. Cylinder no. 5 was thus isolated and by 1540, *Vitaspirit* was ready to re-start the main engine. By this time, tug Kurtarma 3 and tug Kurtarma 7 were in attendance. Using her own power and with the assistance of the tugs, *Vitaspirit* shifted downstream from the accident site. At 1555, she anchored mid-channel in the Strait, using her port and starboard anchors (Figure 9).
