MARINE SAFETY INVESTIGATION REPORT ON A VERY SERIOUS MARINE CASUALTY

VESSEL NAME : YILMAZ KAPTAN
IMO NO : 8132598
FLAG OF THE VESSEL : Türkiye
LOCATION OF THE CASUALTY : Antalya / Türkiye
DATE & TIME OF THE CASUALTY : 19 September 2013 - 16:12 (GMT +3)
FATALITY / INJURY : 1 dead - 2 injured
DAMAGE CONDITION: : There was material damage on board YILMAZ KAPTAN and SEAGULL EGE-7.
ENVIRONMENTAL POLLUTION : None

Board Decision No: 09 / D-04 / 2023

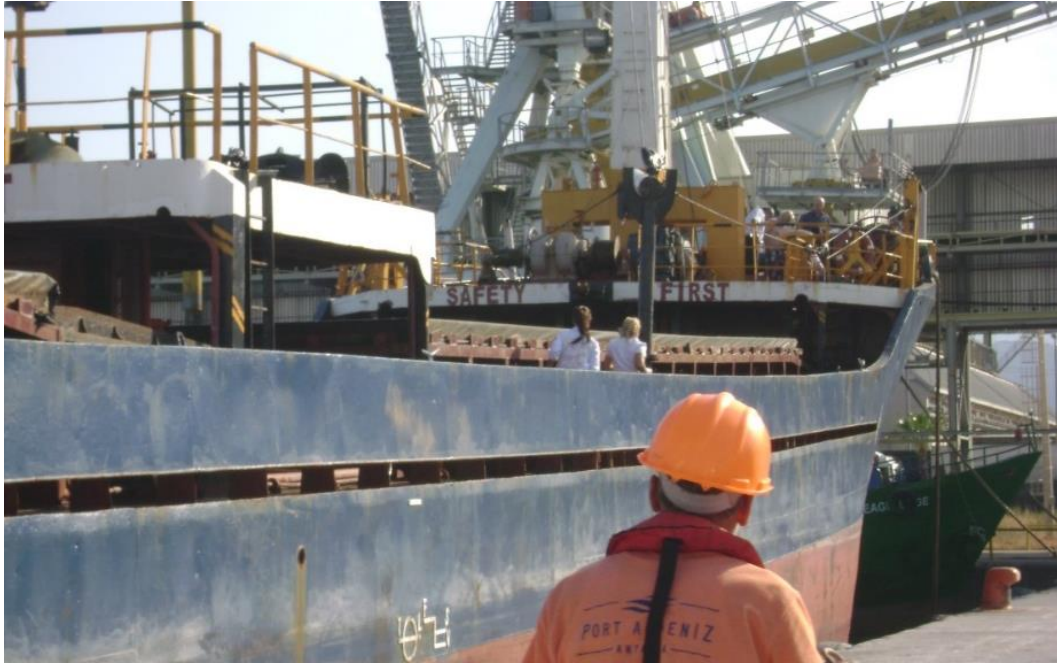
Image 4 Arrival Of Medical Teams To The Casualty Scene

The vessel continued to sail ahead and collided with the waste collection vessel SEAGULL EGE 7, which was moored at the berth.
